## Bulletin: CLIB-0010

**Topic:** HD UltraShift Clutch Broken Pressure Plate Ears

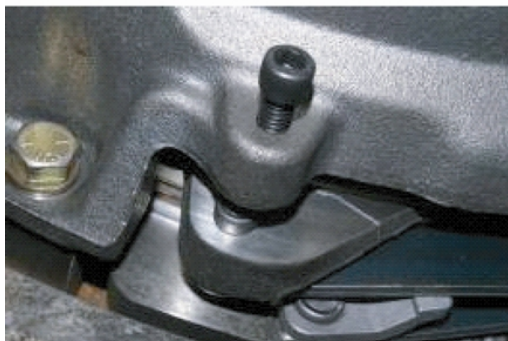
Warranty is seeing a small number of the ears on the pressure plate of the DM UltraShift clutch broken due to the mis-use of the jackscrew. Cases have been observed where the clutch has been operated and caused progressive damage to the clutch housing. The use of the jackscrew associated with the broken pressure plate ear is shown in below pictures. The right pictures show the evidence on the drive strap rivet of the use of the jackscrew. In all cases so far the jackscrew has been removed prior to submitting the claim.

Engineering has been able to replicate the failure by installing the jackscrew and when operating the engine found that it will break the ear on the pressure plate when the engine speed is increased, engaging the DM UltraShift clutch. In this condition, force on the ear of the pressure plate is in excess of 40 ft-lbs of torque, resulting in the breaking of the ear on the pressure plate.

**Broken ear with jackscrew in place**

Advise the technician that when re-installing the HD DM UltraShift clutch and utilizing the use of the jackscrews DO NOT exceed 9 ft-lbs of torque on the jackscrew.

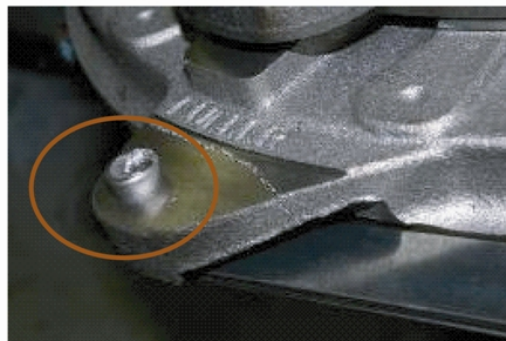
**Damage to rivet from jackscrew**
