Destructive Findings and Shift Detent mod.

Discussion in 'Technical Chat' started by Key-Rei, Jun 12, 2019.

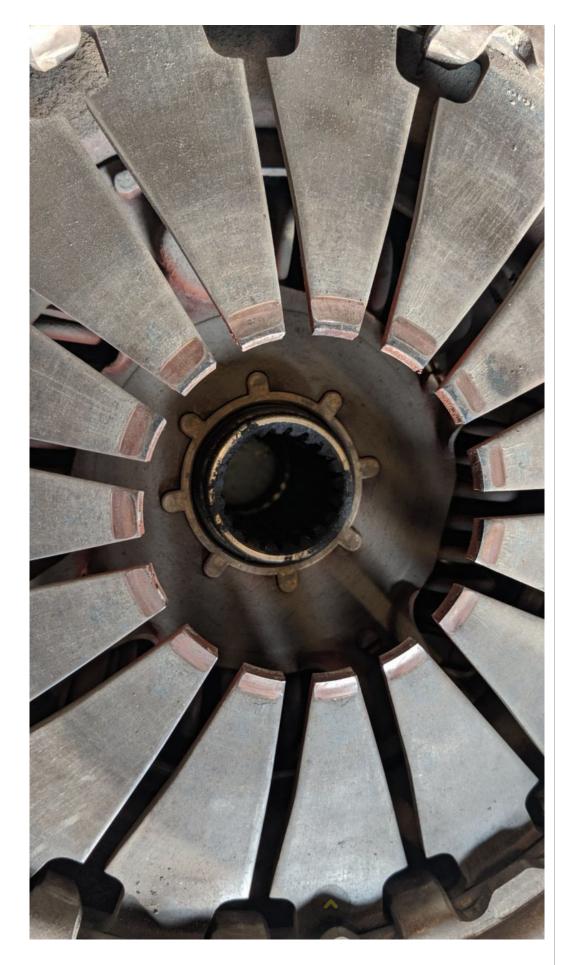
When the TOB is miss aligned on the pressure plate fingers the bearing is unequally loaded and this can generate squeaking and other noise when the clutch is engaged. (Foot off pedal.)

Here you can see how un-centered my bearing was, lower left of image you can see the lip of the TOB rode beyond the edge of the finger and across from it you can see it was a few mm onto the finger. It should be darn close to perfectly centered this is a high speed rotating assembly after all it needs equal support and pressure for even engage and disengagements and balance.

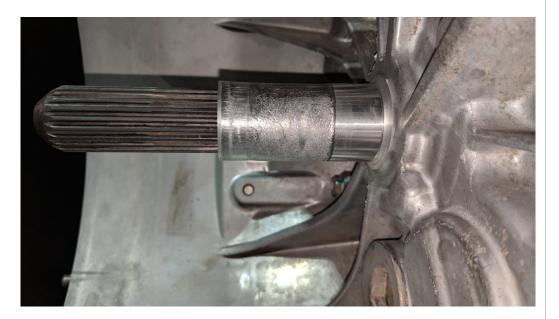
Worn quill, look how scarred that surface is! It should be near

polished to allow the TOB to slide. As is nearly a full mm of material has been removed from the TOB sliding back and forth. As the TOB wears the quill the bearing becomes more and more misaligned and greater pedal force is needed this and wears the quill faster and faster.

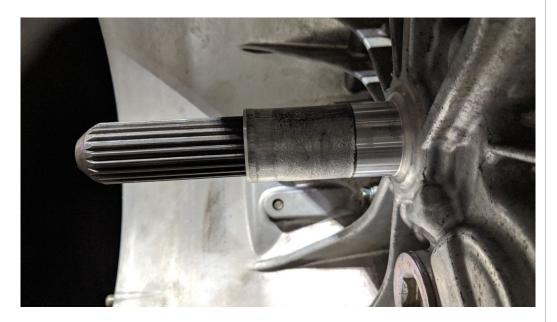
Again without flash look how concave those sides are!

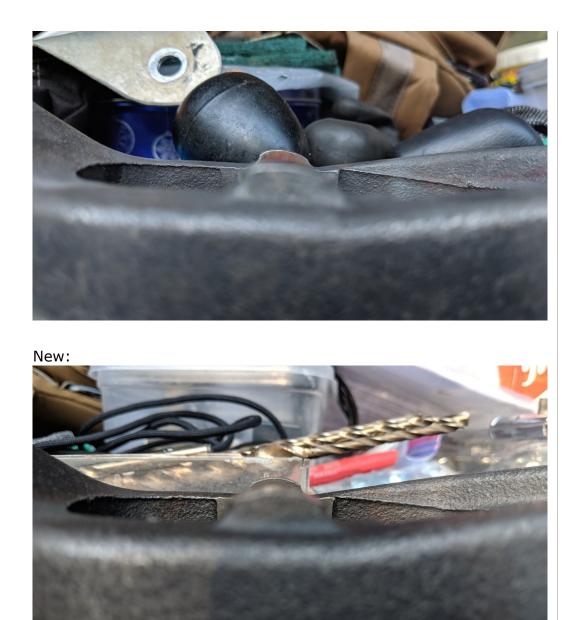
Worn:

It is also possible your alignment and noise issues are due to a worn support fork as seen below look closely at the profile of the humps in focus at the back. (Sorry about the visual noise in the background didn't think to put something solid up behind at the time.)

The fork should be LIGHTLY greased on top of those humps, on the flat insides where it makes contact with the sides of the release bearing and a small dab of grease in the channels on the back where the release bearing spring clips onto it. (Not pictured)

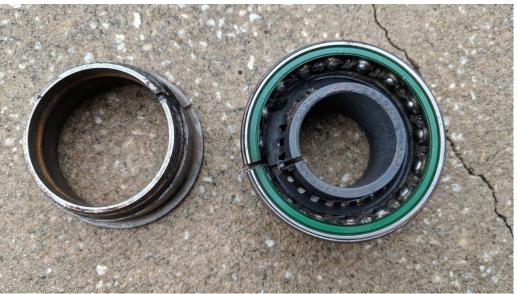
First point of note was made when making the first cut, the OEM bearing uses some form of sintered metallic plastic composite instead of a fully metal sleeve, I suspect this was intended to act sacrificially and be softer to protect the aluminum quill from wear but as the plastic abrades away quickly the metallic flakes are exposed and are harder than the quill and the smooth sliding inner sleeve quickly becomes sandpaper eating at that quill. The quick wearing plastic also allows room for sand to work it's way in between the sleeve and quill wearing even faster.

See the plastic buildup on the side of the cut line from the cutting wheel heat:

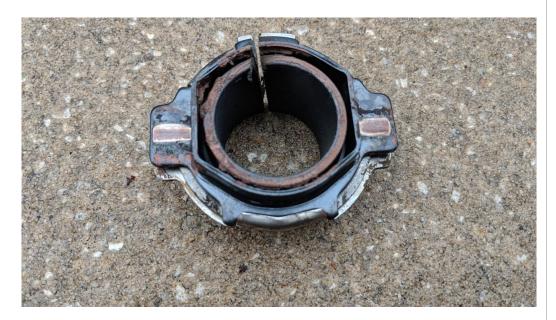
The back of the thatbearing that sits against the fork you can see the spots of wear and notice the flats that fit between the fork fingers when installed. Both the horizontal and vertical surfaces should have a LIGHT film of grease put on them when installing the new bearing.

You can also see residue of Toyota's misunderstanding of the issue squeak fix. What appears to be brass impregnated grease, that is the copper colored funk all over the back side. This is NASTY SHIT like thick nickel anti seize. Power degreaser and a pressure washer won't

Fortunately it seems reasonably susceptible to CRC brake cleaner and a little elbow grease. You now have more warning than I did, be prepared.

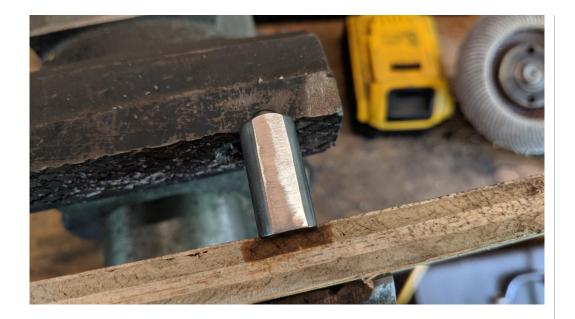
My attempt at grinding before I tried to flush it out and went too far, in retrospect it probably doesn't need to be perfect but I was doing my best to imitate what I saw from the other write up thread's pictures.

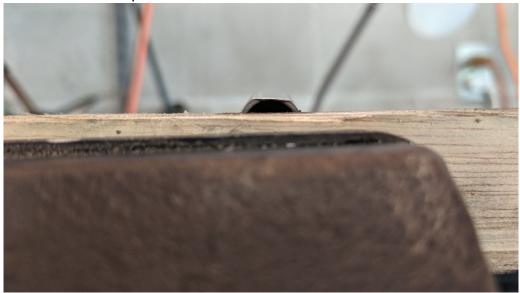
In my opinion this is too far as I realized only after obtaining the new OEM part. I do recommend if you attempt pin modification vs replacement with a factory part that you round the end of the cylinder as a sharp corners of the flat and kerf burn you can see below could hang up and score the aluminum bore of the transmission the pin lives in.

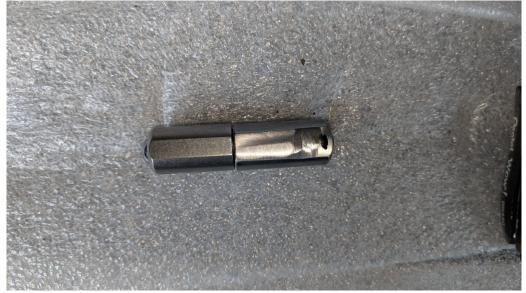
The problem arises as theorized because you have a round cylinder in a round hole and as it travels gear oil intended to lubricate it's action can get behind the pin and then have difficulty escaping when the transmission case and parts are ever so slightly enlarged due to heat soak as the cylinder tries to move back when it slides past the recesses in the shifter shaft as you change gears.

Old pin where you can really see the hole and new 3rd gen pin:

The solution is a detent pin with a D shaped cross section vs the original O shaped.

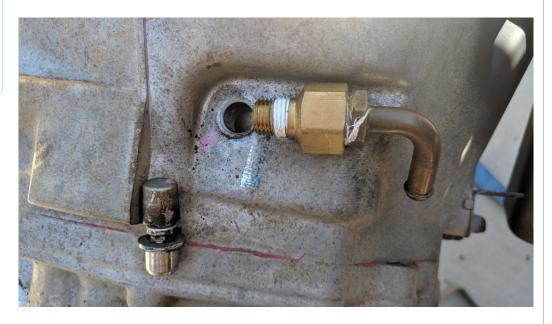
Use a wonder bar to pry the failed factory press fit breather out of the smooth hole the fitting and elbow shown is 1/4 NPT and is to demonstrate size only there is not enough clearance when installed for such a tall fitting.

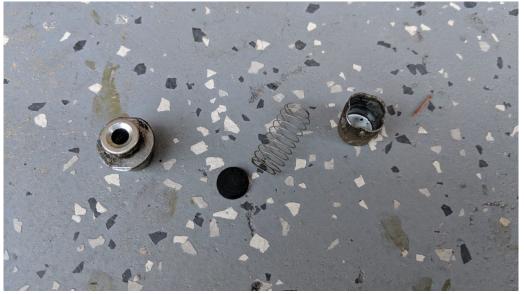
Broken dirty breather bits:
