# Eaton® Clutches CLTS1271

September 2011

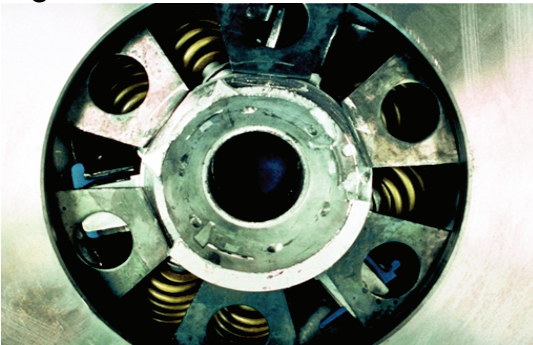
## Failure - Yoke Fingers Rubbing into Clutch Cover

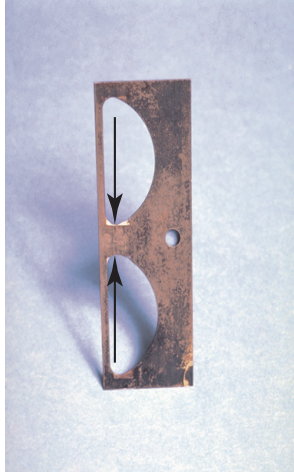
## Failure - Anti-Rattle Springs Installed Backwards

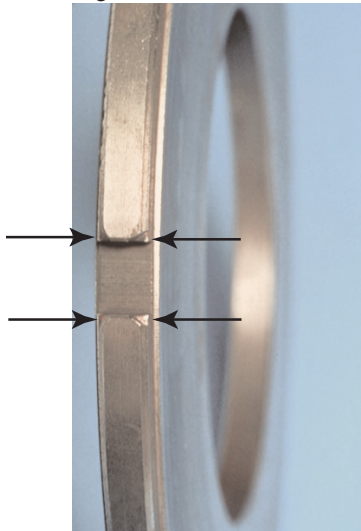
## Failure - Interference Between Retainer Assembly and Rear Disc Rivets

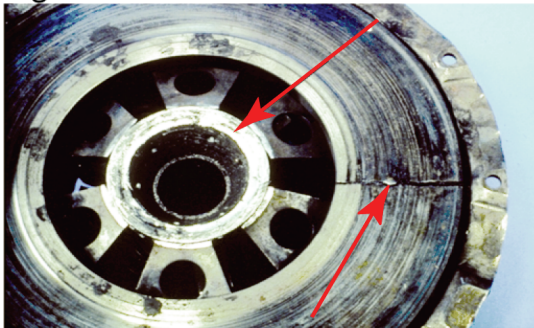
An additional result from the above failure is that while the clutch is engaged, it can begin to slip due to the unloading condition created by the disc and retainer interference. This, in turn, will create excessive heat and can cause the pressure plate to break (see Figure 25, black arrow on pressure plate) and /or the ceramic buttons to separate from the disc (see Figure 58). The above failure may also be preceded by a noise complaint.

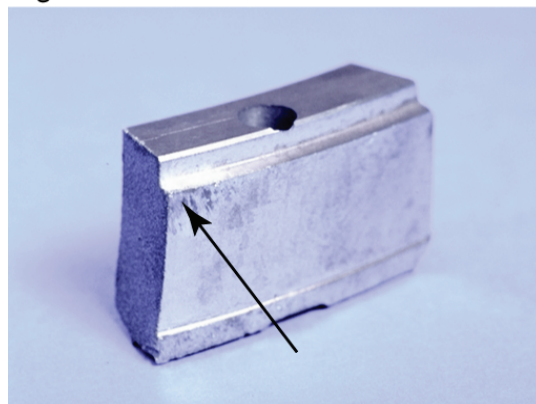
## Failure - Release Bearing

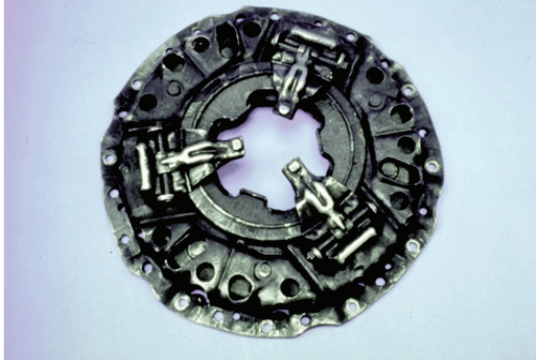
## Failure - Oil Soaked Cover

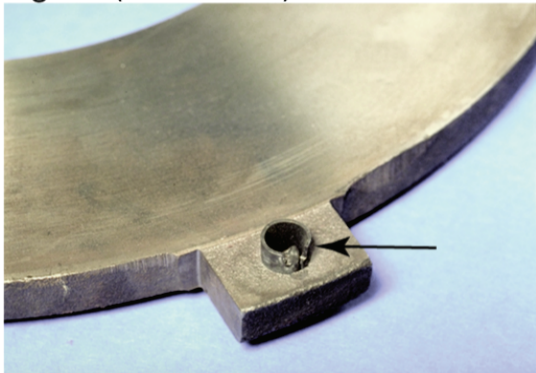
The damage done to the separator pins in Figures 32 and 33 (see arrows) is the result of using the wrong tool combined with excessive force. All four pins (on each intermediate plate) were damaged. When "setting" the four (4) roll pins, the proper tool would be a 1/4" flat nose punch used in conjunction with a small hammer (to help ensure light taps).

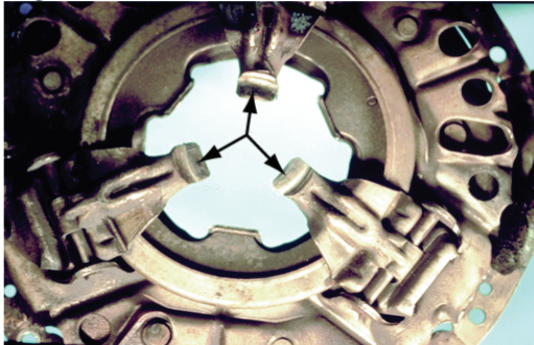
## Failure - Lever Wear

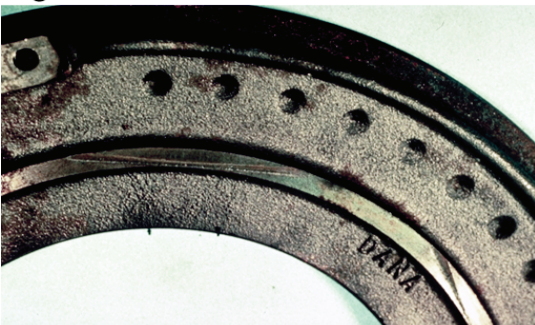
## Failure - Adjusting Linkage to Compensate for Easy-Pedal and Value Line Clutch Wear

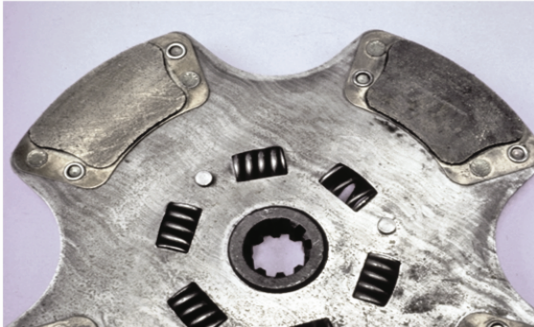
## Failure - Grease on Buttons of Ceramic Disc

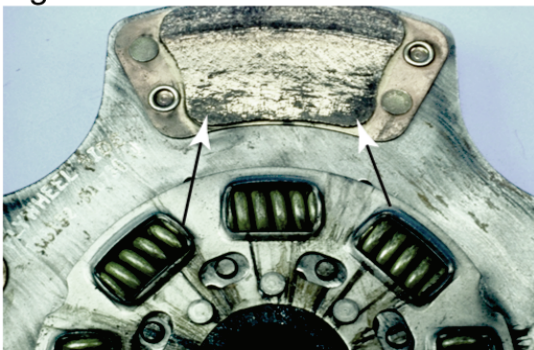
Greasing the splined areas of either the input shaft or disc hub(s) is not recommended because the grease can be spun onto the facing material of the driven disc(s) (refer to both arrows in Figure 44). The circled area in Figure 45 reveals the numerous paths which the grease took as it moved toward the buttons (facing material) of this ceramic driven disc. The photographs in Figures 44-45 are of the same driven disc.

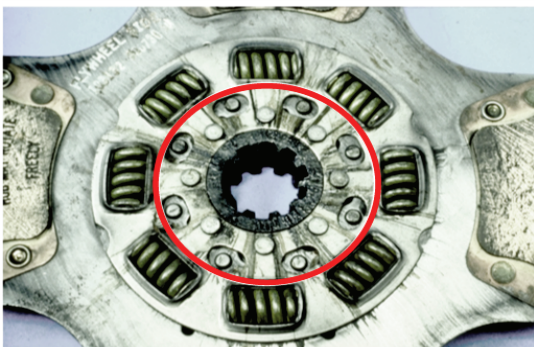
Also, grease on the splined areas of the input shaft/disc hub(s) will attract dirt, worn facing material, etc. which can impede the free movement of the disc hub on the input shaft, potentially causing a "poor release" complaint.

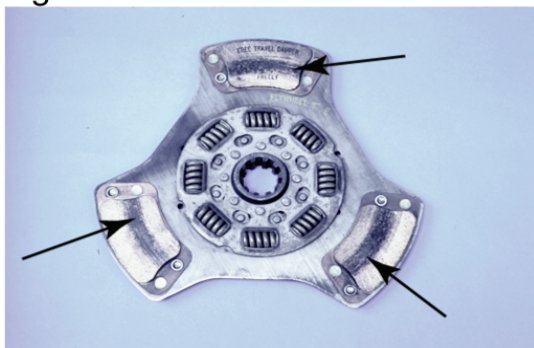
## Failure - Abnormal Wear Pattern at Middle of Disc Button

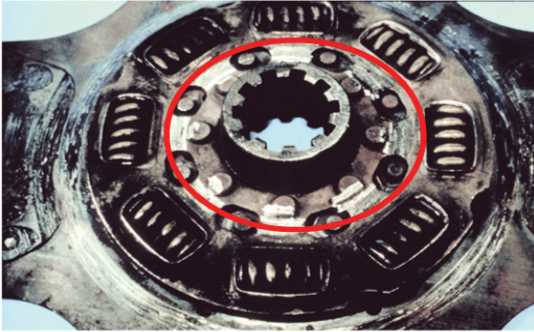
## Failure - Rear Disc Interfering with Retainer Assembly

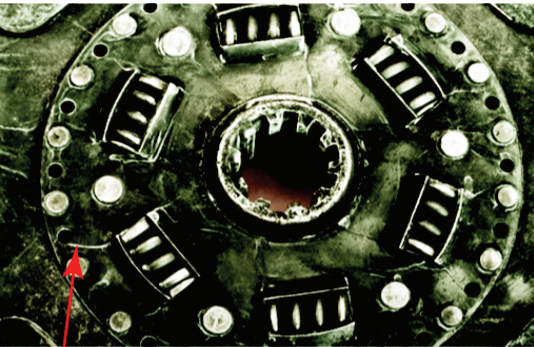
## Failure - Cracked Damper Cover

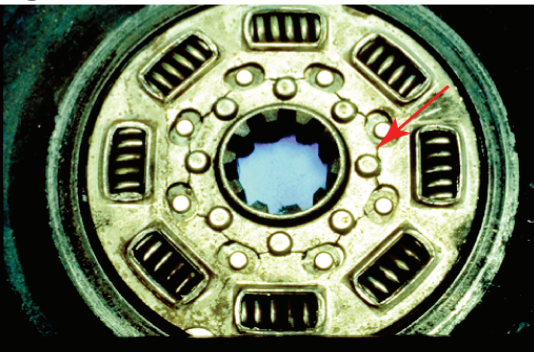
## Failure - Hub of Rigid Driven Disc Worn Excessively or Fractured

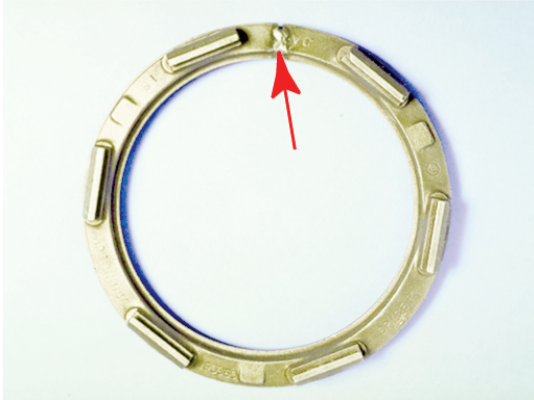
Note also the adjusting ring pictured in Figure 65. It was removed from a non-Eaton rebuilt clutch. This ring was cut open on one side, spread apart, and then welded (see arrow) at a larger diameter to prevent the adjusting ring from becoming loose once it was reinstalled. (Eaton Clutch does not weld adjusting rings, but rather discards any rings that are too loose.)

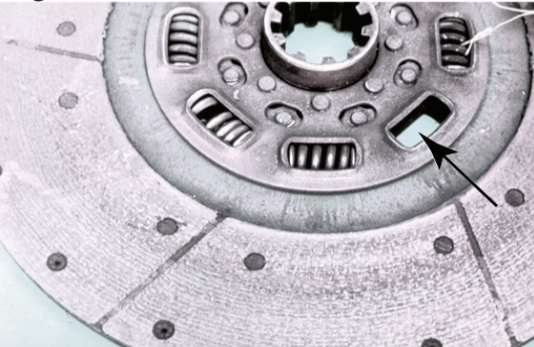
## Failure - Broken and/or Missing Dampener Springs

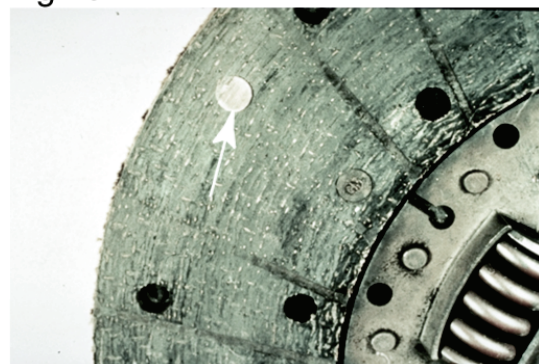
## Failure - Worn Driven Disc Facings

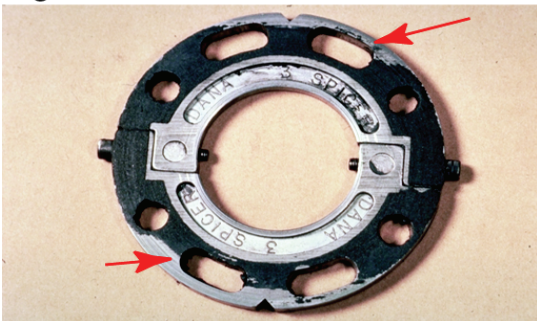
### Failure - Bent/Broken Kwick-Adjust® Mechanism

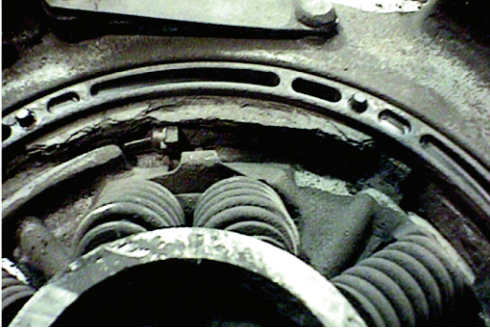
## Failure - Solo Adjustment Rings Contaminated - Solo Stops Adjusting

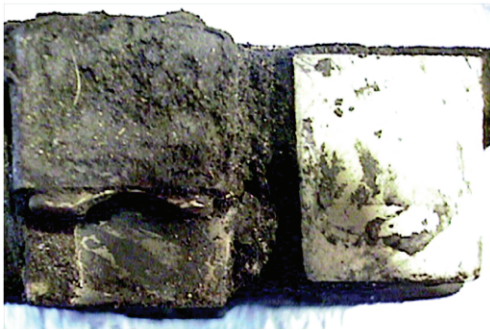
## Failure - Worn Wear Pad on Release Bearing caused by Running the Truck without Free Pedal

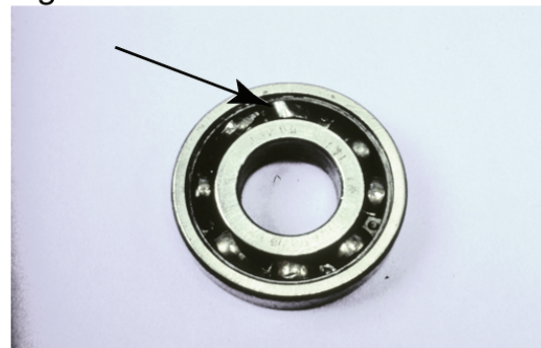
- A seized or rough pilot bearing will allow the input shaft to continue rotating even when the clutch is completely disengaged. As a result, the clutch brake can become damaged and eventually fail (see Figure 73 of “Worn Clutch Brake”).
- If the bearing fits too loose, the end of the input shaft won’t be properly fitted. Also, if the fit is loose, the races will skid rather than rotate the ball bearings.

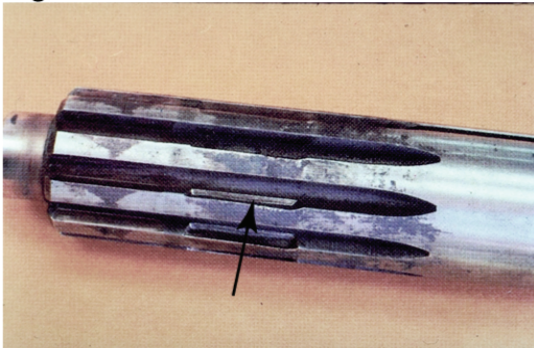
## Failure - Input Shaft (Drive Gear) Spline Wear

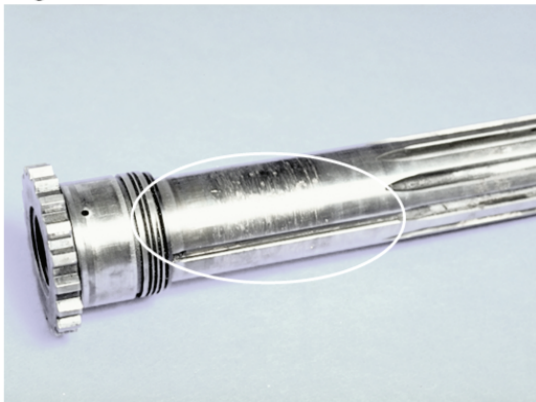
## Failure - Galled Input Shaft
