LuK Failure Diagnosis

Guidelines for Evaluating
Clutch System Malfunctions

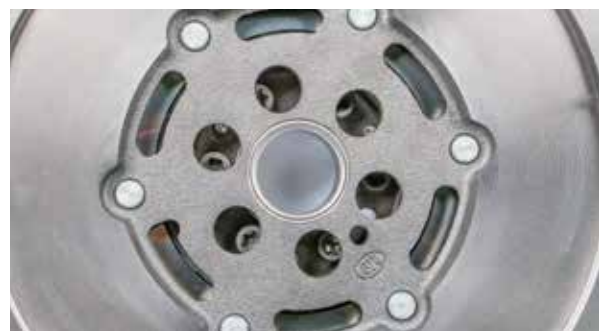
If the holes are offset in relation to the screws, the DMF could already be damaged. If this is the case, an in-depth inspection using the LuK special tool (part no. 400 0080 10) is recommended.

To avoid misdiagnosis in cases of damage, the DMF must also be inspected during the repair. If the holes in the primary and secondary flywheel are so offset that it is impossible to remove the mounting screws, this can indicate that there is a defective flange on the slipping clutch.

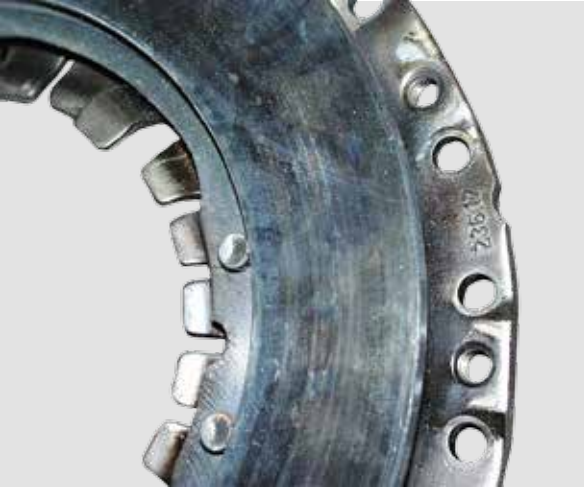
THERMAL LOADING ON THE PRESSURE PLATE IS TOO HIGH

- Oil or grease on the clutch linings
- Play of the release bearing is too low
- Release system is defective
- Operating error, e.g. allowing the clutch to slip for too long

- Rectify the cause
- Replace the clutch kit
- Advise the driver regarding possible operating errors (see page 6)

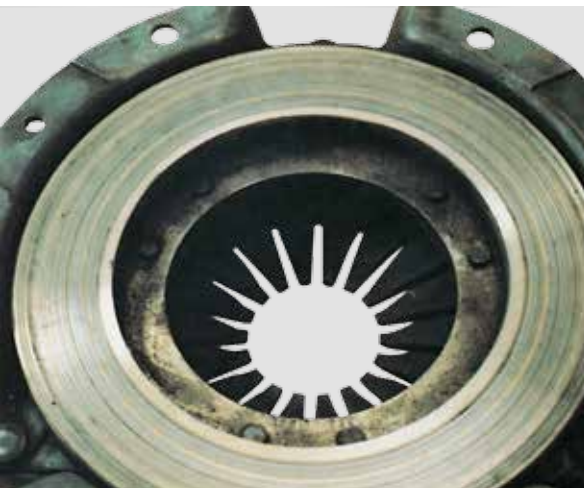
HEAVY SCORING AND TRACES OF OVERHEATING ON THE PRESSURE PLATE

- Clutch has been operated beyond the wear limit
- Play of the release bearing has been set incorrectly
- Release system is defective
- Operating error

- Rectify the cause
- Replace the clutch kit
- Advise the driver regarding possible operating errors (see page 6)

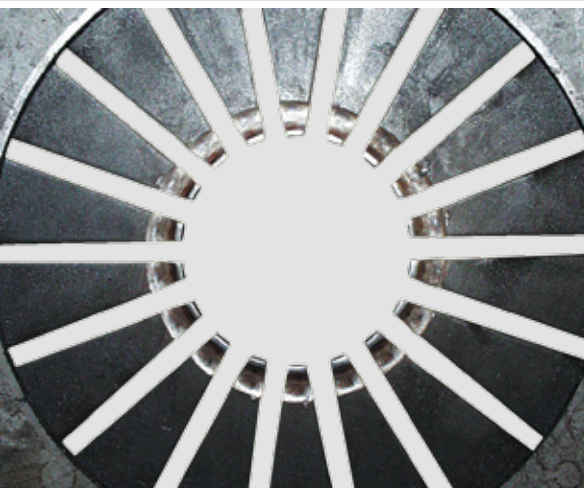
DISK SPRING TIPS HAVE BEEN RUN IN

- Release bearing preload has been set incorrectly
- Release bearing is stiff
- Hydraulic release system is defective

- Clutch slips
- Increased wear on the disk spring tips, to the point that the clutch malfunctions

- Check the release system and rectify damage if necessary
- Replace the clutch, release bearing and guiding sleeve

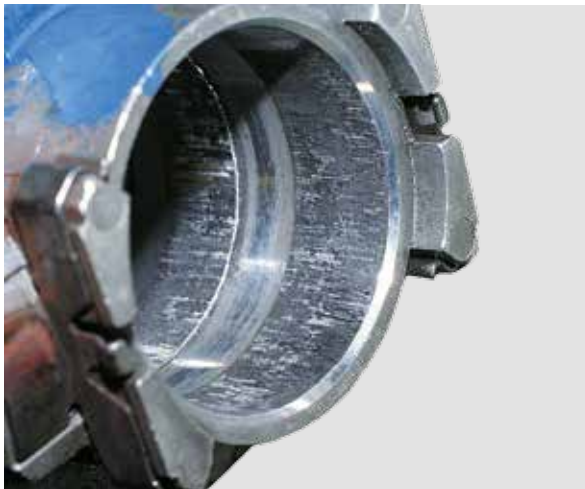
TRACKS IN THE RELEASE BEARING SLEEVE

- Release bearing has been incorrectly or insufficiently greased, or not greased at all
- Sliding bush is worn
- Release bearing is stiff

- Replace the sliding bush and the release bearing
- Grease according to the vehicle manufacturer's specifications if necessary
- Replace the clutch kit

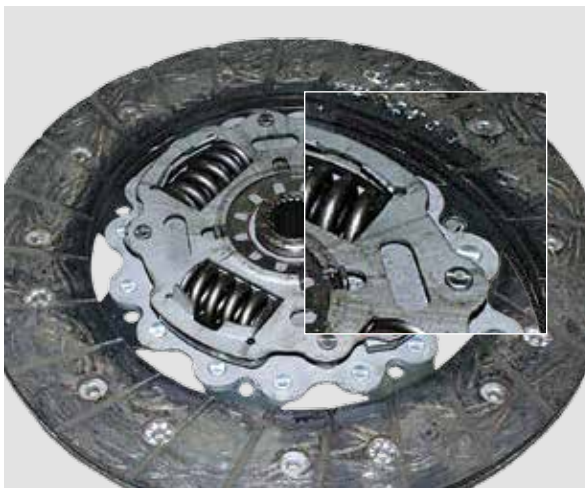
FRICTION LINING ON THE INNER RING IS OILY/ GREASY

- Radial shaft seals or other components in the engine/transmission are leaking
- Hydraulic release system is defective
- Hub profile over-greased

- Lubricant is transferred via the centrifugal force from the hub profile onto the clutch lining, leading to fluctuation of the frictional coefficient, which causes the clutch to grab or slip

- Replace the clutch kit
- Follow the greasing guidelines for the hub
- Check the release system
- Check the engine and transmission for leaks

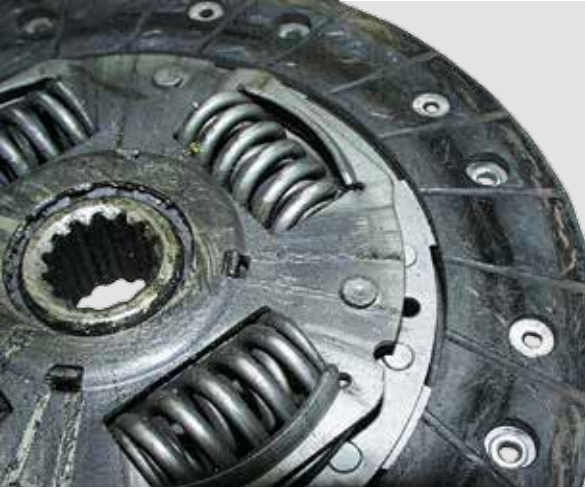
CLUTCH LINING IS OILY

- Radial shaft seals or other components in the engine/transmission are leaking
- Hydraulic release system is defective
- Hub profile over-greased

- Replace the rotary shaft seals
- Clean the clutch cover
- Replace the clutch kit

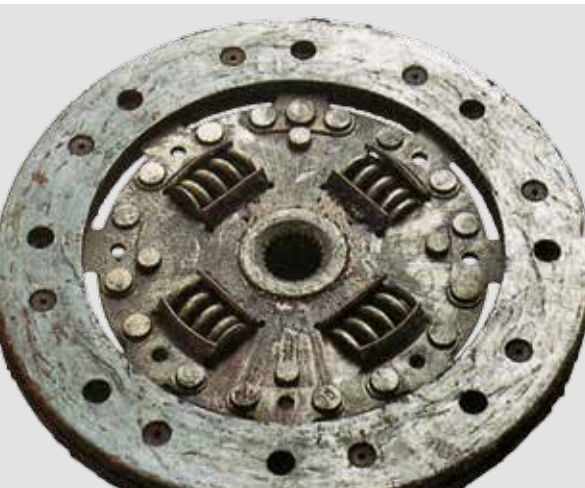
CLUTCH LININGS ARE COVERED IN EXCESS GREASE

- Hub of the clutch disk has not been greased correctly
- Too much lubricant has been used

- Clean the clutch cover
- Clean the transmission input shaft
- Replace the clutch kit
- Grease the hub correctly

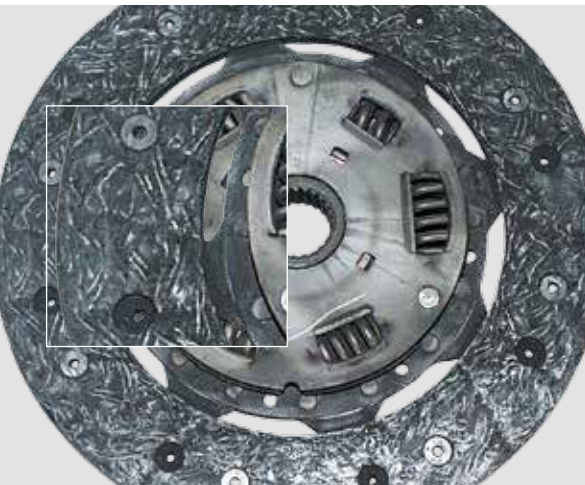
CLUTCH LINING IS WORN DOWN TO THE RIVETS

- Normal wear
- Vehicle was still driven despite the clutch slipping
- Driving errors (in the event of a premature malfunction)
- Incorrect clutch
- Release system is defective

- Replace the clutch kit
- Check the release system and repair if necessary
- Advise the driver regarding possible operating errors (see page 6)

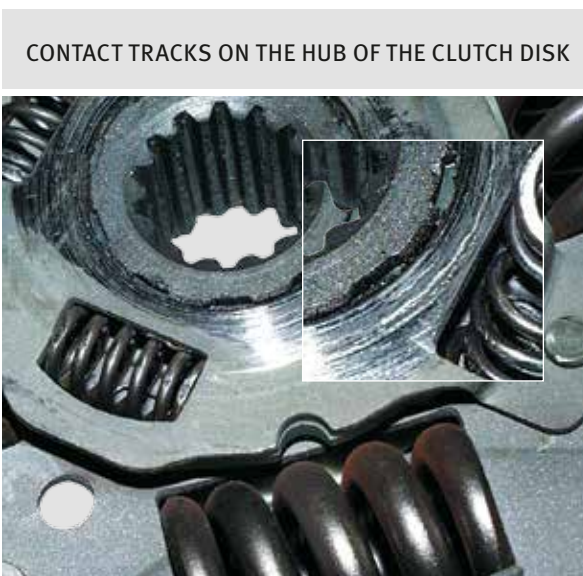
- Assembly error (installation direction of the clutch disk is incorrect)
- Incorrect clutch disk has been installed

- Replace the clutch kit
- Note the correct installation position of the clutch disk

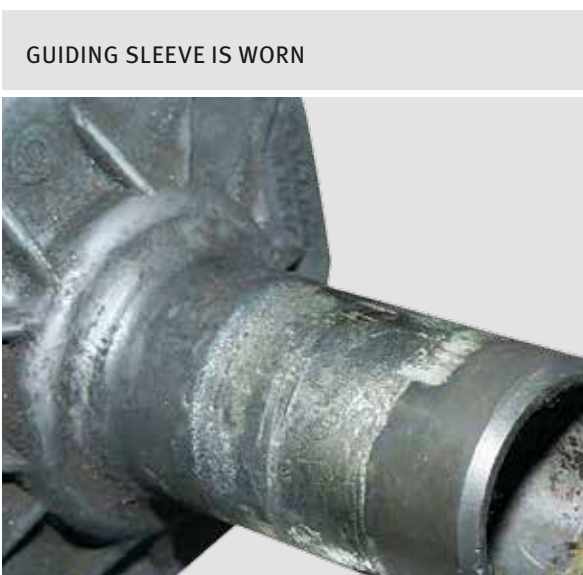
- Normal wear
- Insufficient/unsuitable lubricant has been used
- Material pairing between the guiding sleeve/release bearing is incorrect
- Release bearing is stiff

- Replace the clutch kit
- Replace the guiding sleeve
- Follow the greasing guidelines

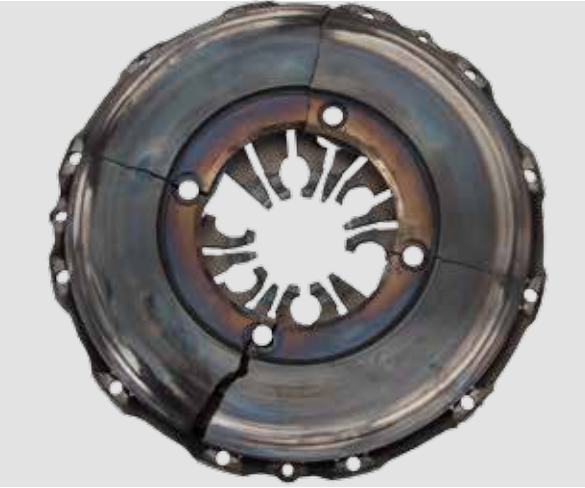
PRESSURE PLATE HAS OVERHEATED/BROKEN

- Damage caused by force and operating errors
- Driving with an excessive load

- Replace the clutch kit
- Advise the driver regarding operating errors

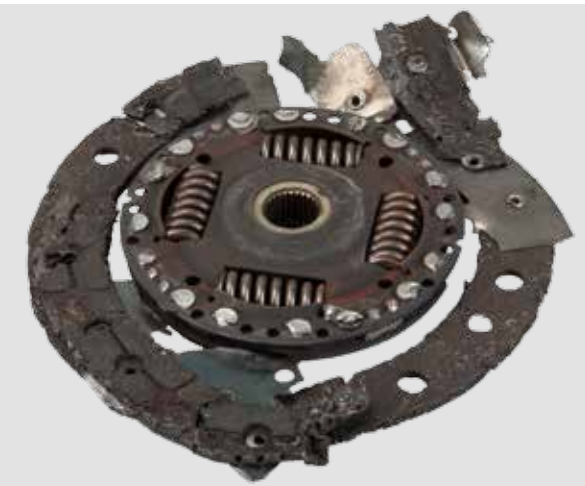
CLUTCH DISK HAS BURST

- Damage caused by force and operating errors
- Speed of the clutch disk was higher than the burst speed of the lining. This condition occurs when the speed of the vehicle exceeds the maximum permissible speed of the gear when the gear is engaged and the clutch is actuated continuously

- Replace the clutch kit
- Advise the driver regarding operating errors

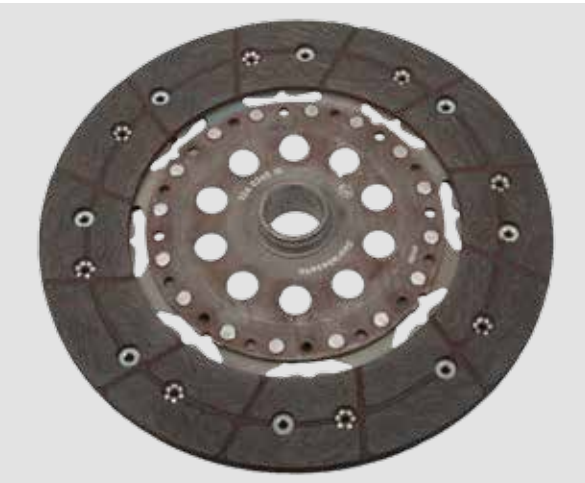
GEARING MISSING ON THE HUB OF THE CLUTCH DISK

CAUSES:

- DMF is defective
- DMF is blocked because the pressure plate screws are too long
- Vibration damper for the belt pulleys is defective

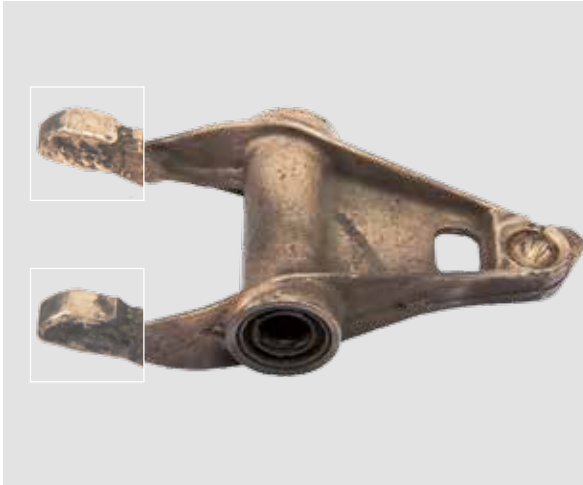
RELEASE FORK TIPS ARE WORN
(PULL-TYPE CLUTCH)

CAUSES:

- Normal wear
- Release fork was not replaced when the clutch was replaced despite wear

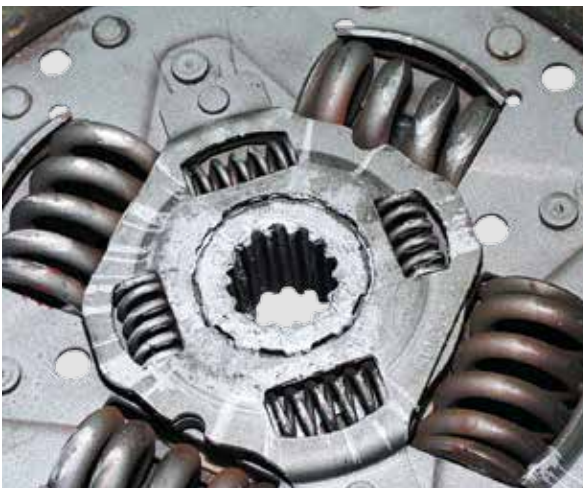
HUB PROFILE HAS BEEN INCORRECTLY GREASED

- Unsuitable or excessive grease has been applied

- Lubricant is transferred via the centrifugal force to the friction surfaces of the clutch, leading to fluctuation of the frictional coefficient, which causes the clutch to grab

- Observe the specifications of the vehicle manufacturer for greasing the hub when performing a clutch replacement. Use the instructions on page 40 as an alternative if there are no documents available from the vehicle manufacturer

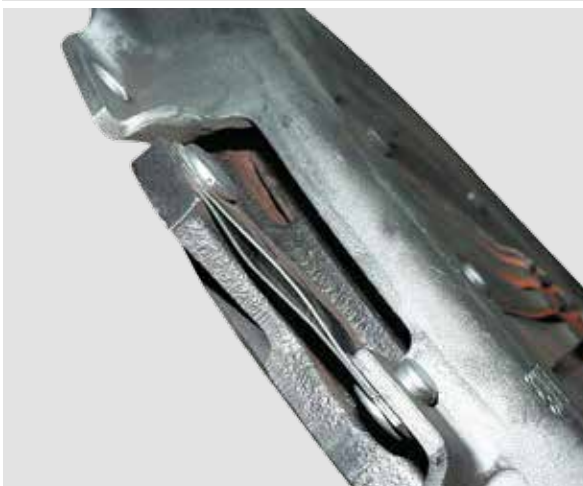
TANGENTIAL LEAF SPRING IS BENT

CAUSES:

- Play within the powertrain (e.g. due to a dislodged disk joint or flex disk)
- Reverse torque transmission in the clutch (towing in first or second gear, shifting error, load reversal caused by the conveyor belt in a car wash when the vehicle is in first gear)

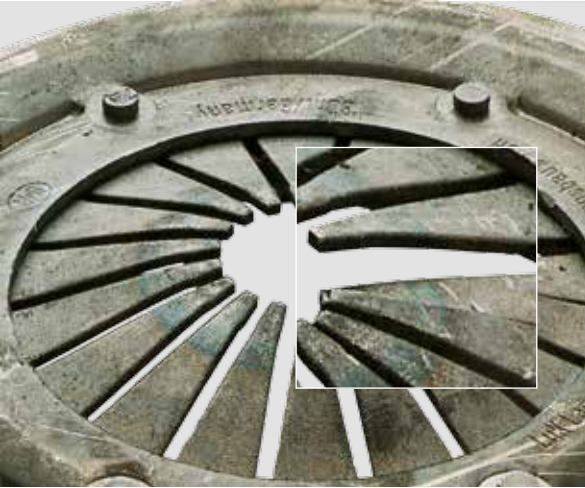
DISK SPRING TIPS ARE BENT

- Assembly error: Disk spring tips have been bent during installation of the transmission

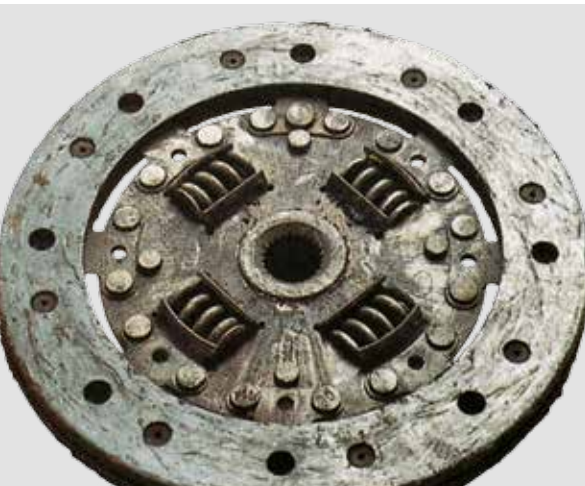
CLUTCH LINING IS OILY

- Assembly error (incorrect and/or excessive lubricant applied)
- Engine or transmission is leaking

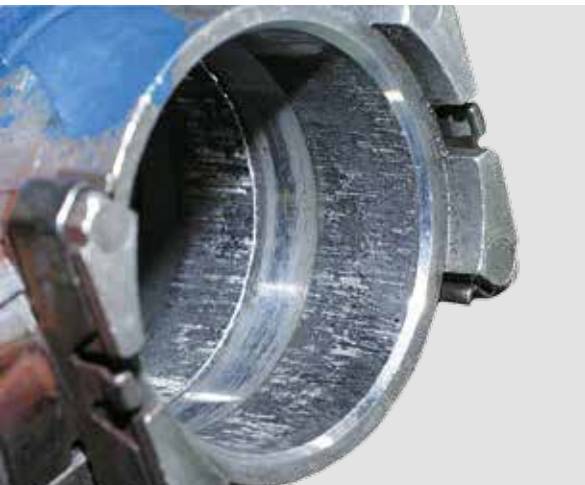
RELEASE BEARING IS STIFF,
SIGNS OF WEAR ARE VISIBLE

- Incorrectly or insufficiently greased
- Sliding bush is worn and was not replaced when the clutch was replaced

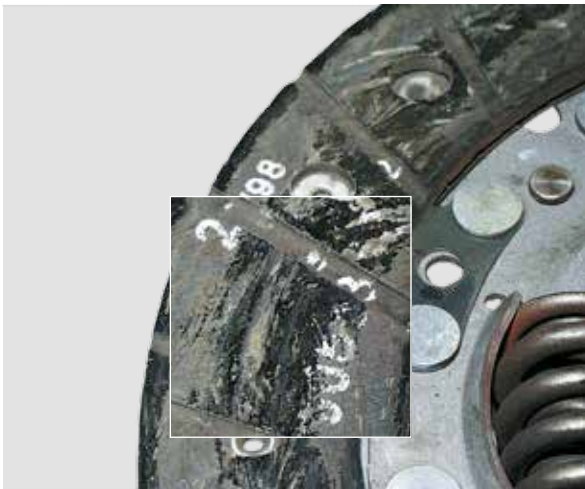
LINING SCORED ON THE FLYWHEEL SIDE

- Wear on the friction surface of the flywheel was not noticed when the clutch was replaced
- Rigid flywheel has not been reworked or the DMF has not been replaced

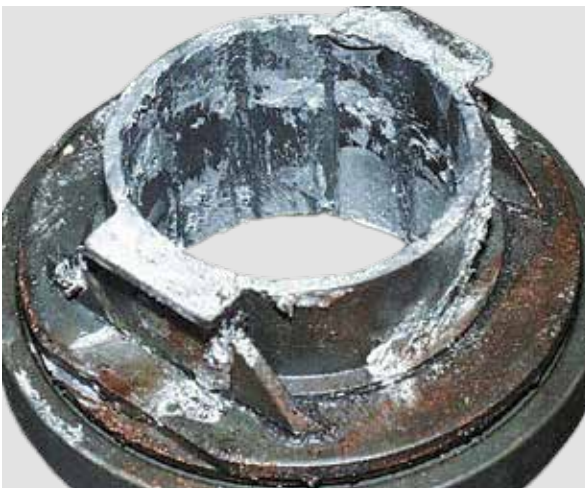
RELEASE BEARING HAS BEEN INCORRECTLY GREASED

- Release bearing or sliding bush have been greased using an unsuitable lubricant

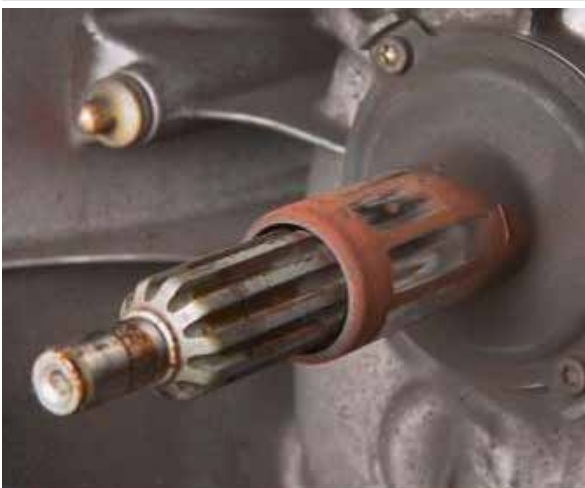
GUIDING SLEEVE HAS BEEN RUN IN

- Normal wear
- Sliding bush is worn and was not replaced when the clutch was replaced

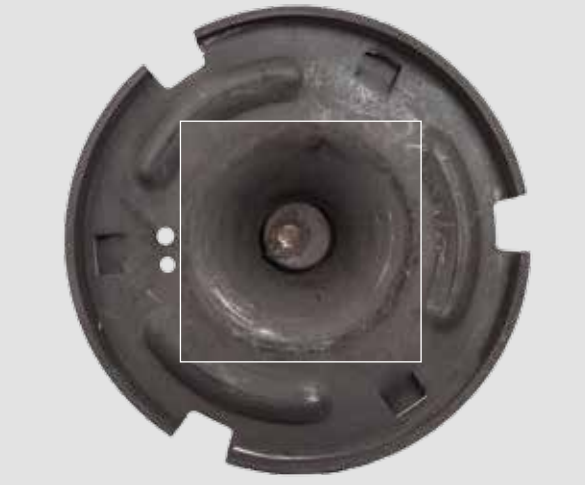
OFF-CENTER CONTACT TRACK IN THE RELEASE SPRING (VW CLUTCH SYSTEM)

- Release bearing on the push rod is deformed
- Guide bush on the push rod is worn

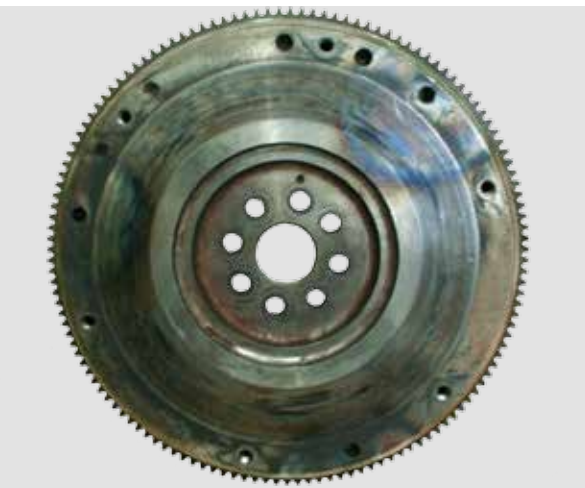
FRICION SURFACE ON THE FLYWHEEL IS WORN

- High temperatures, e.g. due to operating errors or a defect in the release system
- Friction surface on the flywheel is worn (rigid design) and was not reworked when the clutch was replaced
- DMF is worn and has not been replaced

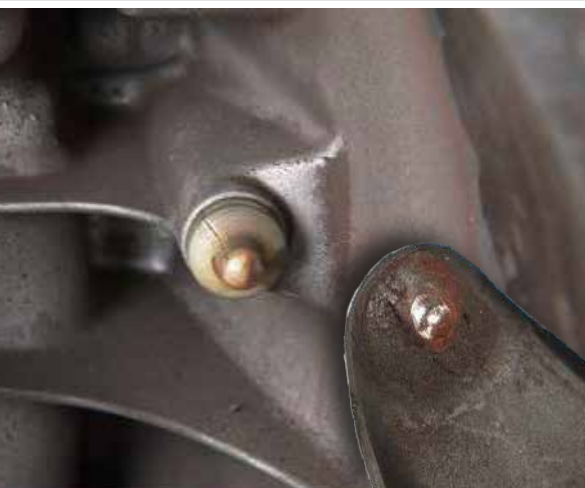
RELEASE FORK AND/OR BALL PIN IS WORN

- Normal wear

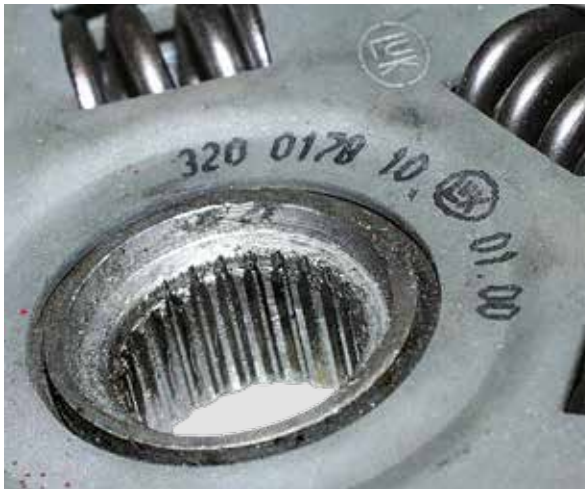
HUB PROFILE IS DAMAGED

- Transmission input shaft has been forced into the hub
- Clutch disk was not centered during installation
- Incorrect clutch has been installed

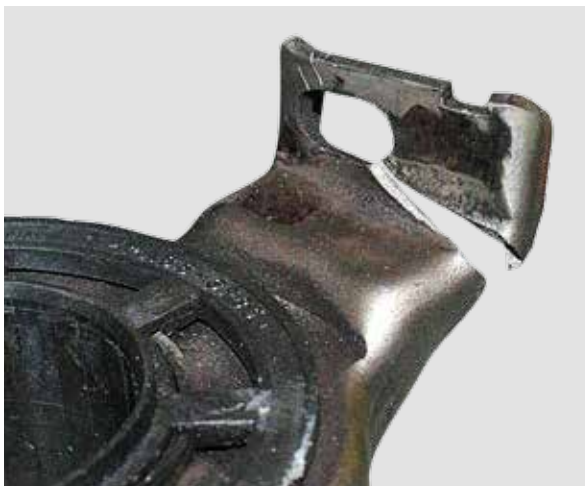
RELEASE FORK MOUNT ON THE RELEASE BEARING IS BROKEN

- Fork and release bearing not installed correctly
- Incorrect release bearing installed

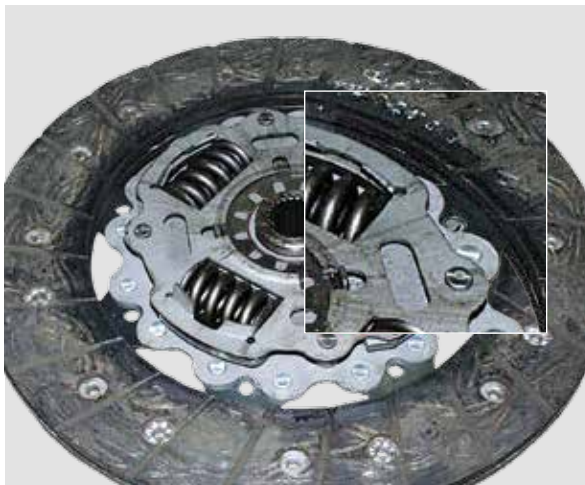
FRICITION LINING ON THE INNER RING IS OILY/ GREASY

- Radial shaft seals or other components in the engine/transmission are leaking
- Hydraulic release system is defective
- Hub profile over-greased

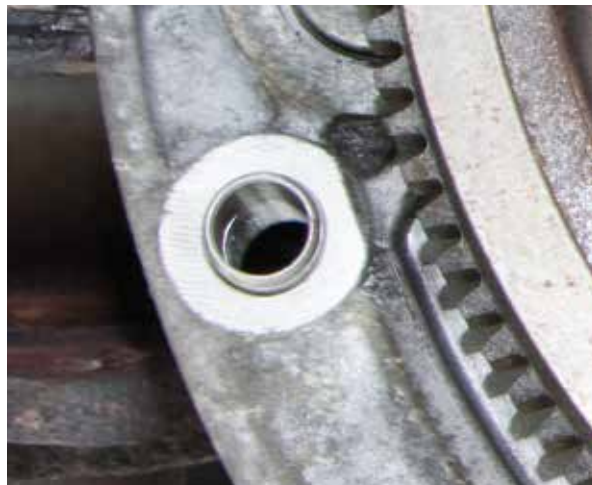
If the centering sleeve is missing or deformed, this can cause problems when disengaging the clutch.

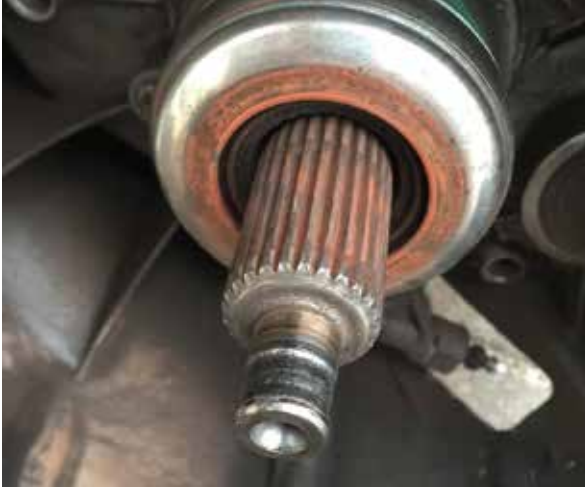
PILOT BEARING IS DEFECTIVE

- Pilot bearing was not checked, lubricated or replaced when the clutch was last replaced

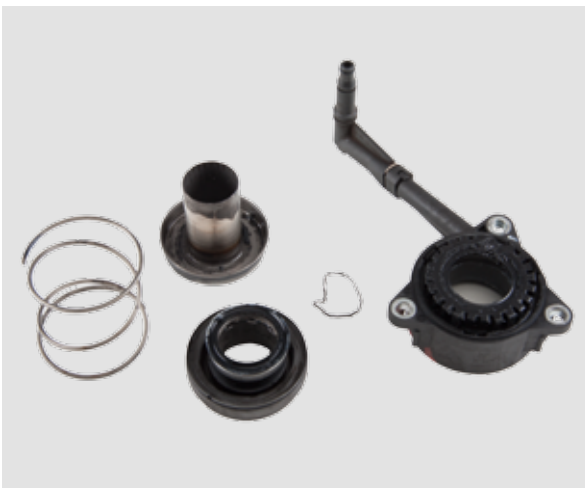
MECHANICAL DAMAGE TO THE CSC

- Sliding bush of the CSC has rotated and worked loose from the housing due to the axial clearance of the transmission input shaft being too high

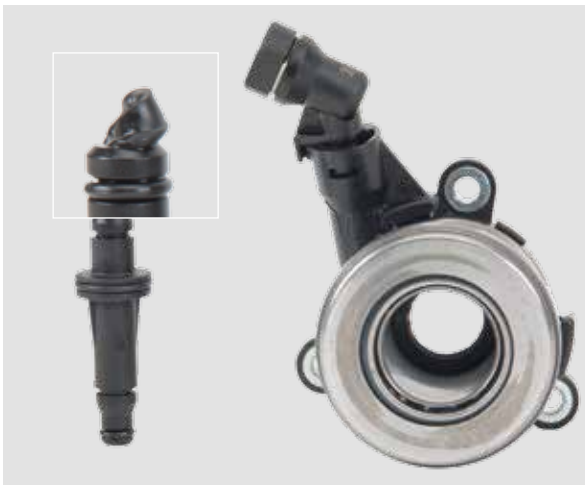
CSC BURSTS DIRECTLY AFTER INSTALLATION

- When the new CSC was installed, the old seal was not removed from the cable connection. After the installation, the old seal acts as a valve and prevents pressure from being released from the CSC. Once the clutch has been actuated a few times, the pressure increases so much that the CSC bursts

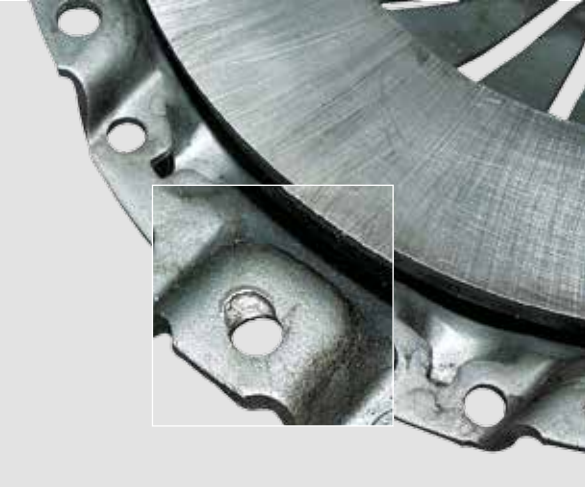
CLUTCH COVER IS DEFORMED

- Centering pin in the flywheel was not accounted for when installing the pressure plate

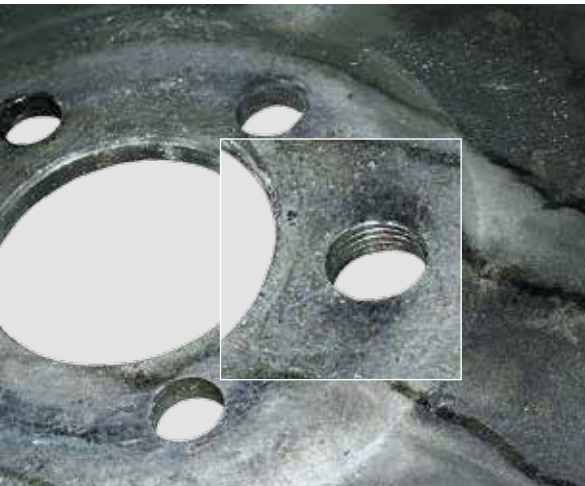
THREAD IN THE SCREW HOLES IS WORN, TANGENTIAL LEAF SPRING IS BROKEN (VW)

- No securing agent used to fix the clutch screws in place
- Reinforcing panel not installed between the clutch screws and the clutch cover
- Screws have been tightened to the incorrect torque

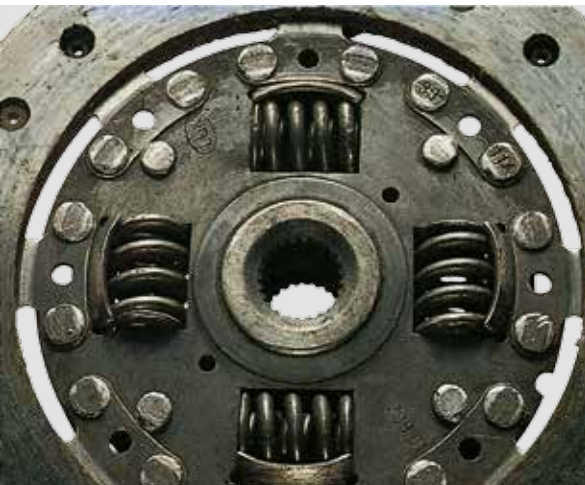
CONTACT TRACKS ON THE RIVET HEADS OF THE SEGMENT RIVETING (VW)

CAUSES:

- Snap ring on the pressure plate has been installed incorrectly
- Unsuitable snap ring has been installed

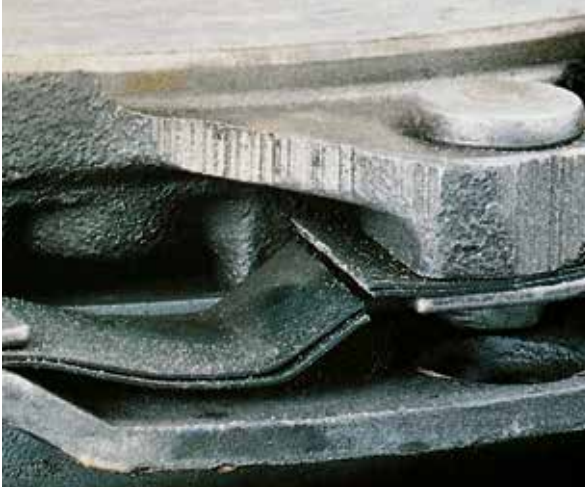
TANGENTIAL LEAF SPRING IS BROKEN

- Play within the powertrain, e.g. a dislodged flex disk
- Operating errors, e.g. towing in first or second gear, shifting error
- Incorrect clutch has been installed

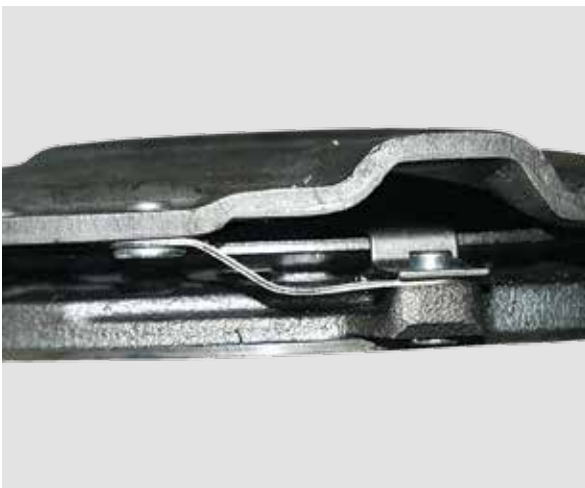
TANGENTIAL LEAF SPRING IS BENT

- Play within the powertrain, e.g. a dislodged flex disk
- Operating errors, e.g. towing in first or second gear, shifting error
- Improper bearing arrangement for the clutch
- Clutch dropped before or during assembly
- Incorrect detent when screwing on the clutch

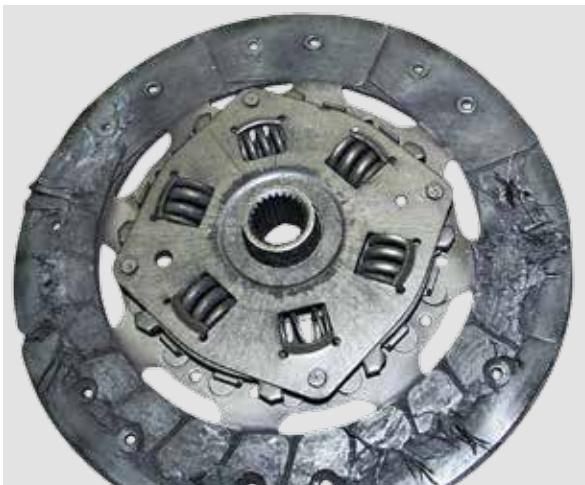
LINING IS BURNT OR HAS WORKED LOOSE

CAUSES:

- Defective rotary shaft seal on the engine/gearbox, causing the lining to become oily
- Release system is stiff or defective
- Depth dimension was not considered when reworking the flywheel (rigid design) or the mounting surface of the clutch has not been machined

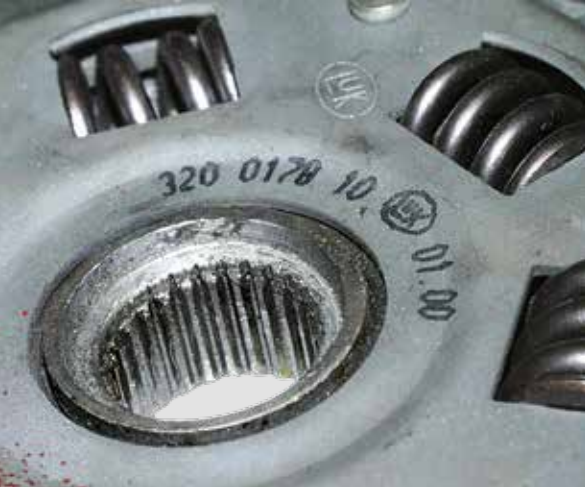
HUB PROFILE IS DAMAGED

- Transmission input shaft has been forced into the hub
- Clutch disk was not centered during installation
- Incorrect clutch has been installed

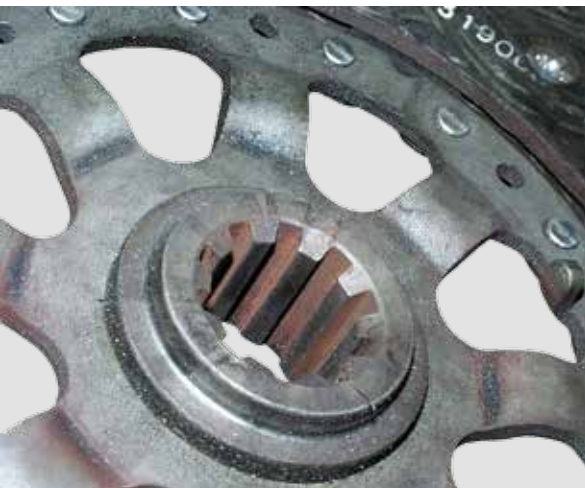
FRETTING CORROSION (RUST FILM) ON THE HUB PROFILE

- Transmission input shaft or hub profile not greased at all or greased using an unsuitable lubricant

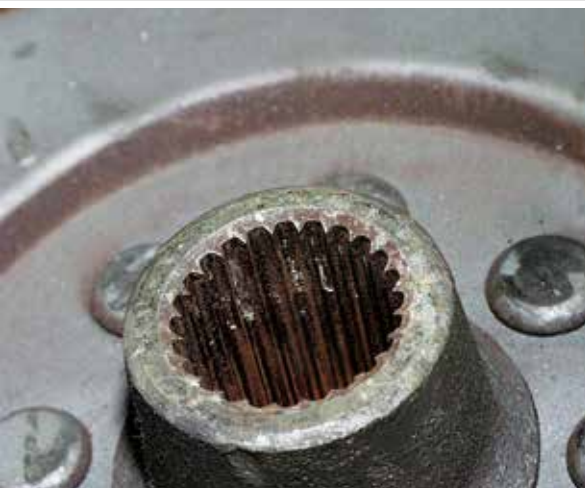
HUB PROFILE IS DEFORMED, TAPERED GEARING PROFILE

- Pilot bearing is defective
- Angular displacement between the engine and the transmission
- No centering sleeve or the centering sleeve is damaged

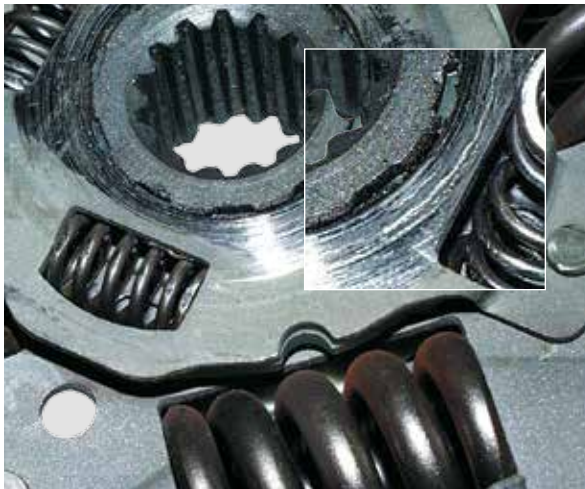
CONTACT TRACKS ON THE FIRST STAGE DAMPER OF THE CLUTCH DISK

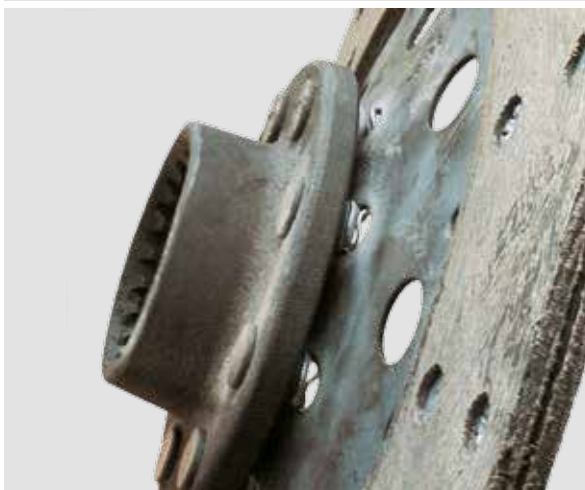
CLUTCH DISK HAS BECOME SAUCER-SHAPED

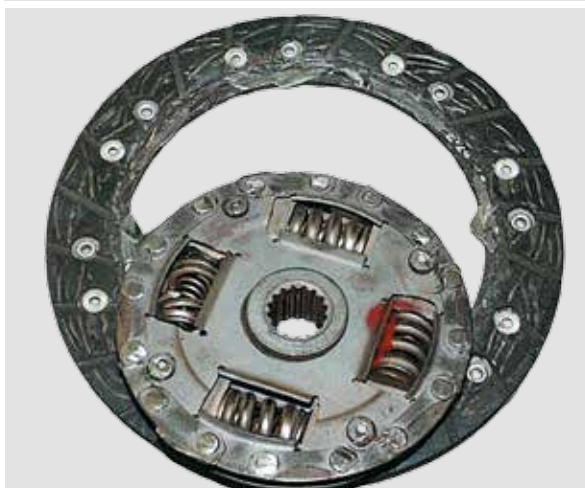
DISC ASSEMBLY IS BROKEN

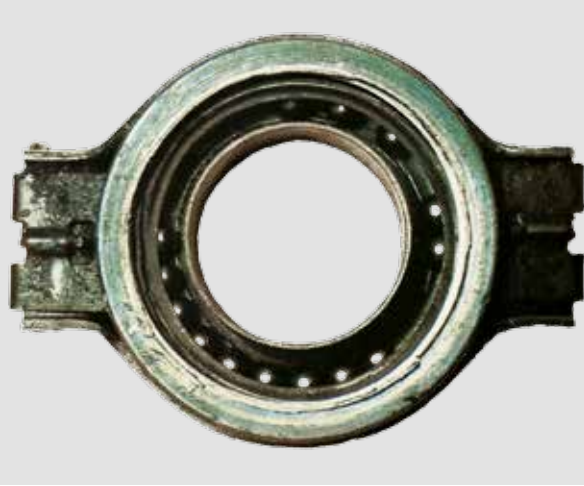
CONTACT BUSHING AND BALL BEARING ON THE RELEASE BEARING ARE DESTROYED

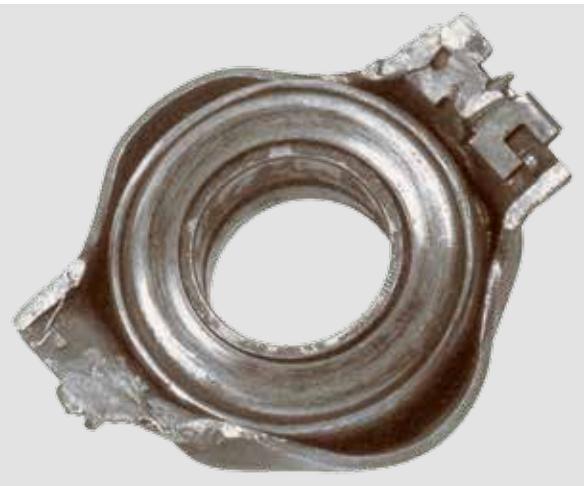
HOUSING OF THE RELEASE BEARING IS DEFORMED

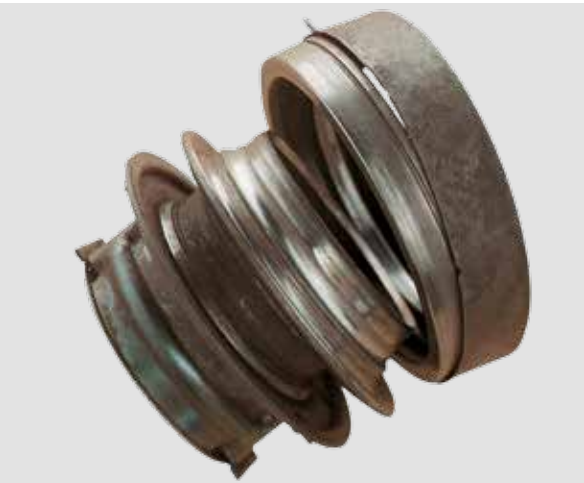
FLANGE ON THE RELEASE BEARING IS WORN THROUGH

CAUSES:

- Default setting of the release fork is incorrect (Opel)
- Preload on the release bearing is too low

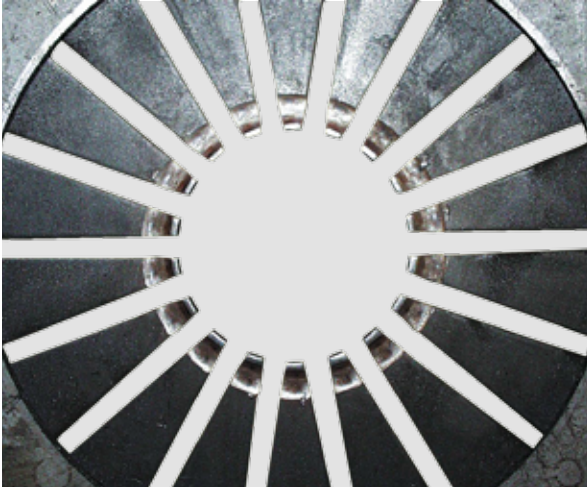
DISK SPRING TIPS HAVE BEEN RUN IN

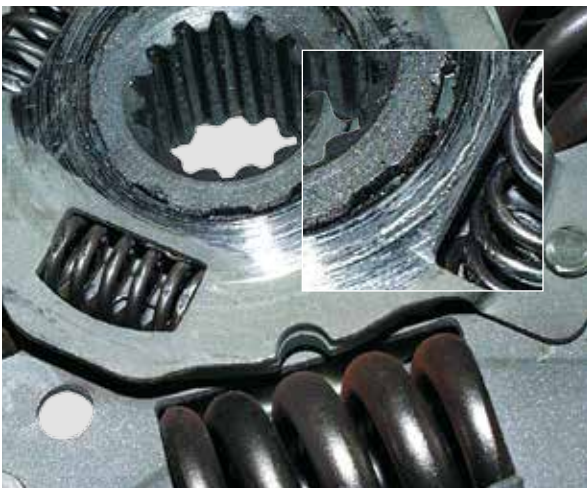
CONTACT TRACKS ON THE FIRST STAGE DAMPER

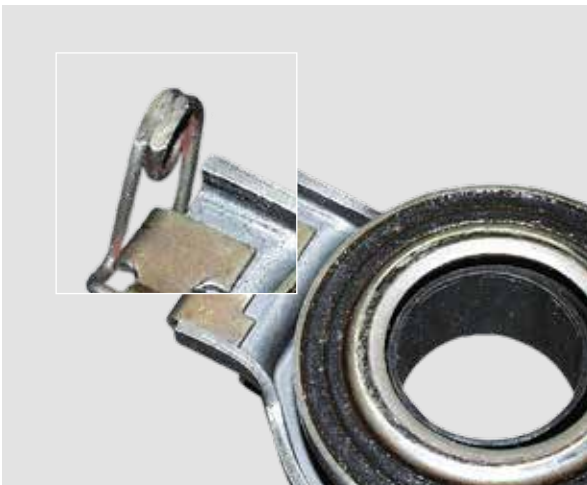
CONTACT TRACKS ON THE FORMED SPRING

- Set the preload of the release bearing (specification: 80–100 N)
- Replace the release bearing and the guiding sleeve
- Replace the clutch kit

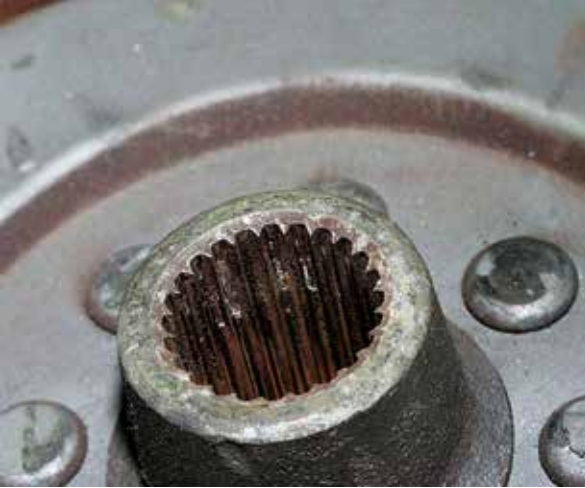
HUB PROFILE IS DEFORMED, TAPERED GEARING PROFILE TORSIONAL DAMPER IS DESTROYED

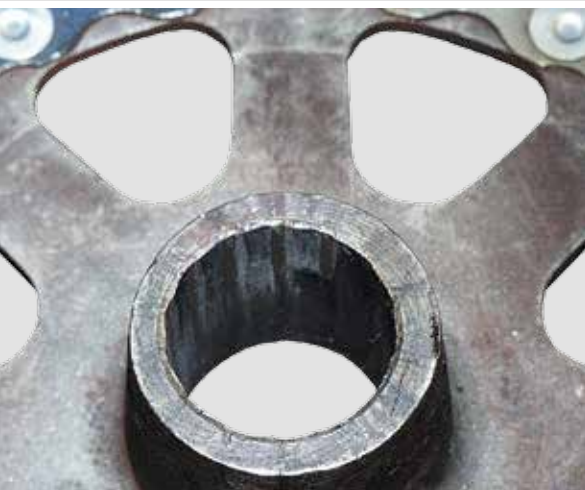
HUB PROFILE IS COMPLETELY MISSING

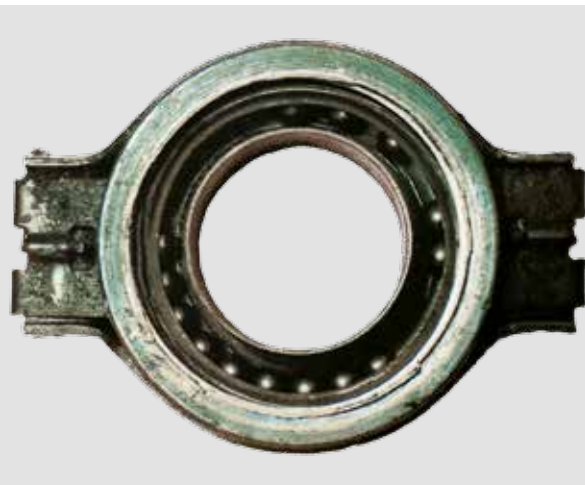
CONTACT BUSHING AND BALL BEARING ARE DESTROYED

CAUSE:

- Release bearing is overheating because the play of the release bearing is incorrect

- Replace the clutch kit
- Replace the release bearing and the guiding sleeve
- Set the play of the release bearing correctly

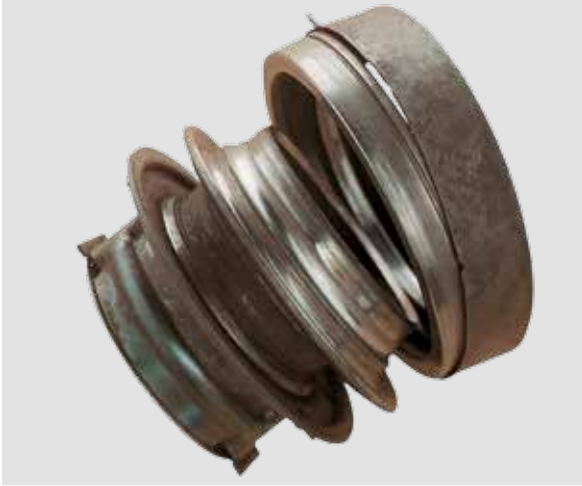
FLANGE ON THE RELEASE BEARING IS WORN THROUGH

CAUSES:

- Default setting of the release fork is incorrect (Opel)
- Preload on the release bearing is too low

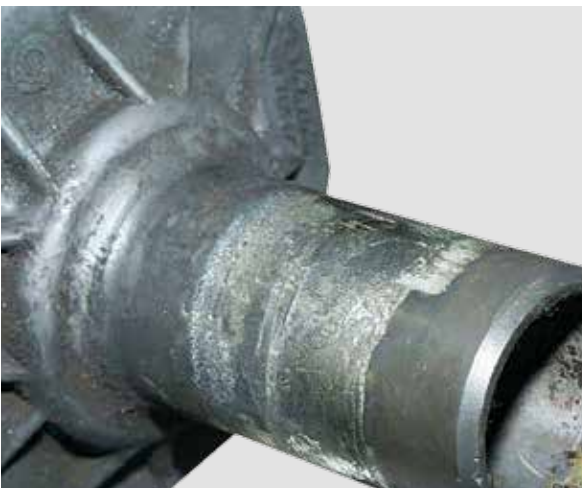
SIGNS OF WEAR VISIBLE ON THE GUIDING SLEEVE

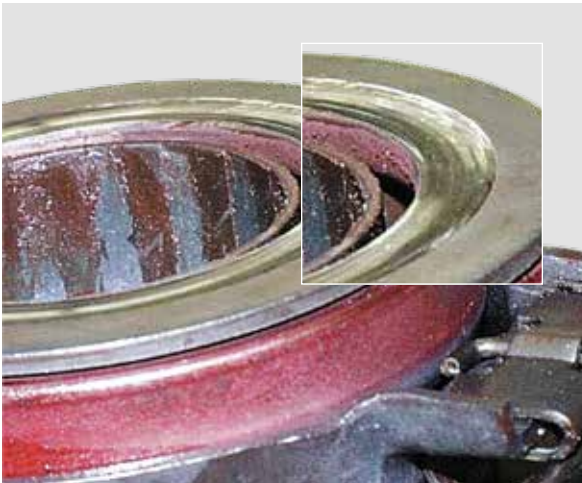
SIGNS OF WEAR VISIBLE ON THE THRUST RING OF THE RELEASE BEARING

CAUSES:

- Default setting of the release fork is incorrect (Opel)
- Preload on the release bearing is too low

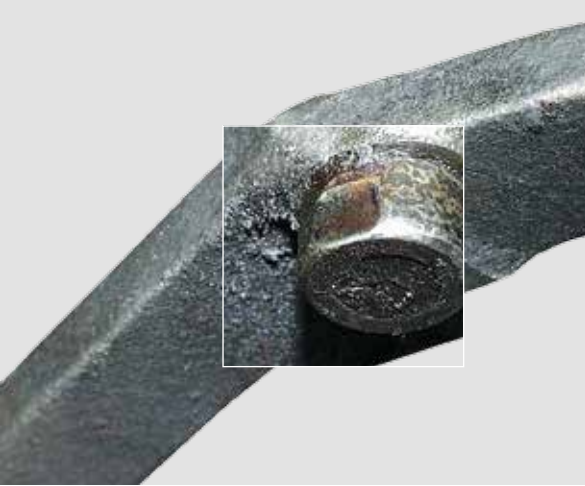
RELEASE BEARING SEATING ON THE RELEASE FORK HAS BEEN RUN IN

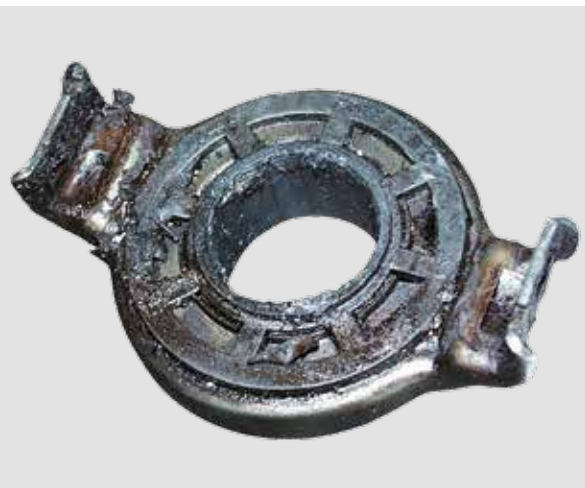
RELEASE BEARING SEATING IS WORN

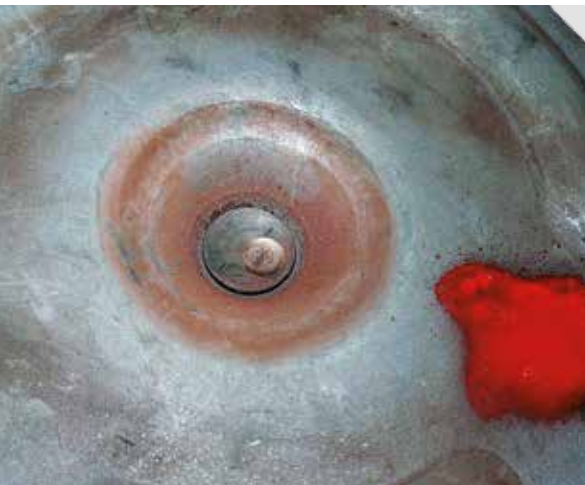
OFF-CENTER CONTACT TRACK IN THE RELEASE SPRING (VW CLUTCH SYSTEM)

CAUSES:

- Release bearing on the push rod is deformed
- Guide bush on the push rod is worn

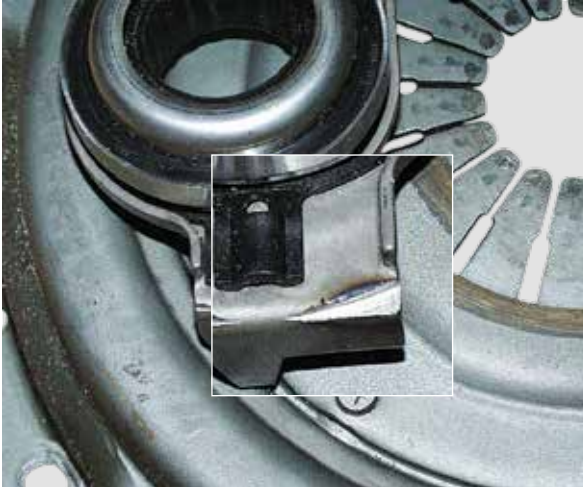
CONTACT TRACKS ON THE CLUTCH COVER AND RELEASE BEARING

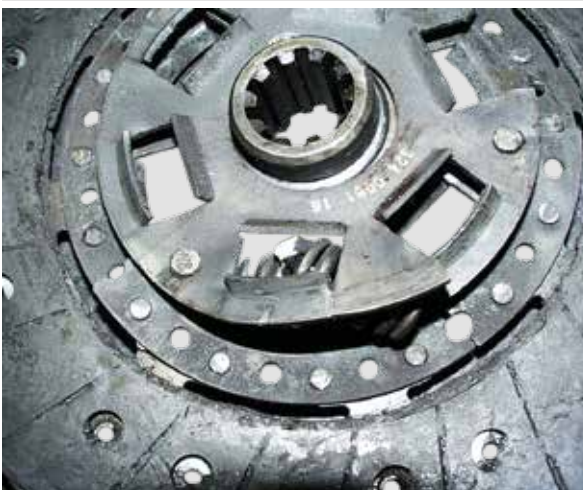
TORSIONAL DAMPER IS BROKEN

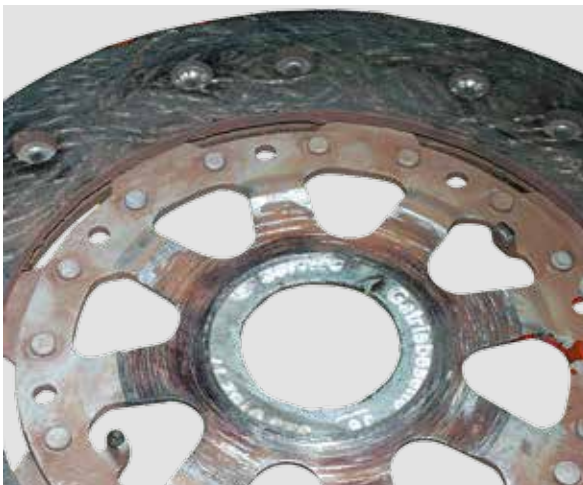
HUB OF THE CLUTCH DISK IS BROKEN

CAUSES:

- Assembly error
- Installation position of the clutch disk has not been taken into account

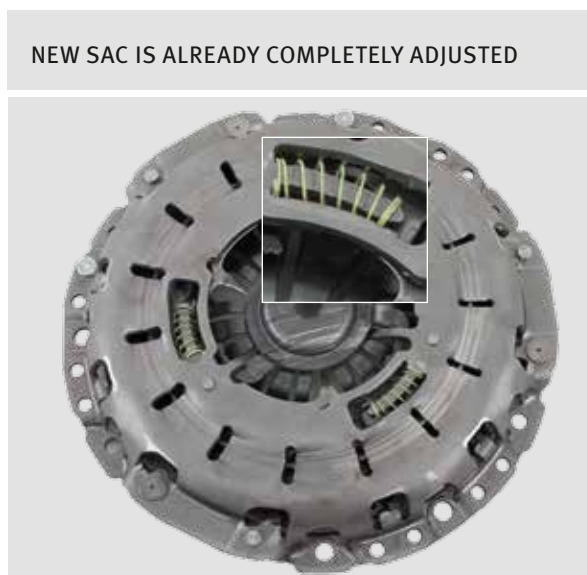
CAUSES:

- Improper transport
- Assembly error (the detent was removed from the clutch before assembly)

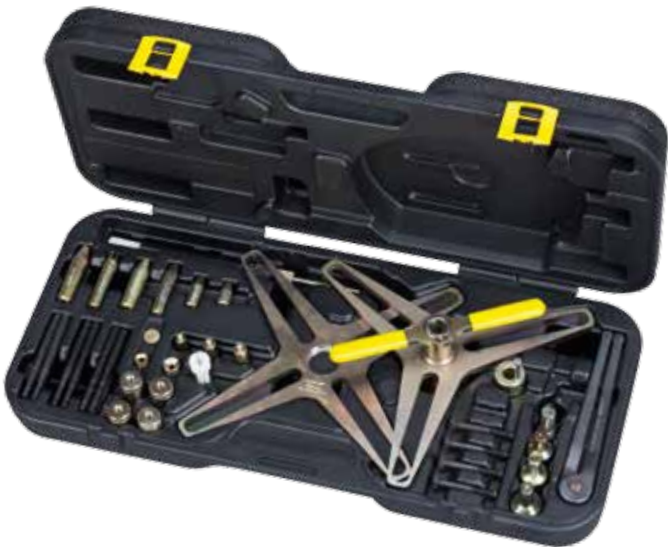
Special tools set (part no. 400 0237 10)
for assembling the clutch
