VALEO CLUTCH TROUBLESHOOTING GUIDE

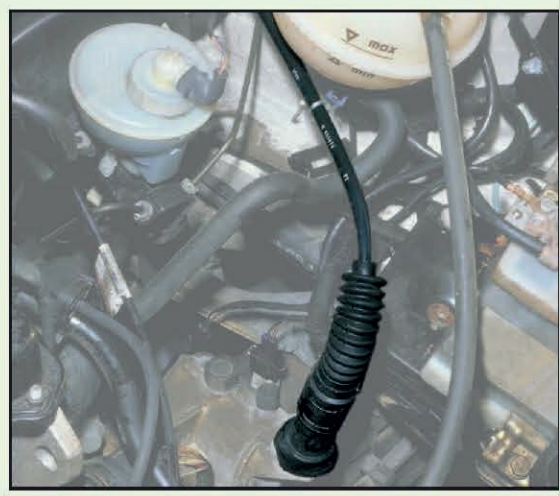
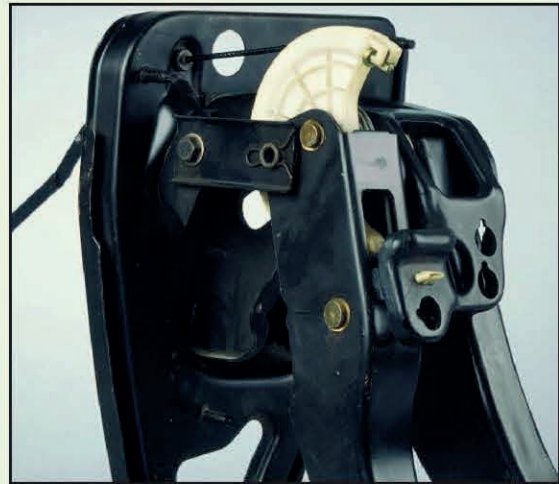
Slipping Clutch

CAUSE- The self-adjusting mechanism has become jammed.

ACTION- Replace or repair the self-adjusting mechanism or in the case of semiautomatic adjusters - reset.

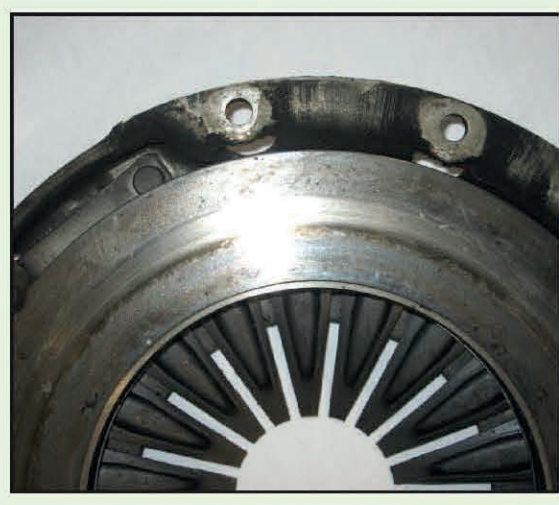
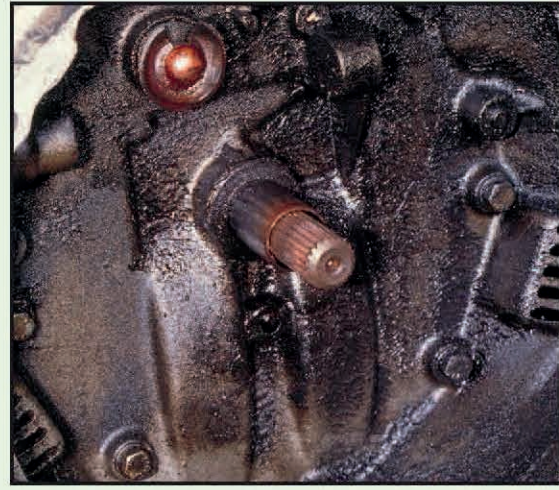
Slipping Clutch

CAUSE- Clutch facing material is oil contaminated.

ACTION- Replace leaking oil seals. Clean off excess oil and install new clutch.

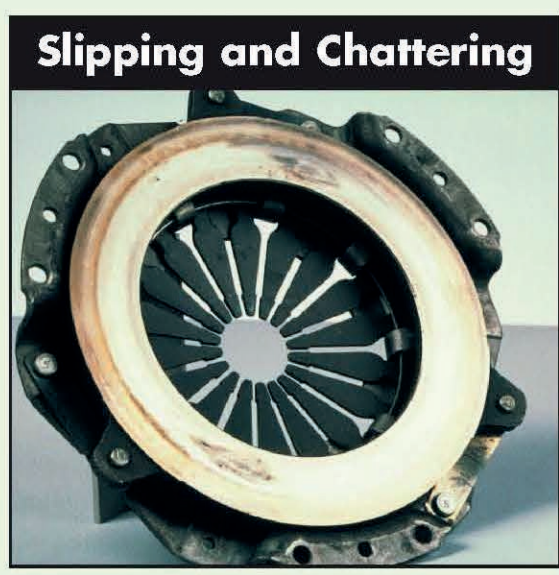
Slipping and Chattering

CAUSE- Driver resting foot on the clutch pedal or incorrect clutch adjustment.

ACTION- Do not use the clutch pedal as a footrest. Inspect for correct clutch adjustment.

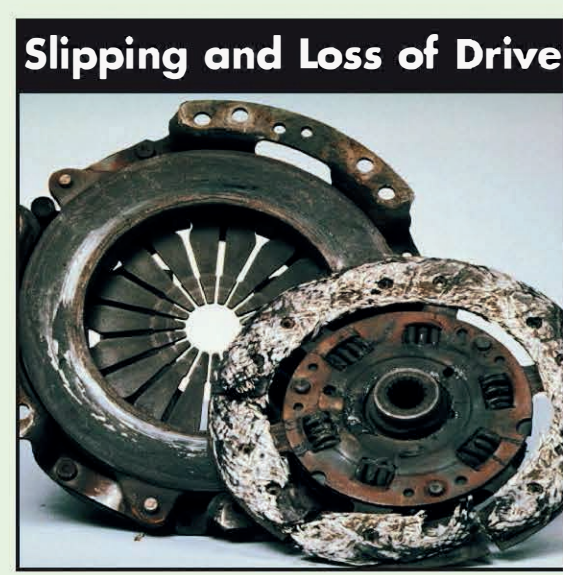
Slipping and Loss of Drive

CAUSE- Driver resting foot on the clutch pedal. Seized/sticking release system.

ACTION- Install new clutch. Check all components of the release system, particularly self-adjusting release systems and guide tubes. Check for leaking oil seals.

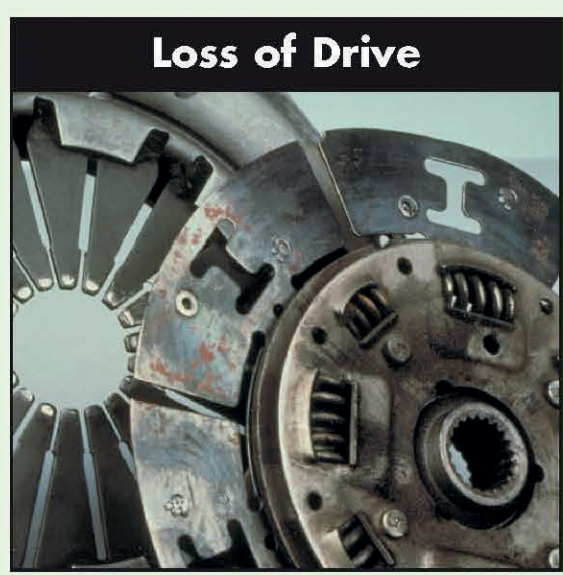
Loss of Drive

CAUSE- The clutch has been disengaged at speeds in excess of the maximum for the gear selected or the incorrect gear has been selected (missed shift). This has caused the facings to burst.

ACTION- Install new clutch and educate the driver.

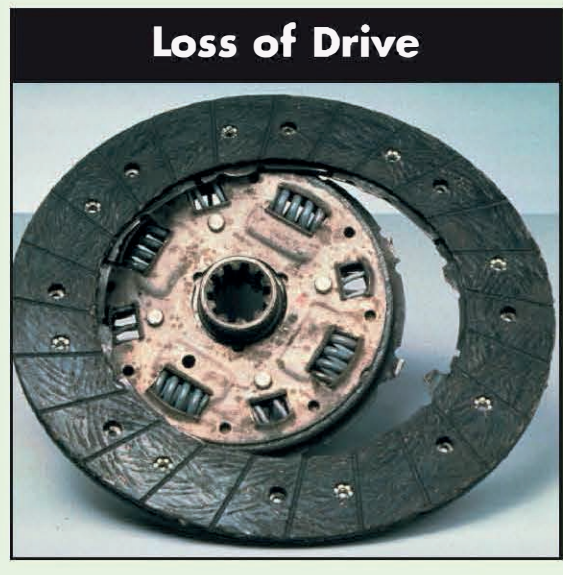
Loss of Drive

CAUSE- Transmission has been hung on the shaft during installation. Angular misalignment of the transmission to engine.

ACTION- Install new clutch and support transmission during installation. Do not allow the transmission to hang on the clutch disc during installation. Check for missing bell housing dowel sleeves, worn pilot bushing/bearing or foreign matter between transmission and engine including wires, cables or brackets. The above problems will cause cracking in the segments, leading to separation of the damper and facing/segments.

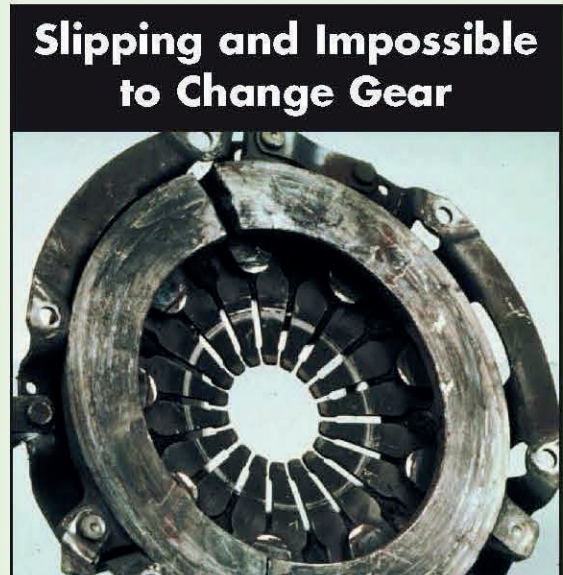
Slipping and Impossible to Change Gear

CAUSE- Overheating due to excessive clutch slippage.

ACTION- Install new clutch kit. Check all components of the release system, particularly self-adjusting release systems and guide tubes. Check for leaking oil seals.

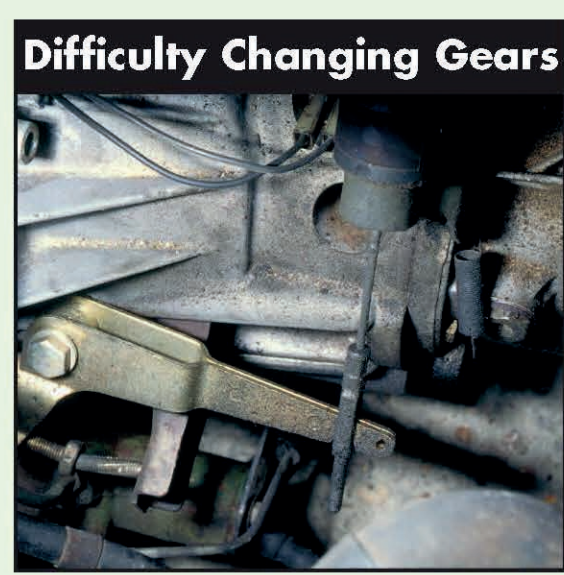
Difficulty Changing Gears

CAUSE- Release bearing travel is insufficient.

ACTION- Inspect release mechanism for full travel or lost motion due to worn parts. A stamped steel release arm can wear and break. Always remove and check arm and external pivots. Install new fork bushings and lubricate as required with high melting point grease.

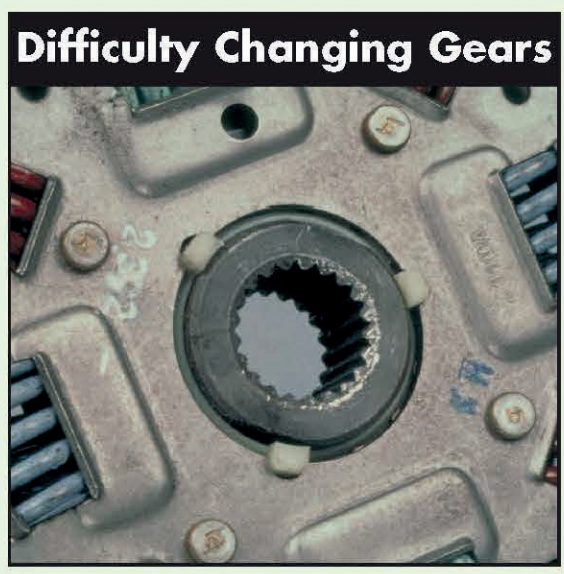
Difficulty Changing Gears

CAUSE- The transmission was forced into position damaging the splines of the disc hub.

ACTION- Install new clutch and carefully control the position and alignment of the transmission during installation. Use a transmission jack and possibly install temporary guide pins to assist in aligning the transmission to the engine.

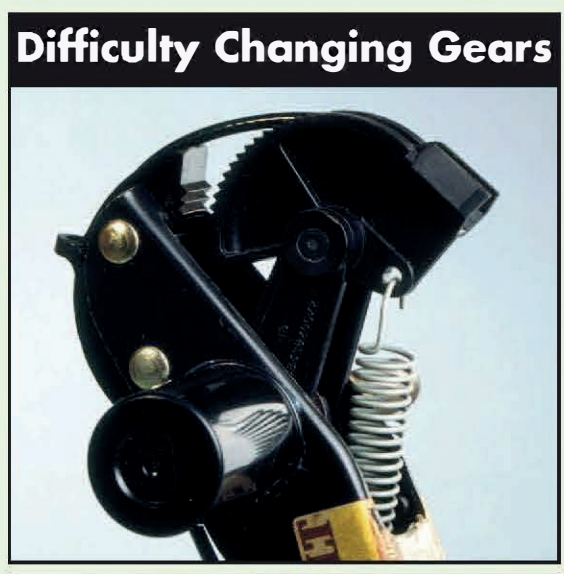
Difficulty Changing Gears

CAUSE- The self-adjusting mechanism fails to lock due to worn ratchet and pawl.

ACTION- Repair self-adjusting release system, replace ratchet and pawl.

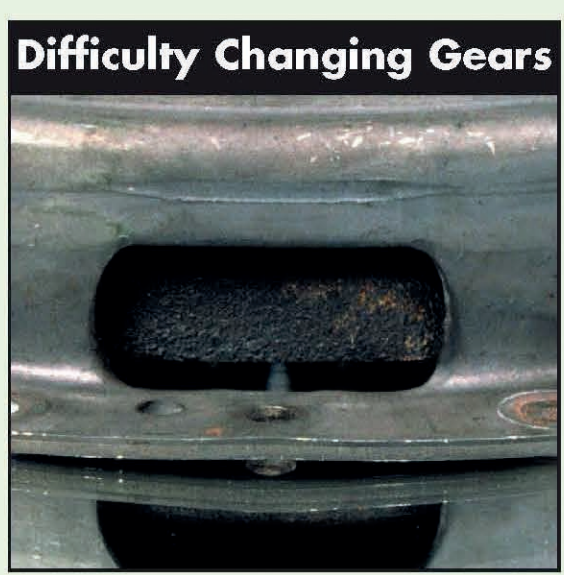
Difficulty Changing Gears

CAUSE- The cover has not been located on the flywheel dowel pins correctly.

ACTION- Install new clutch and ensure all flywheel dowel pins are in position and in good condition. Do not use air tools to tighten the bolts.

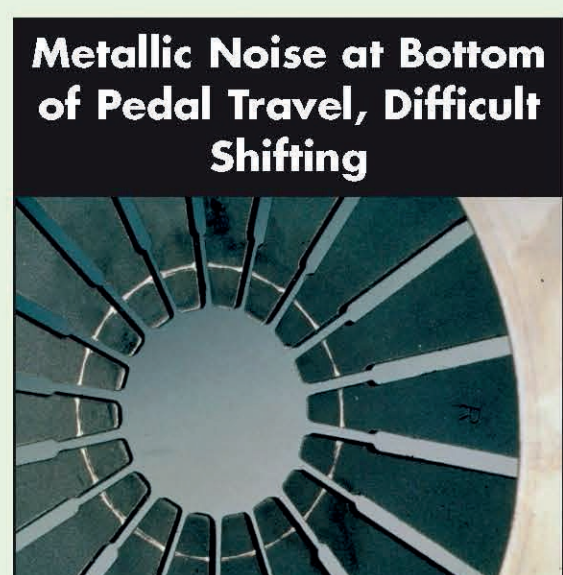
Metallic Noise at Bottom of Pedal Travel, Difficult Shifting

CAUSE- The release travel is excessive causing the diaphragm spring to contact the clutch disc.

ACTION- Install new clutch and ensure correct clutch adjustment.

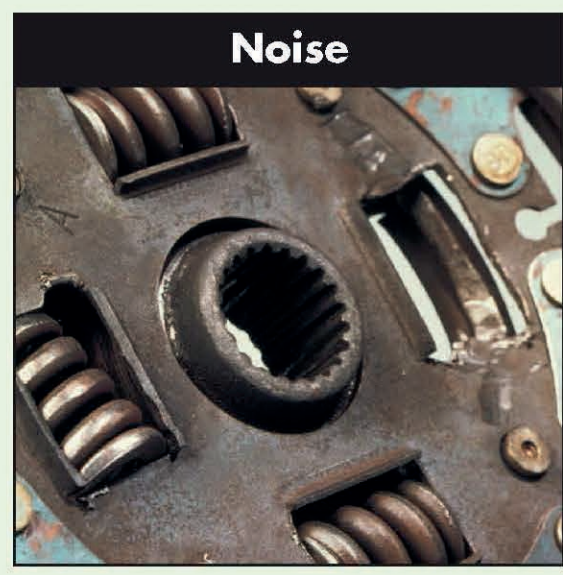
Noise

CAUSE- Installation is missing the transmission to engine dowel sleeves or pilot bushing/bearing. This has created a concentric misalignment of the engine to the transmission. The torsion damper is destroyed, broken damper springs, stop pins show contact from the hub flange and the hub pilot is worn.

ACTION- Carefully inspect for missing dowel sleeves and worn dowel sleeve holes in the bell housing. Replace pilot bushing/bearing and inspect the transmission to engine alignment.

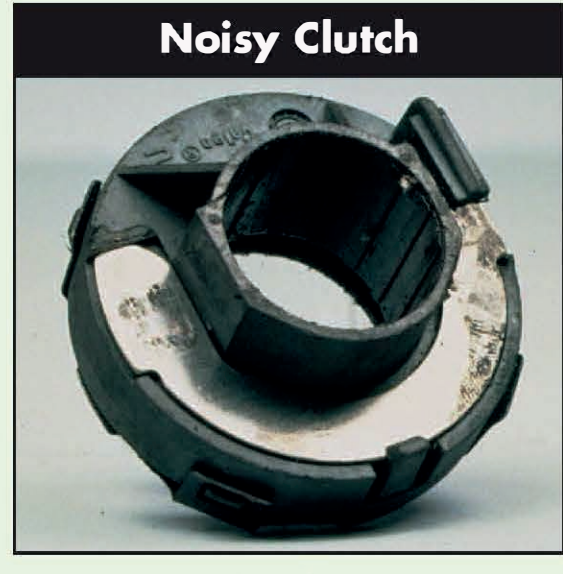
Noisy Clutch

CAUSE- Broken location lug due to worn release fork and/or no lubrication.

ACTION- Replace any worn components and install new clutch. Apply a liberal amount of high temp grease to the fork contact pads.

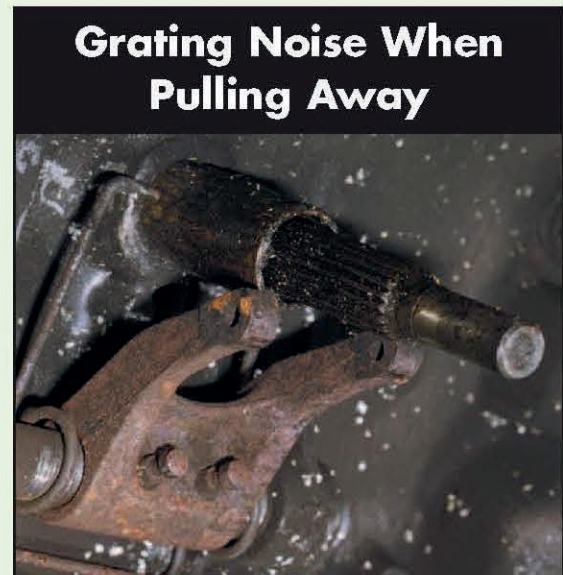
Grating Noise When Pulling Away

CAUSE- Insufficient lubrication of the clutch fork, particularly at the pivot point.

ACTION- Clean and lubricate all components using a high temp grease. If excessively worn, replace the fork and ball stud.

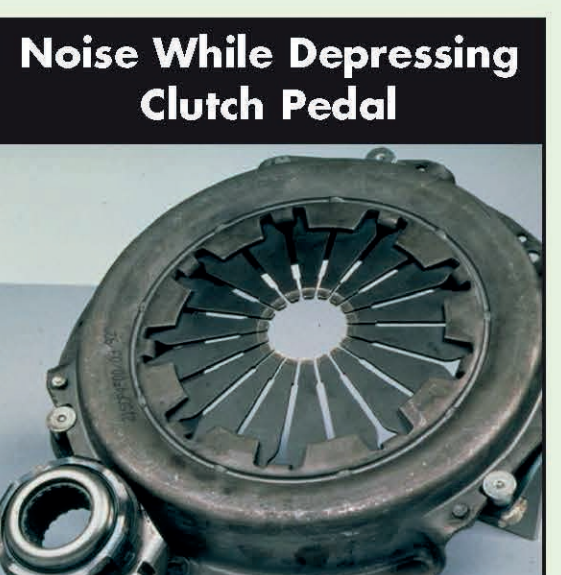
Noise While Depressing Clutch Pedal

CAUSE- Seized release bearing due to excessive heat caused by incorrect bearing pre-load or loss of grease.

ACTION- Install new clutch and check all components and adjustments of the release system i.e. cables, linkages, fork, ball studs, fork bushings and self-adjusting release systems.

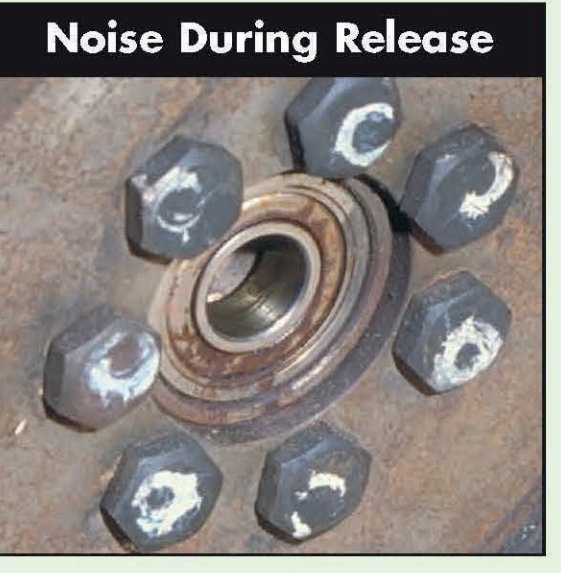
Noise During Release

CAUSE- Seized/worn pilot bearing/bushing.

ACTION- Replace pilot bearing/bushing.

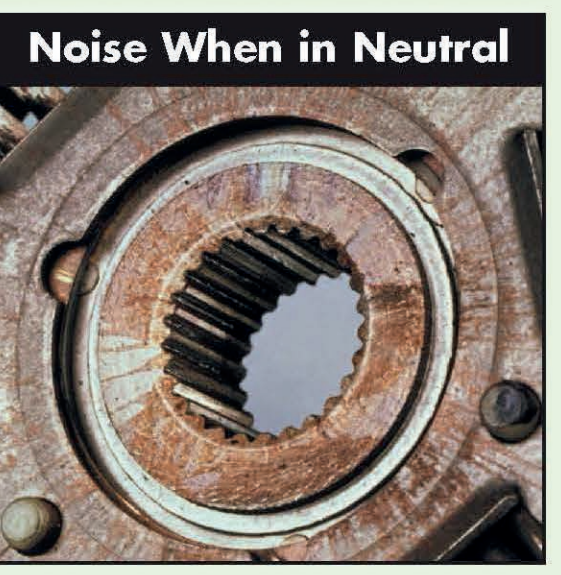
Noise When in Neutral

CAUSE- Oil or grease has contaminated the disc pre-damper making it ineffective.

ACTION- Install new clutch and sparingly use the spline grease supplied in the Valeo Clutch Kit.

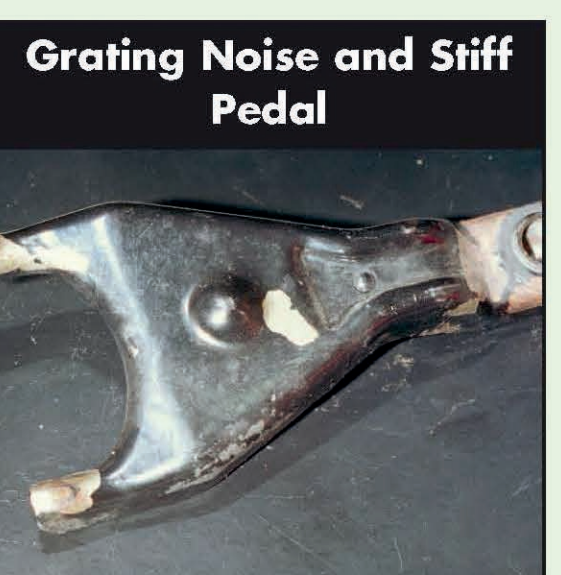
Grating Noise and Stiff Pedal

CAUSE- Insufficient lubrication of the clutch fork, particularly at the pivot point.

ACTION- Clean and lubricate all components using a high temp grease. If excessively worn, replace the fork and ball stud.

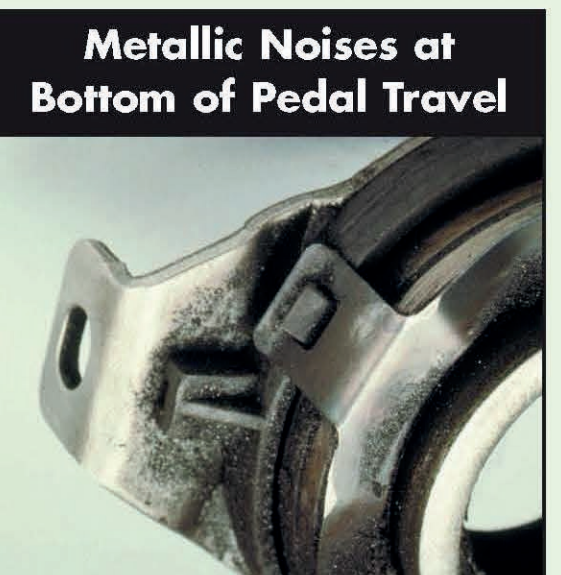
Metallic Noises at Bottom of Pedal Travel

CAUSE- The release travel is excessive causing the diaphragm spring to contact the bearing carrier.

ACTION- Install new clutch and ensure correct clutch adjustment.

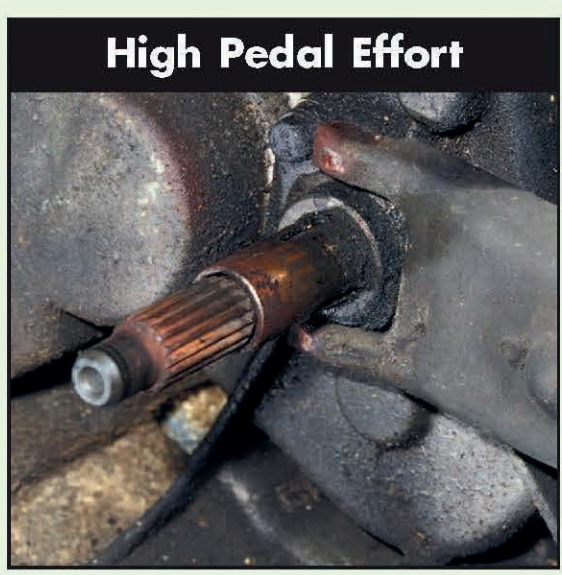
High Pedal Effort

CAUSE- The release bearing does not freely slide on the guide tube.

ACTION- Clean and lubricate the guide tube to bearing contact area with high temp grease. If the guide tube is worn or scored, replace the guide tube.

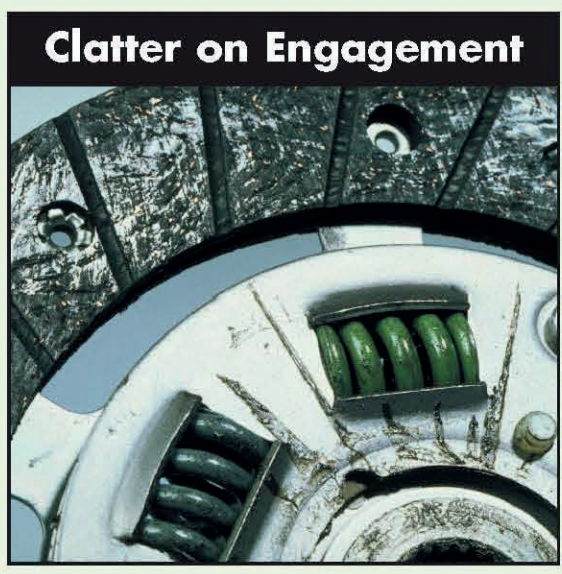
Clatter on Engagement

CAUSE- Excessive amount or incorrect type of grease applied to input shaft.

ACTION- Install new clutch and use the spline grease supplied in the Valeo Clutch Kit.

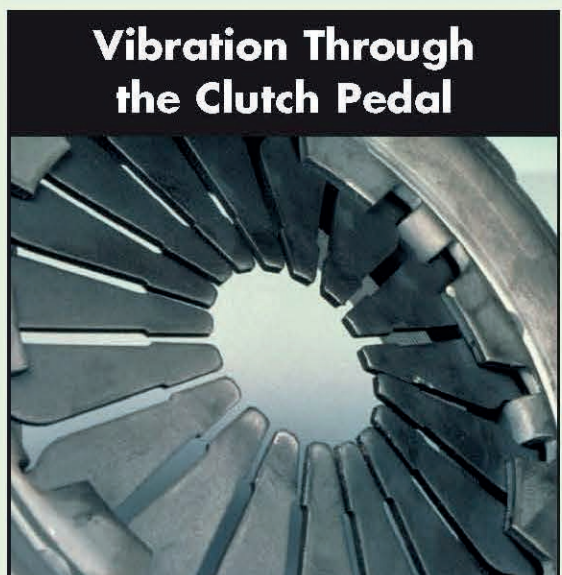
Vibration Through the Clutch Pedal

CAUSE- The transmission shaft has struck and bent the diaphragm spring fingers during installation.

ACTION- Install new clutch and carefully align and control the position of the transmission during installation.

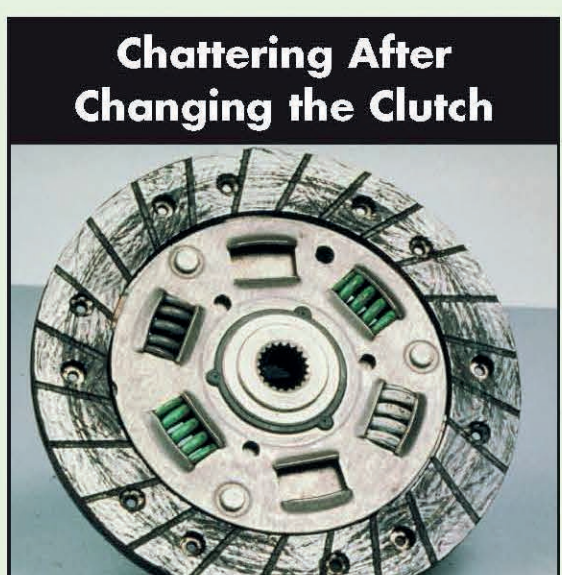
Chattering After Changing the Clutch

CAUSE- Flywheel surface worn. Flywheel needs to be resurfaced or replaced.

ACTION- Replace or resurface flywheel and install new clutch.

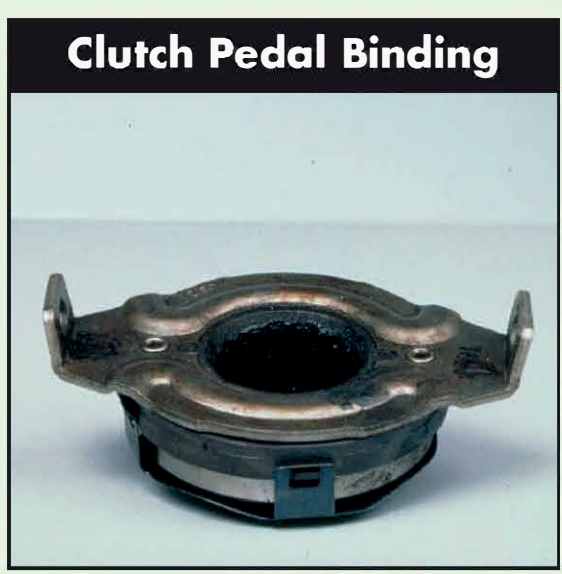
Clutch Pedal Binding

CAUSE- The release bearing guide tube is worn or the release arm/fork is bent/worn.

ACTION- Install new clutch and guide tube. Inspect all release system components and repair or replace as needed.
