FAULT FINDING

Trouble Shooting Clutch Systems

EXEDY

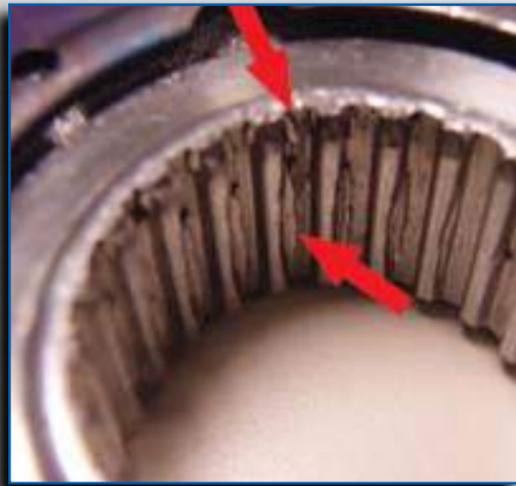
PROBLEM: Contact mark on the teeth of spline and the end of hub.

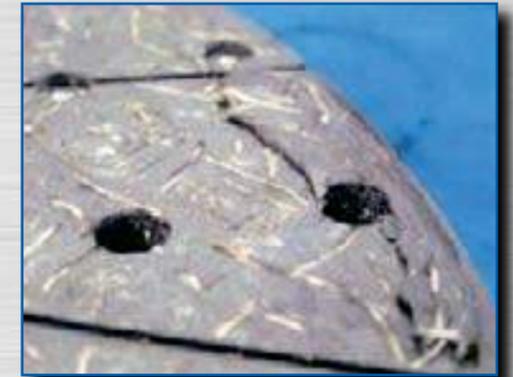
PROBLEM: Burrs at the end of hub due to uneven wear on the spline teeth.

SYMPTOM: Difficult to disengage gears.

SOLUTION: Lightly grease spline, wipe off excessive grease after tentative installation and ensure there is smooth sliding of clutch disc on main drive shaft.

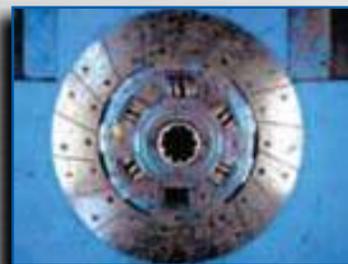
PROBLEM: Damaged torsion springs.

SYMPTOM: Unable to disengage gears/Noisy clutch.

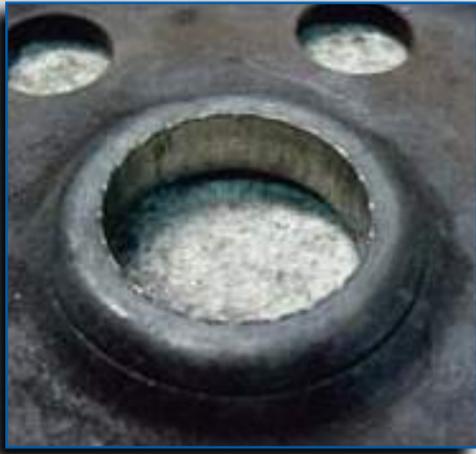
Stripped Out Spline

PROBLEM 1: Stripped out or wore teeth on spline.

SOLUTION: During the installation of transmission, align drive line,
-height
-angle
-spline teeth
then fit without excessive force.

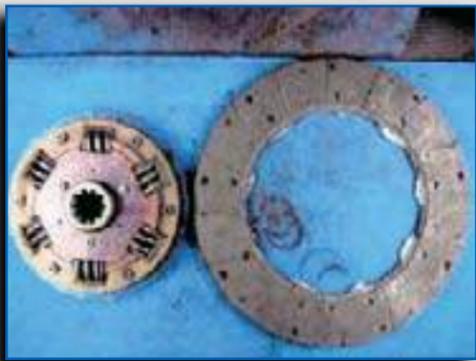
Separated clutch disc assembly

PROBLEM: Oily Facings.

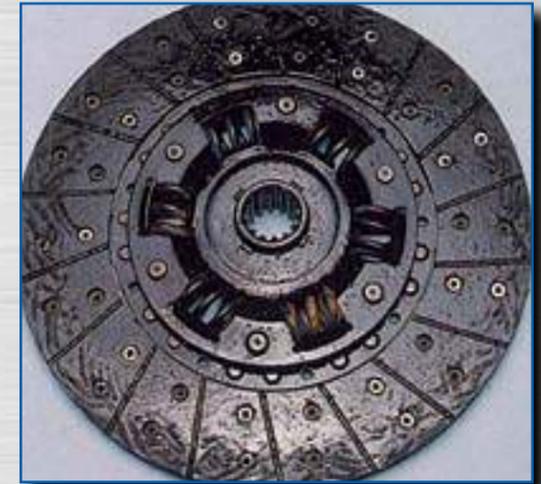
PROBLEM: Difficult gear engagement/broken rubber dampeners.

SOLUTION: 1. Fit genuine EXEDY/Daikin clutch.
2. Driver education.

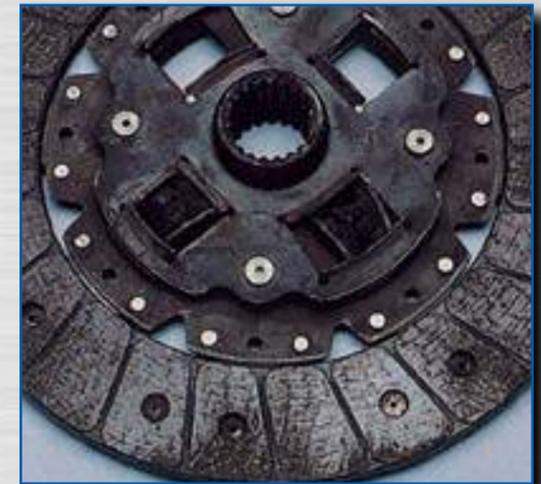
PROBLEM: 1. Crashing noise in gear box, non release.
2. Warped and bent clutch disc.

SYMPTOM: Difficult gear change.

SOLUTION: 1. Do not hang gear box during clutch installation. Always use a clutch aligning tool.
2. Do not force gear box into clutch disc spline.
3. Driver education/check free travel.

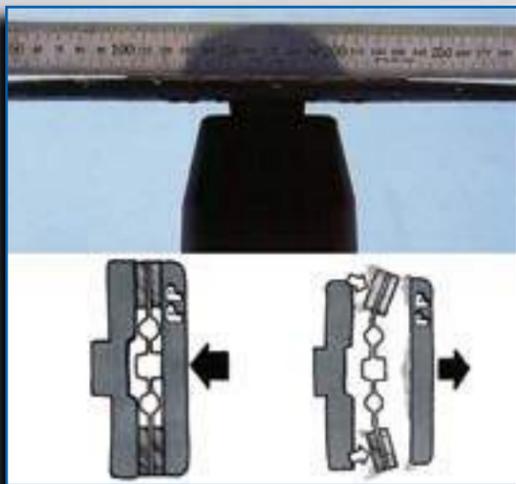
PROBLEM: Power not transmitting to drive train because of broken facings.

SOLUTION: Driver education.

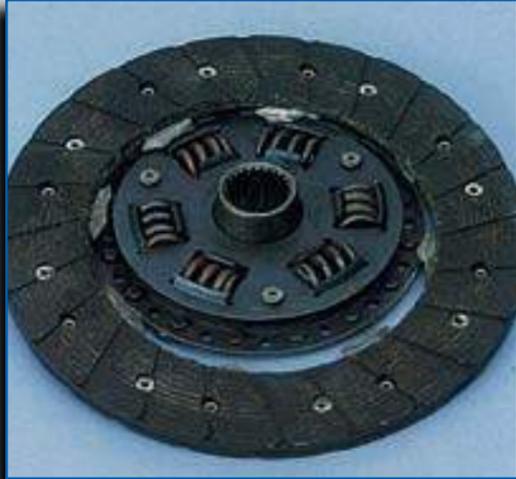
PROBLEM: No drive, power not transmitted because of broken segments on clutch disc.

1. Check pilot bushing or bearing and replace if necessary. Align gear box and use the assistance of a transmission jack and always clean mating surfaces before installation.
2. Check gear box for metal fragments than remove and repair as necessary.

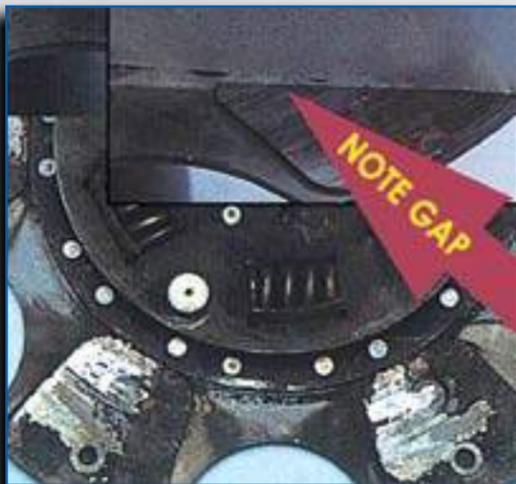
PROBLEM: Premature wear cerametallic button type clutch disc.

SOLUTION: Drivers education; observe bedding in procedure. Due to the weight of this type of disc it takes longer for the rotating clutch to slow down while clutch cover assembly is in a separation position away from the clutch disc. Clutch must be depressed a few seconds longer whilst shifting gear specifically when there is no clutch brake attached to the system.

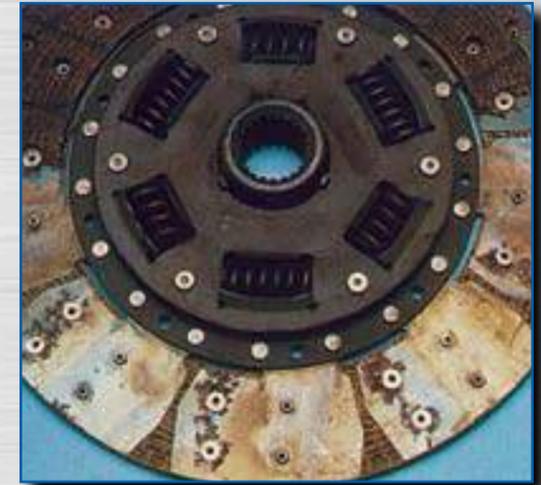
PROBLEM: Broken facing of clutch disc on clutch cover assembly pressure plate side.

SOLUTION: Driver education. Proper fitting practice.

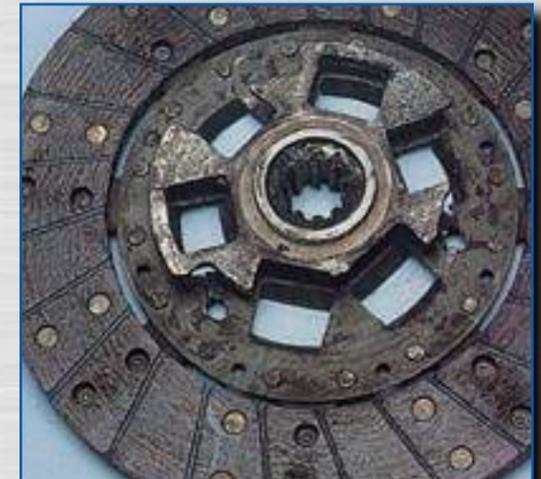
PROBLEM: Clutch disc completely ruined.

1. Always check clutch disc on flywheel for fouling before installation.
2. Always refer to installation procedures on EXEDY/Daikin packaging.

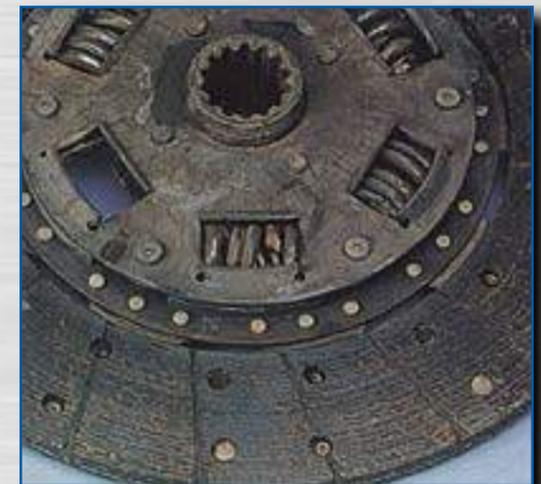
PROBLEM: Damaged torsion springs.

SOLUTION: Choose and fit and appropriate EXEDY/Daikin clutch to suit this application (e.g. silent type design or LTD design).

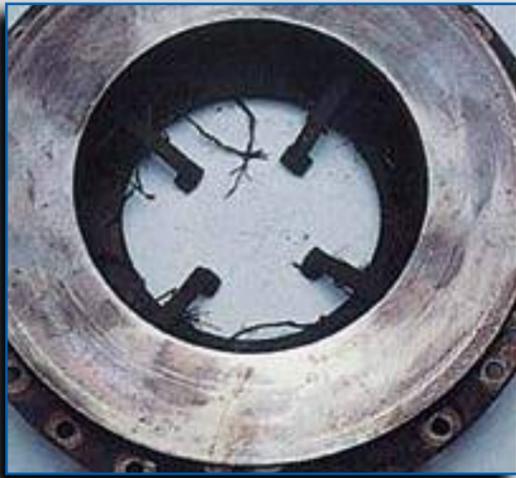
PROBLEM: Burst clutch disc/no transmitted power.

- SOLUTION:**
1. Always refer to EXEDY/Daikin packaging instructions before installing clutch.
 2. Try clutch disc on main drive for smooth sliding before installation.

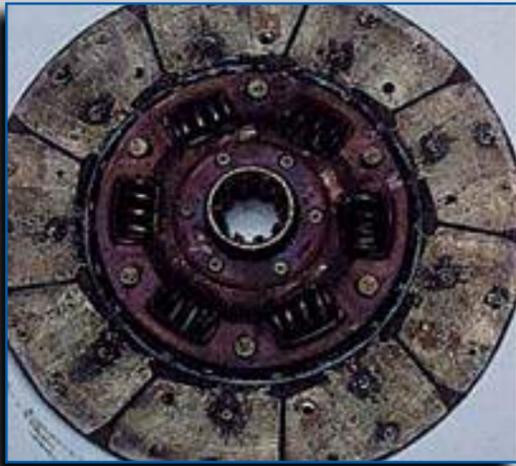
PROBLEM: Different number of spline on main drive to those on clutch disc/diameter of spline incorrect.

SYMPTOM: Unable to fit clutch disc on main drive shaft.

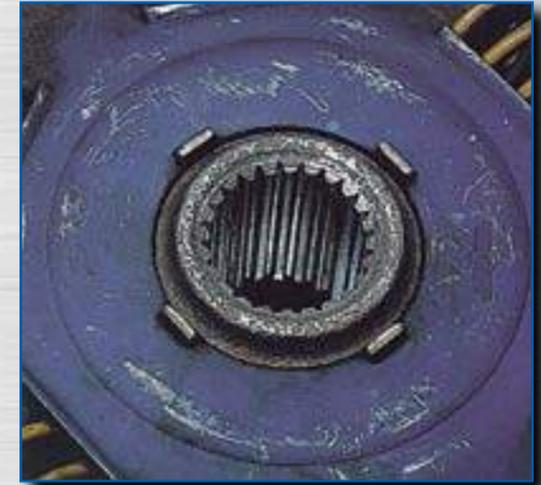
PROBLEM: Crashing in all gears/damaged and burred splines.

SOLUTION: Fit new pilot bearing or bush.

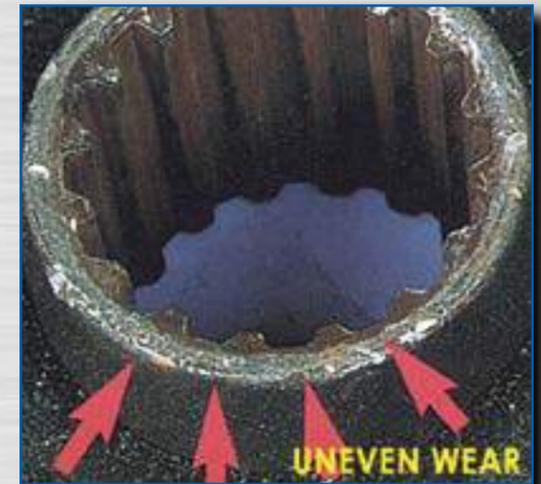
PROBLEM: Noisy and cannot transfer power/splines completely disintegrated.

- SOLUTION:**
1. Always check clutch disc for smooth sliding on spline.
 2. Check and replace spigot/pilot bearing of bushing. (Mini UK and Europe: Check primary gear for worn bushing; if worn replace).

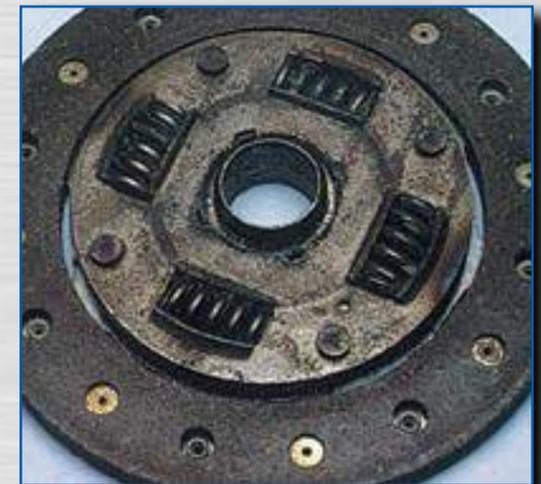
PROBLEM: Damaged facing material.

SOLUTION: Always check before installation that facing is intact. Replace clutch disc.

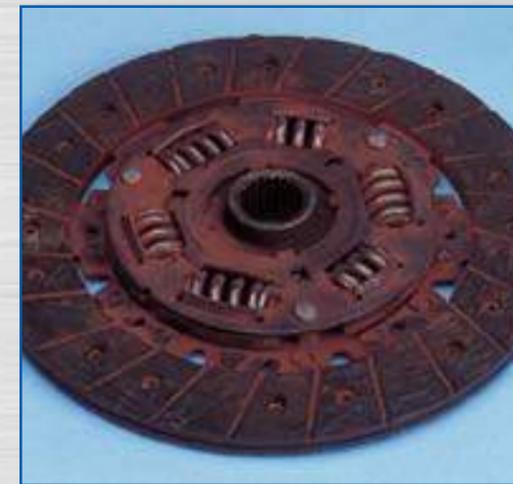
PROBLEM: Torque stopper springs broken. Difficult gear engagement which may lead to clutch failure.

SOLUTION: 1. Refer misalignment tips.

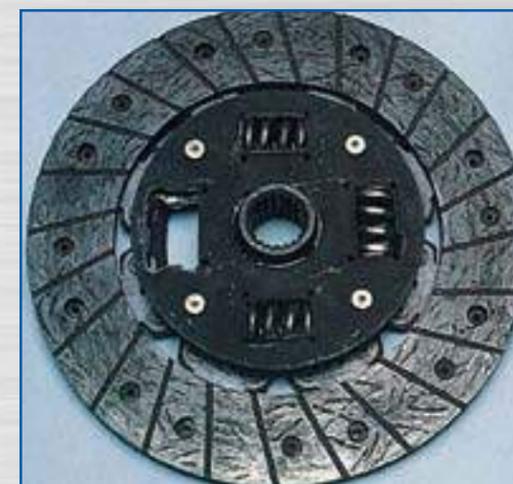
PROBLEM: Wrong type of lubrication on input shaft spline.

1. Use specified grade of grease of vehicle manufacturer (high melting point grease). Do not use anti-seize.
2. Replace clutch disc with new disc unit.
3. Proper installation practice.

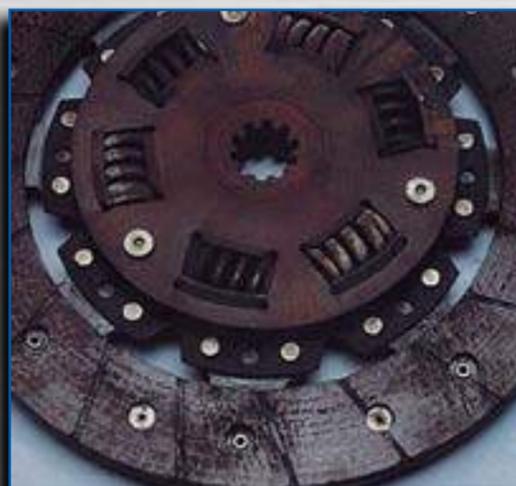
PROBLEM: Melted grease on clutch disc side plate.

1. Lightly grease spline, wiping of excessive grease and ensure there is smooth sliding of clutch disc on main drive.
2. Replace clutch disc with new disc unit.
3. Use only high melting point grease.

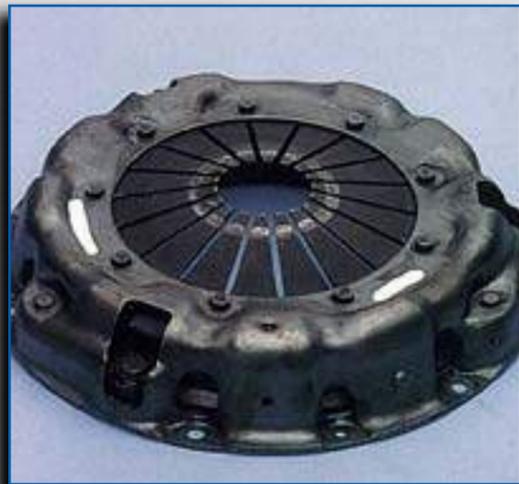
PROBLEM: Excessively worn diaphragm fingers.

SYMPTOM: Pedal graunch sometimes described as erratic feeling when depressing clutch pedal with engine running but OK when not running/notchy clutch pedal.

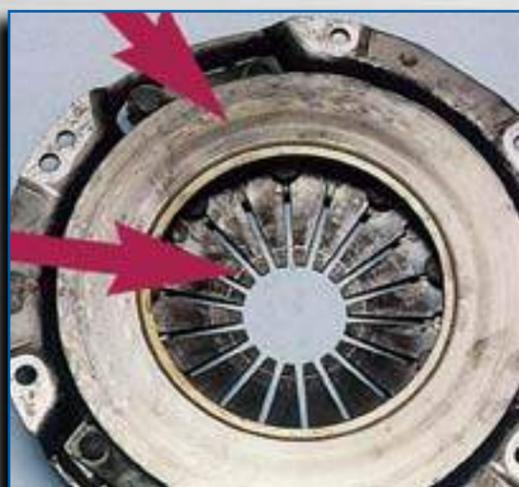
PROBLEM: Diaphragm fouled on clutch disc. Crashing in gear and unable to obtain clutch adjustment.

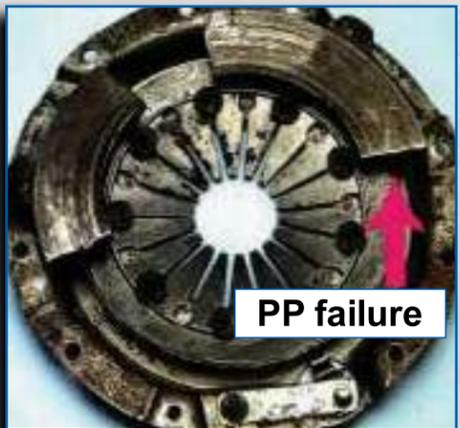
Breakage of pressure plate

PROBLEM: Burst pressure plate casting.
SYMPTOM: No drive/Noisy clutch.
CAUSE: 1. Over revving of engine that has exceeded manufacturers' specifications.
 2. Overheating of casting due to constant abuse of clutch. The main spring has weakened through extreme influence of heat.
SOLUTION: 1. Do not use covers where engine has been modified to excess manufacturer's rpm specification.
 2. Driver education not to activate the clutch in excessive semi disengagement position.

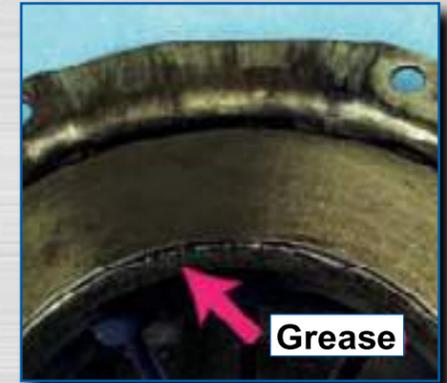
Grease on friction surface

PROBLEM: Oil or grease contamination on friction surface.
SYMPTOM: Slipping clutch/Judder.
CAUSE: Excessive grease or low viscosity grease causes this problem.
 Melted grease on friction material affected friction coefficient and caused slipping or judder.
SOLUTION: Lightly grease spline, wipe off excessive grease after tentative installation and ensure there is smooth sliding of clutch disc on main drive shaft.

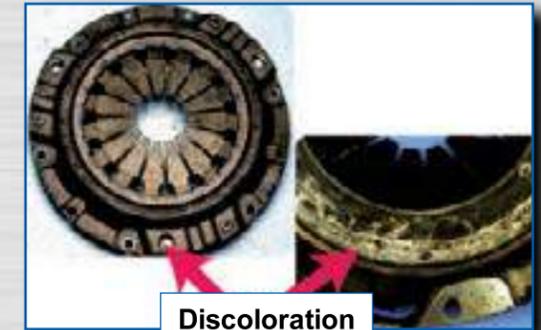
Friction surface, cover discoloration

PROBLEM: Discoloration on friction surface and/or clutch cover.
SYMPTOM: Slipping clutch.
CAUSE: Extreme friction surface temperature rise and slips under extreme clutch operation. This may cause discoloration of clutch.
SOLUTION: Driver education not to activate the clutch in excessive semi disengagement position.

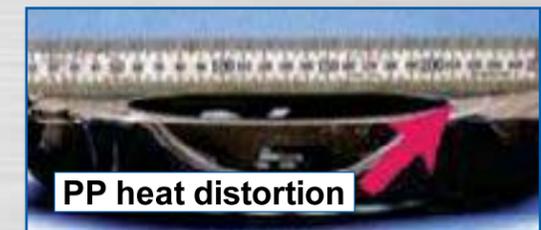
Pressure plate heat distortion

PROBLEM: Warped clutch cover assembly by reuse.
SYMPTOM: Clutch drag.
CAUSE: Insufficient contact due to warped pressure plate. Only clutch disc was replaced which caused partial contact on friction surface and slipped during heavy load condition.
SOLUTION: Always replace a clutch disc, a clutch cover and a clutch thrust release bearing when replacing clutch system.

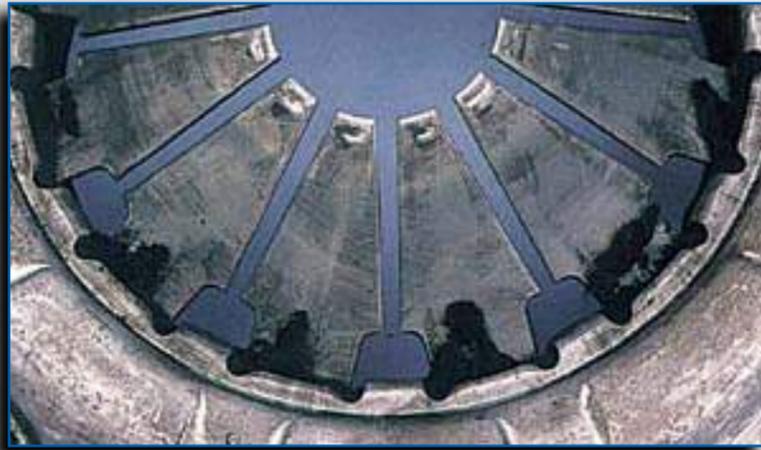
PROBLEM: Worn clutch disc facing fibres and dirt lodged between diaphragm spring and clutch cover housing causing loss of clamp load.

Note: These problems are common on farm vehicles, vehicles travelling on sand and 4x4 recreational vehicles.

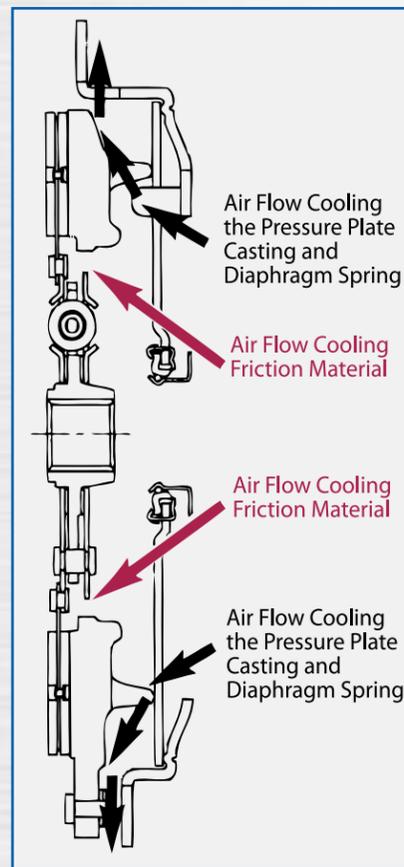
PROBLEM: 1. Vehicle vibrates/shakes when clutch is being released, at take off.

SOLUTION: Always resurface flywheel before installing new clutch. Refer to figure below.

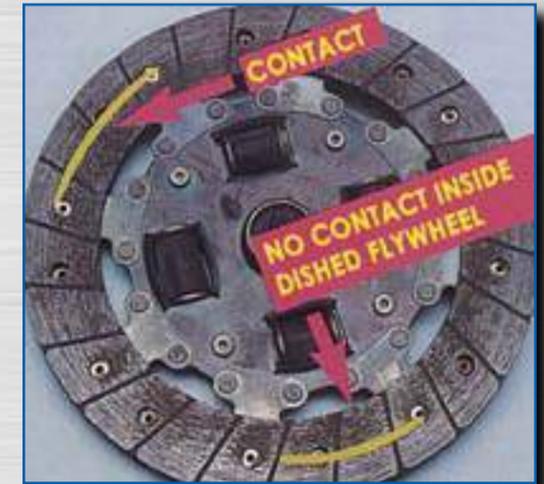
PROBLEM: Highly glazed to a mirror finish pressure plate cover assembly casting/red dust on clutch components.

SOLUTION: 1. Replace complete clutch and pilot (spigot) bearings.
2. Avoid misalignment on installation.

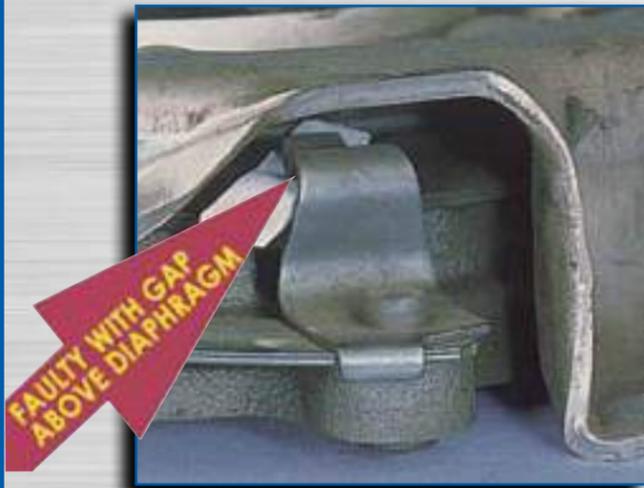
PROBLEM: No gear selection/difficult engagement. Stretched and damaged retractor clip. (Clip stretched above diaphragm).

SOLUTION: When the transmission is installed onto the mating area of the engine the release bearing is preliminarily set into position where the release fork of the transmission is fitted. After installation of the transmission the release lever must be pulled in the direction reverse to the release firmly. The bearing is then snapped in. (Also refer manufacturer's specifications).

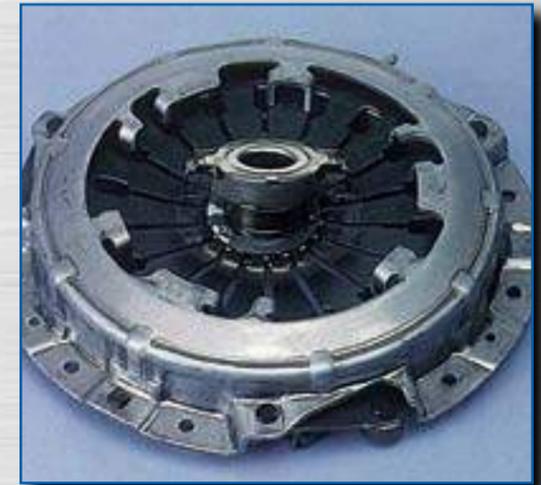
PROBLEM: Crashing gears/stretched and damaged retractor clip. (Clip under diaphragm).

SYMPTOM: Difficult engagement/disengagement after installation of new clutch.

CAUSE: 1. Interference due to release bearing over stroke.
2. An incorrect clutch disc may interfere with diaphragm, when you depress the clutch pedal.

SOLUTION: 1. Refer to clutch adjustment procedure, and adjust pedal free play.
2. Use the correct clutch disc.

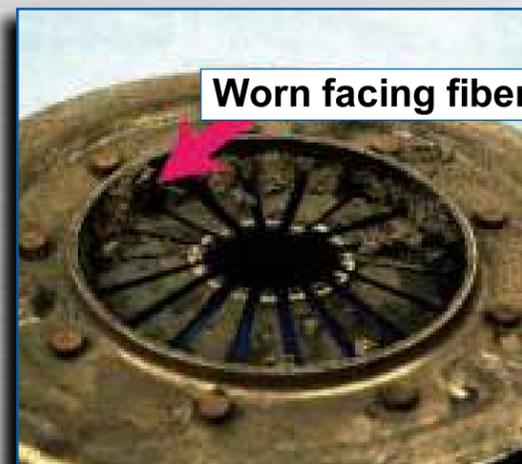
Worn facing fiber

Worn facing fibers and dirt lodged

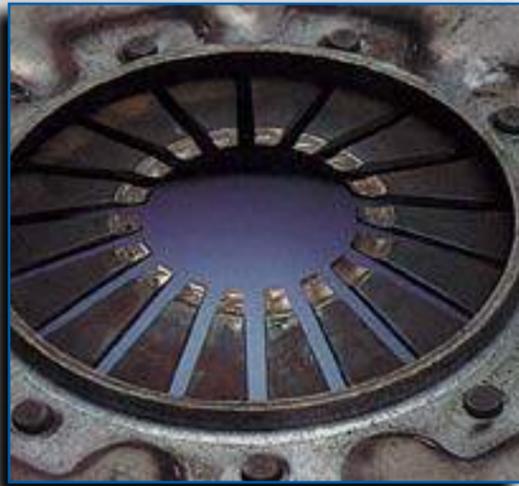
PROBLEM: Excessive wear on diaphragm tips and a highly glazed pressure plate casting.

SYMPTOM: Slipping clutch/shudder/judder.

CAUSE: The pressure plate cover assembly was torqued down incorrectly i.e. not diagonally.

SOLUTION: Tighten bolts temporary by hand, then torque down in correct diagonal sequence one by one.

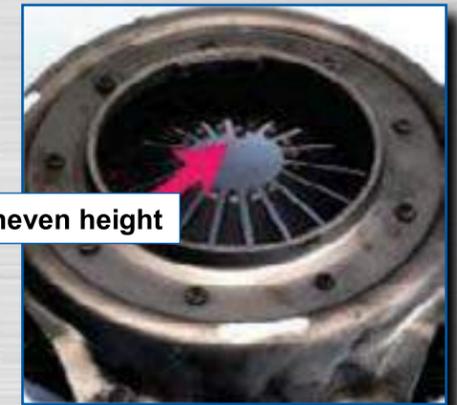
Uneven diaphragm tips

PROBLEM: No clamp load on to clutch disc.

CAUSE: Clutch cover pressure plate assembly hold down bolts to assist ease of installation not removed.

- SOLUTION:** Remove hold down bolts.
1. Do not remove clutch lever adjustment nuts.
 2. Common in Japanese trucks

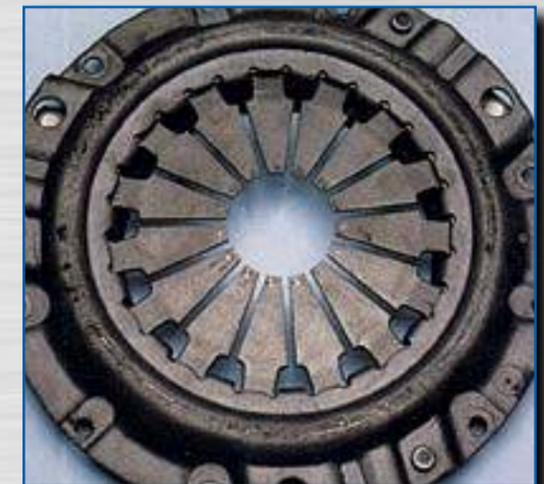
- PROBLEM:**
1. Hold down bolts still in pressure plate assembly.
 2. Unable to adjust.
 3. Will not transmit power.

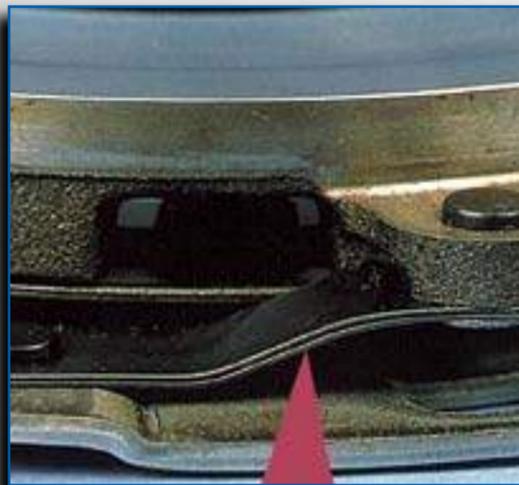
PROBLEM: Unable to change gear/bent drive straps.

- SOLUTION:**
1. Driver education.
 2. Install correct cover assembly for application.
 3. Fit extra straps to suit heavy duty application (optional), or use EXEDY/Daikin Sports clutch.

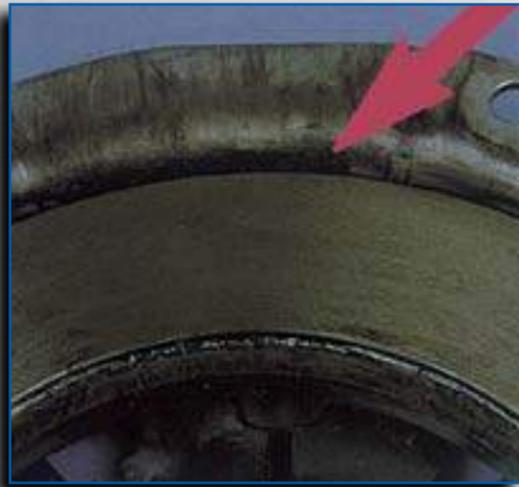
PROBLEM: Engine revving when power applied during acceleration/will not transmit power. Evidence of oil contamination on cover assembly.

SOLUTION: 1. Rectify oil leaks.
2. If re-using a new cover that has been contaminated with oil, de-grease the cover assembly and lightly lubricate diaphragm pivot rings before re-installing with light base oil.

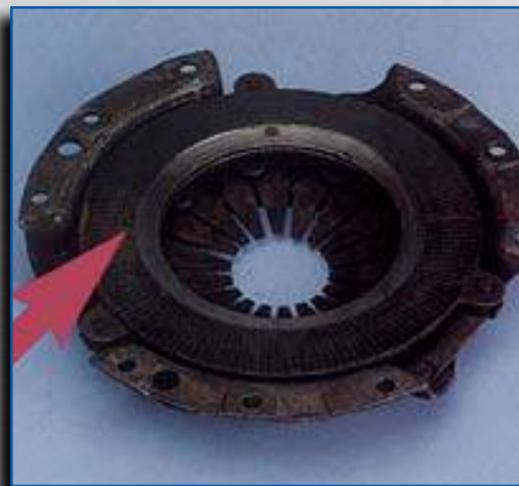
PROBLEM: Excessively scored clutch cover pressure plate assembly.

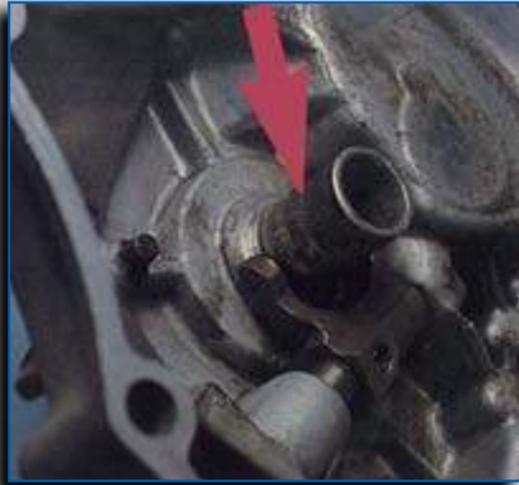
PROBLEM: Worn fixed gear box quill shaft/gear box nose cone slide.

SYMPTOM: Notchy clutch pedal when depressing clutch.

CAUSE: Clutch thrust bearing fitted incorrectly e.g. back to front.

SOLUTION: Replace with new bearing fitted correctly i.e. right way round.

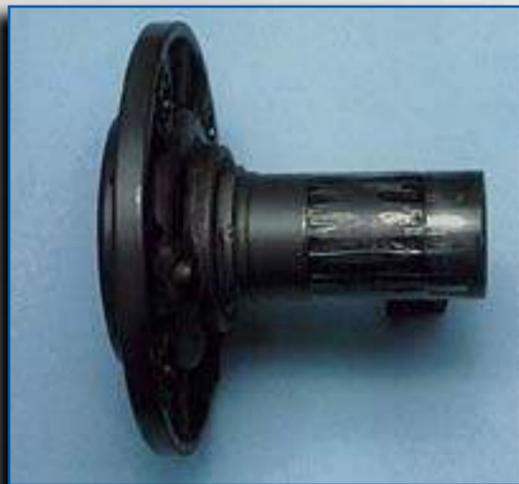
PROBLEM: Worn quill shaft.

1. Fit new clutch kit as it is too late for adjustment of old clutch.
2. Always check free travel at service.

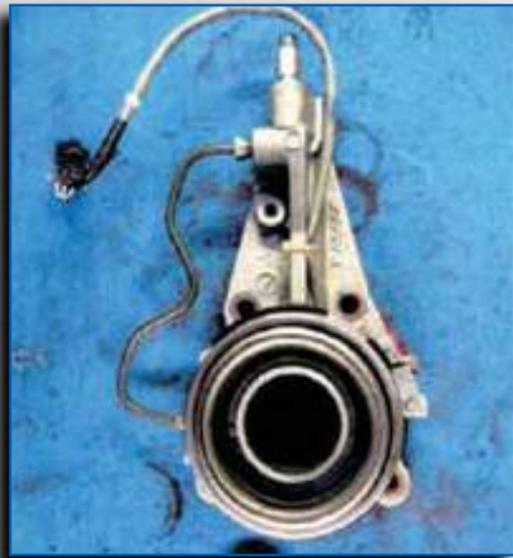
Malfunction of cylinder assembly

PROBLEM: Difficult to disengage gear/Slipping clutch.
SYMPTOM: Malfunction of cylinder assembly.
CAUSE: In case of CSC, Concentrated Slave Cylinder, internal piston not traveling smoothly causes system failure, and it may result in following symptom;
Difficult to disengage gear:
 1. Fixing or sticky movement causes short stroke and results in difficult to disengage.
 2. Leaking oil causes short stroke and results in difficult to disengage:
Slipping clutch:
 1. Oil on a friction facing due to leakage from cylinder assembly causes slipping clutch.
 2. In case of malfunction in regard to piston return, it causes continuous semi-disengagement and results in slipping clutch as well as facing abnormal wear and burst by burnout.
SOLUTION: Always replace with new cylinder assembly. Install cylinder assembly after ensuring smooth movement.

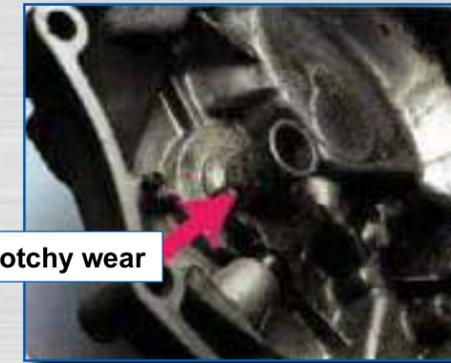
PROBLEM: Notchy clutch pedal/Slipping clutch.
CAUSE: Abnormal wear on front cover, notchy wear. Clutch release bearing carrier not travelling smoothly on quill shaft/gear box nose cone slide.
SOLUTION: Apply appropriate grease. Renew worn out parts or scratched parts.

Notchy wear on front cover

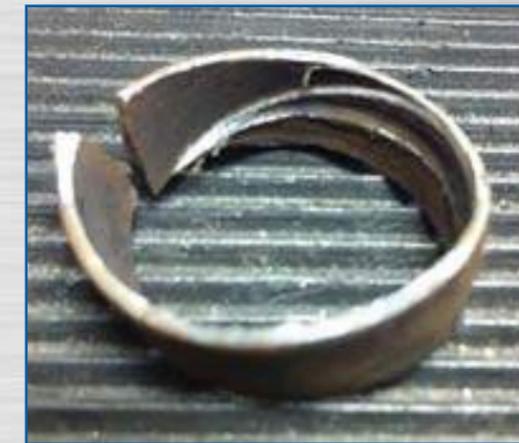
Clutch cover mounting surface

Friction surface

PROBLEM: Clutch slipping, premature wear.
CAUSE: **Slipping:** Not enough friction area causes less torque transmittance and results in slipping under heavy load due to reuse of worn flywheel.
Premature wear: Reuse of worn flywheel is same condition as worn clutch disc, and it results in premature wear. If you resurface friction surface only, it causes premature wear as well
SOLUTION: 1. Replace with new clutch.
 2. Use flywheel which has the same dimension as new, the height ★ between clutch cover mounting surface and friction surface shown in figure.

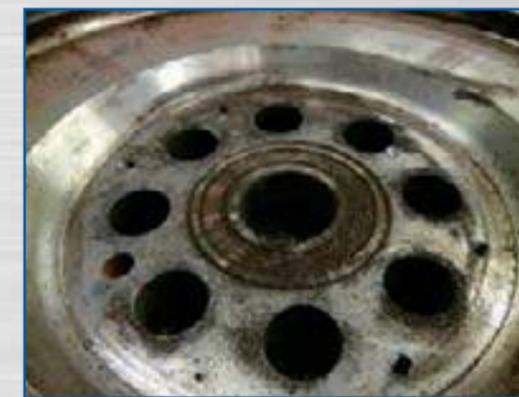
Deteriorated pilot bearing

PROBLEM: Difficult to disengage gear/Noisy clutch.
CAUSE: Reuse of pilot bearing.
Noise: Reuse of deteriorated pilot bearing may cause abnormal noise from the bearing under depressing clutch pedal condition.
Difficult to disengage gear: Reuse of bearing which is not smooth movement causes difficult to disengage gear, because it transmits torque under disengagement condition.
SOLUTION: Always replace with new pilot bearing when you replace clutch.

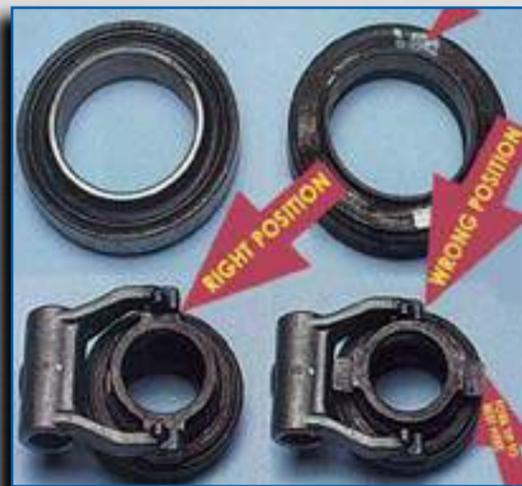
- PROBLEM:** Excessive score marks on clutch thrust bearing.
SYMPTOM: Excessive free travel/clutch does not disengage/ noisy - Japanese range of trucks.
CAUSE: Incorrectly fitted clutch thrust bearing carrier to clutch release fork causing bearing carrier to spin off the fork tips and bearing carrier saddle. This problem could also be caused if the tension on the release bearing carrier wire clip is not sufficient.
SOLUTION: 1. All care should be taken when replacing bearing carrier on the clutch fork. Also ensure the retaining spring clip has sufficient tension.
 2. Always work clutch thrust bearing carrier both forward and backward to ensure that the fork is retained firmly on the carrier saddle.

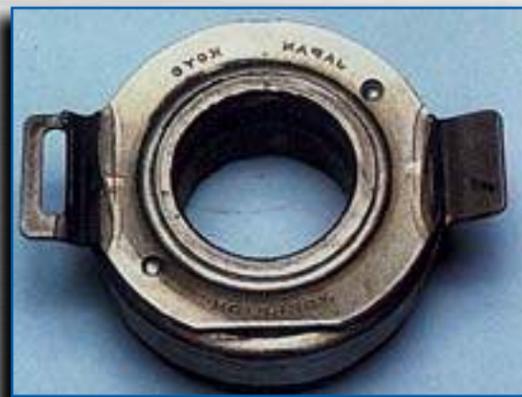
- PROBLEM:** Broken saddle clip.
SYMPTOM: Noisy rattle and difficult to engage gear.
CAUSE: Careless installation as spring retaining clip not assembled to fork during installation, or tension on wire retaining clip not correct.
SOLUTION: 1. Check tension on wire retaining clip.
 2. Always check bearing on clutch release fork after installing bearing on it. Move the fork in both directions to ensure bearing is secure before refitting gear box.

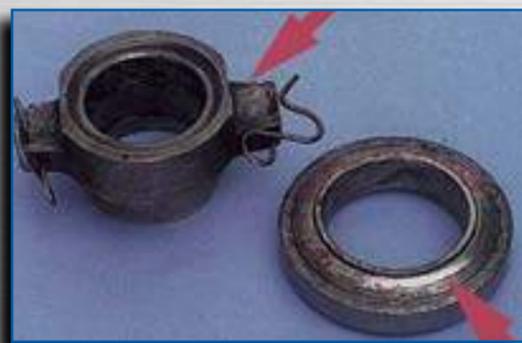
- PROBLEM:** Worn clutch thrust bearing carrier.
SYMPTOM: Pulsating pedal with engine running.
CAUSE: Faulty installation as the clutch thrust bearing carrier is worn on the saddle where the fork pivots. This also reduces the tension on the wear clip retainer. In this case, due to the lack of tension the fork has become dislodged and scored the back of the bearing.
SOLUTION: Always replace worn clutch thrust bearing carriers and worn forks.

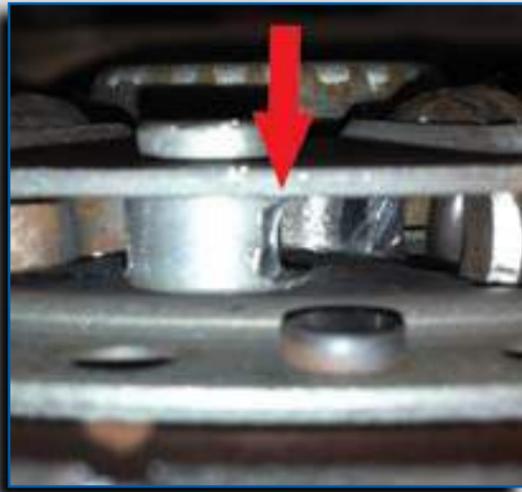
PROBLEM: Noise, Difficulty engaging gears.
CAUSE: Broken drive hub on clutch disc. Damaged stop pin from high RPM clutch "dumping" or "side skipping" from a stop.
SOLUTION: Driver education, change driving style.

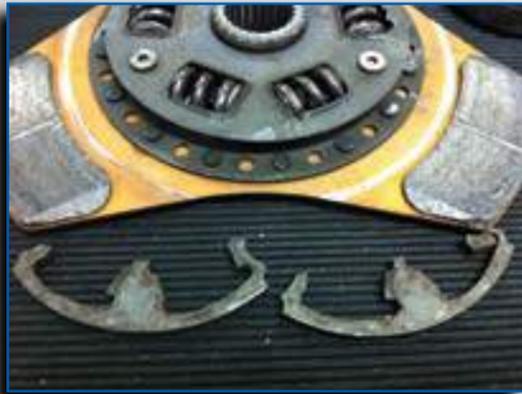
PROBLEM: Difficulty changing gears.
CAUSE: Intermediate plate not in the correct location on the flywheel.
SOLUTION: Always line up the blue marks on all the components during installation.
TECH TIP: A center punch can be used to leave an indentation on each component as the paint can be affected by chemicals

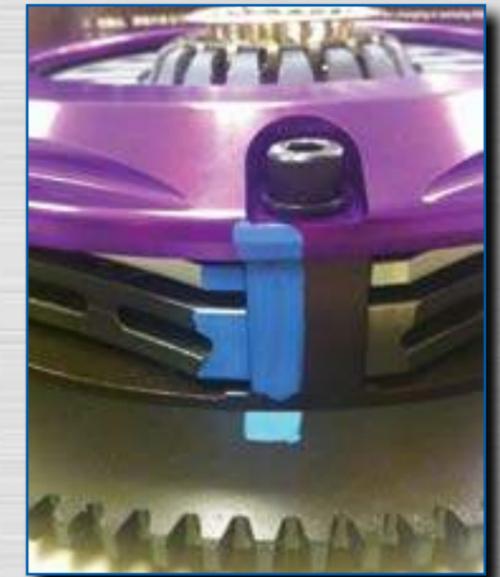
PROBLEM: Gearbox noise, difficulty changing gears.
CAUSE: Damaged spline hub and disc due to one or more of the following:
 1. Inadequate lubrication on input shaft
 2. Burrs on input shaft of transmission not allowing hub to slide freely.
 3. Too much pressure plate left from improperly adjusted pedal stop or hydraulic assembly.
 4. Bad input shaft bearing, pilot bearing or pilot bushing causing hub to wobble against discs.
SOLUTION: 1. Use proper lubrication on input shaft.
 2. Inspect input shaft on transmission for burrs or damage.
 3. Properly adjust pedal stop and/or hydraulic assembly.
 4. Measure input shaft in play, inspect pilot bearing/bushing.

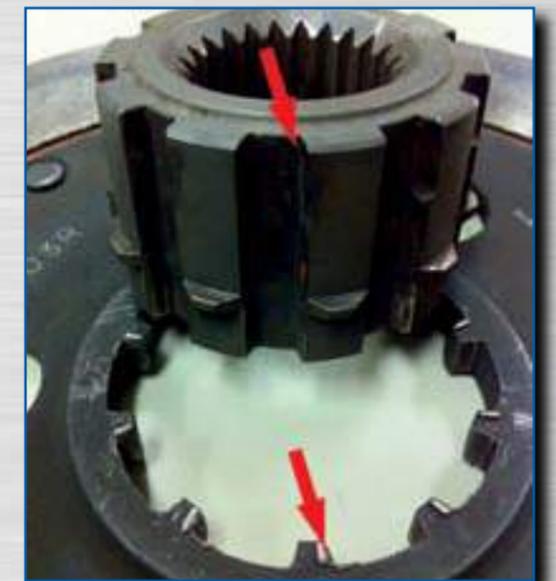
PROBLEM: Clutch slippage.
CAUSE: Over greasing the input shaft.
SOLUTION: Use a thin coating of grease, uniform and evenly on input shaft.
TECH TIP: Slide clutch disc on to input shaft to evenly distribute grease on spline. Wipe away all excess grease from end of spline and disc. Be careful not to touch facing of disc with grease.

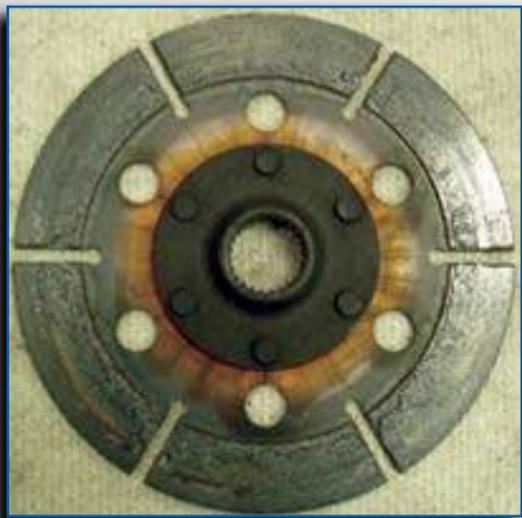
PROBLEM: Difficulty changing gears.
CAUSE: Mis-shift at high RPM or aggressive down shifting at high RPM.
SOLUTION: Driver education, Change driving style, use lug type multi plate clutch.

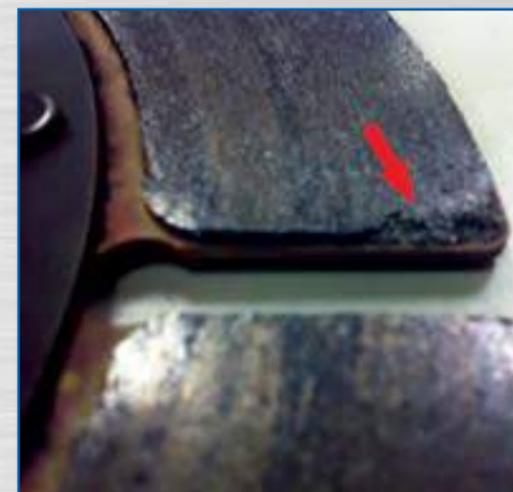
PROBLEM: Chipped facing.
CAUSE: Improper break in of clutch assembly.
SOLUTION: Follow manufactures break in procedures.

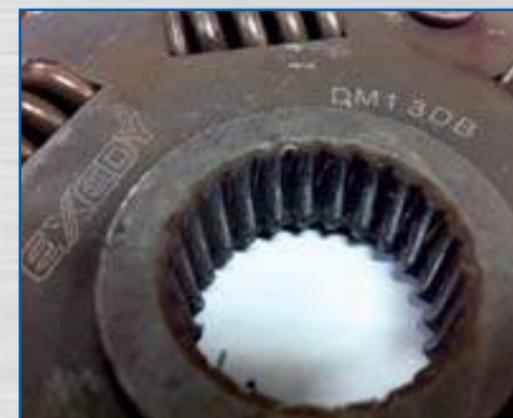
PROBLEM: Difficulty changing gears.
CAUSE: Spline damage on the bottom disc(s) from not being aligned properly.
SOLUTION: Use the proper alignment tool for vehicle application.
TECH TIP: Twist the alignment tool to align the bottom discs while finger tightening the cover bolts.

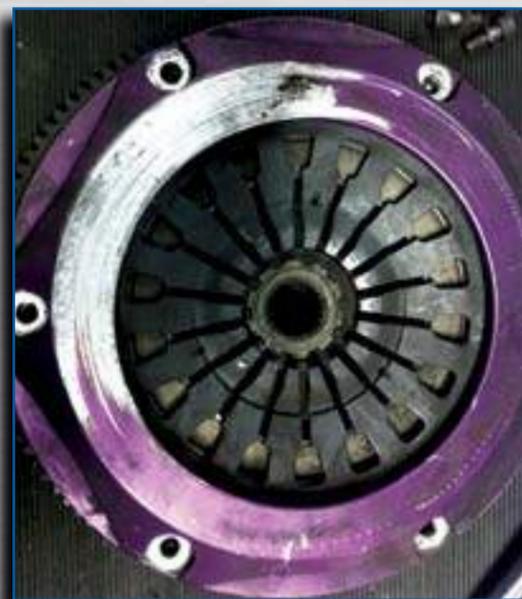
PROBLEM: Clutch slippage "slipping".
CAUSE: Loose cover assembly bolts from improper bolt tightening torque procedure.
SOLUTION: Use manufacture bolt torque specs. Tighten evenly. Use thread locker to ensure bolts do not loosen.
 Refer to page 70 for proper tightening specifications.

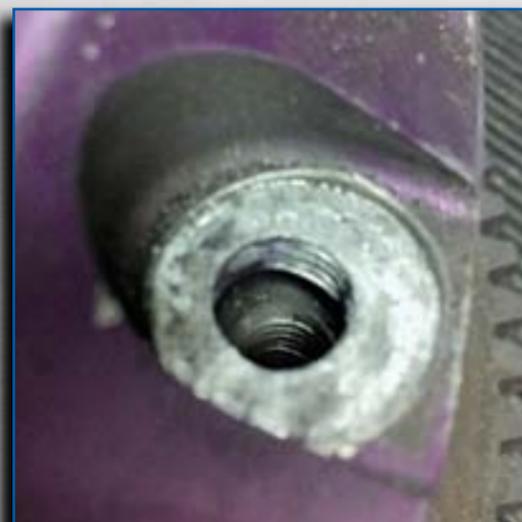
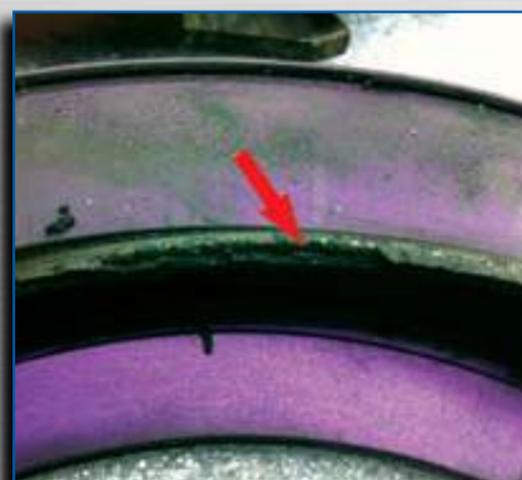
PROBLEM: Difficulty changing gears, no release.
CAUSE: Debris built up in pivot ring area between cover and diaphragm spring.
SOLUTION: Disassemble cover assembly and clean thoroughly.

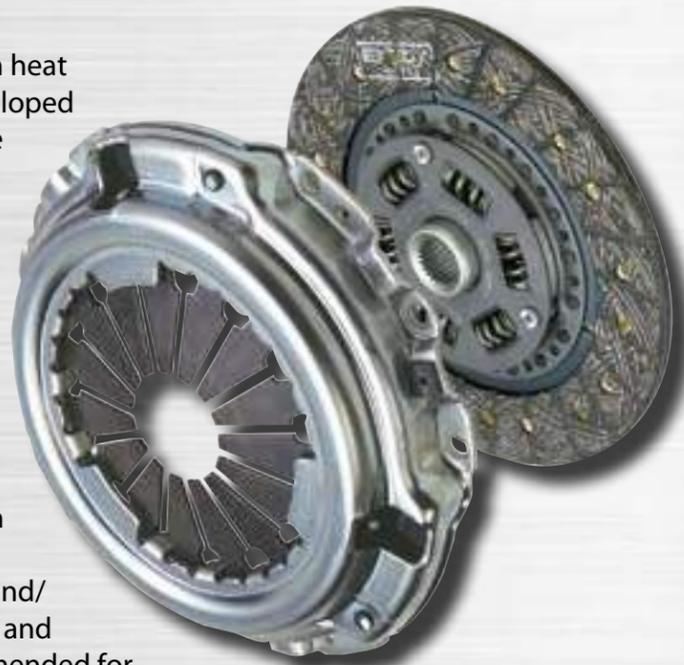
Clutch Cover

These clutch covers are designed to achieve a clamping load that is approximately 40% higher than the genuine part allowing a higher torque transmitting capacity. Ductile material is used for all pressure plates and, high burst strength can be achieved in all temperature ranges.

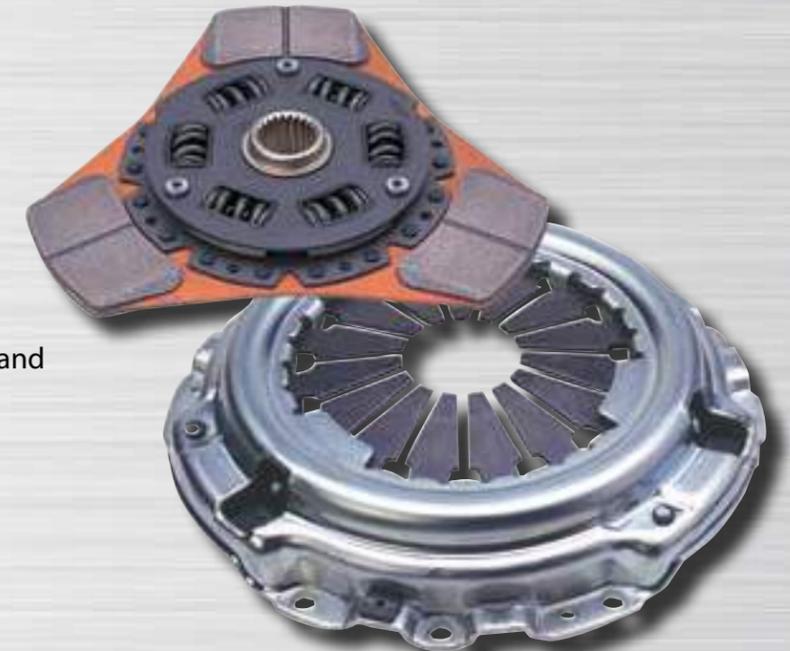
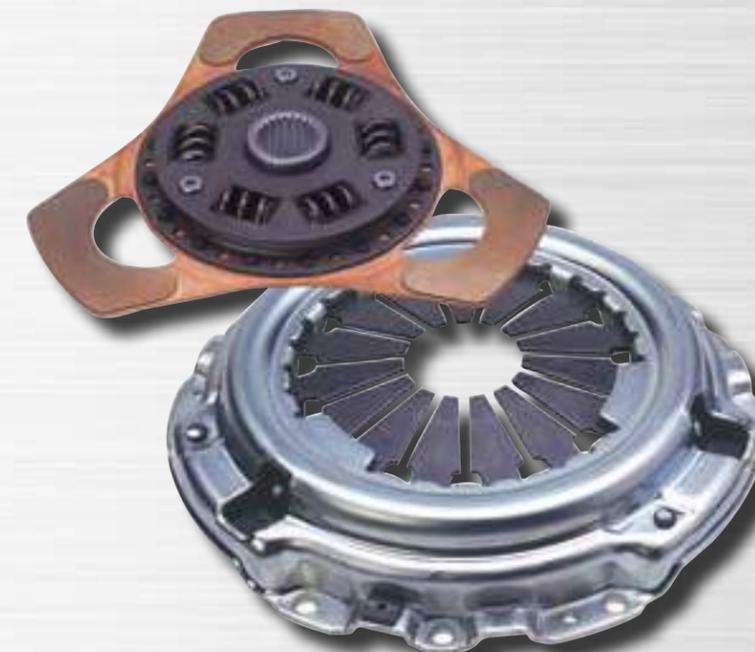
Thin Disc

Thick Disc

The "thick" discs have better heat capacity and therefore better durability in demanding applications. Even with the "thick" disc, our three and four puck designs typically have less inertia than a stock disc and work well for street, rally and track use.

The "thin" discs offer greatly reduced inertia to improve shift effort, allow for quicker shifting, and improve synchro durability. These discs are approximately 1/2 the thickness of a stock disc and are recommended for circuit track use only.

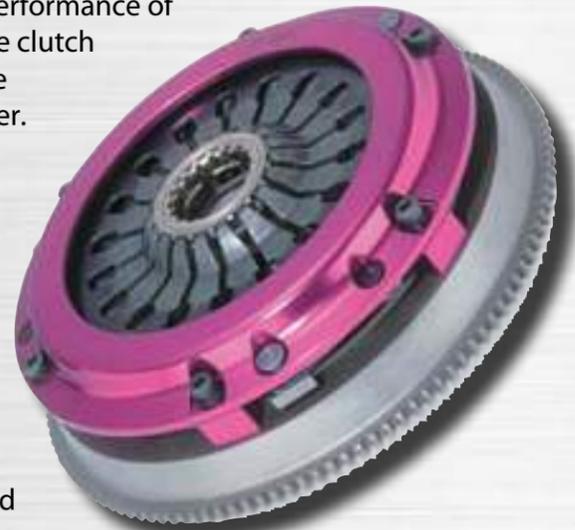
Patented One Touch Snap in Function

The problem of detachment difficulties is solved by the use of EXEDY original one-touch snap in bearing design. Detachment can easily be accomplished with the use of a screwdriver, alternatively, the bearing can be snapped back into place while activating the release fork.

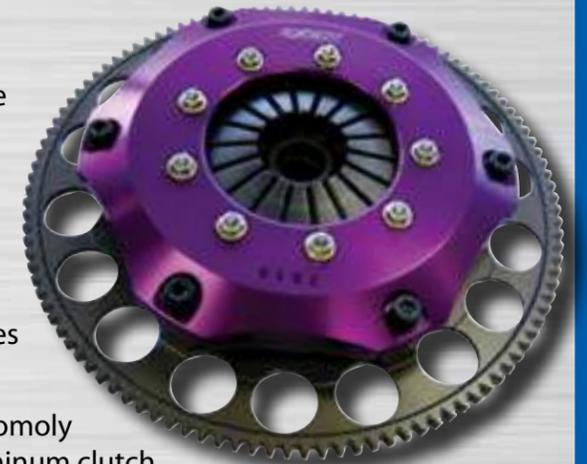
SD Type

This model has been developed for high powered street cars and race cars with up to approximately 600TQ @ FW. They feature ventilated, thick intermediate plates for improved life and spring damper discs to protect your transmission and drive line.

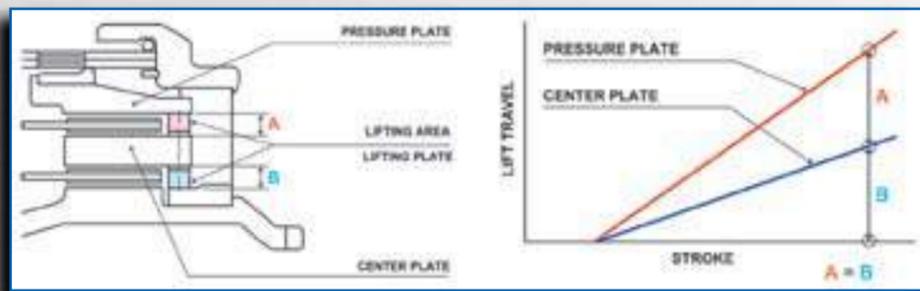
The amount of center plate travel during release is always maintained in a neutral position by the reaction force of the lifting plate attached to both sides of the center plate.

- Improved disengagement (accelerated separation from friction surface).
- Improved disc life by eliminating unbalanced wear at the T/M and F/W side.
- Prevents and lowers mechanical noise.

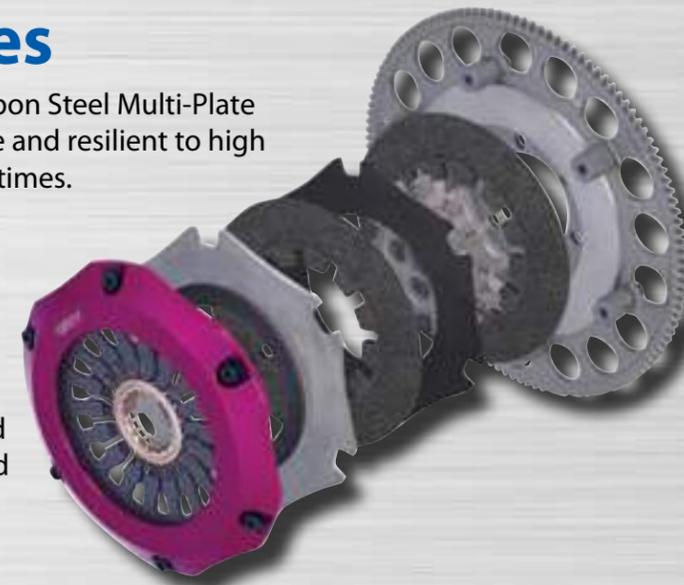
High Heat Resistance

Carbon materials are baked at more than 3600 degrees Fahrenheit, which allows the carbon material to dissipate heat far better than conventional metallic material. Heat expansion rate is 1/20th of iron therefore eliminating a change in clutch feel that may happen due to distortion caused by expansion during driving. Carbon material not only has a high heat resistance but also a "non-stick" characteristic that eliminates disengagement problems.

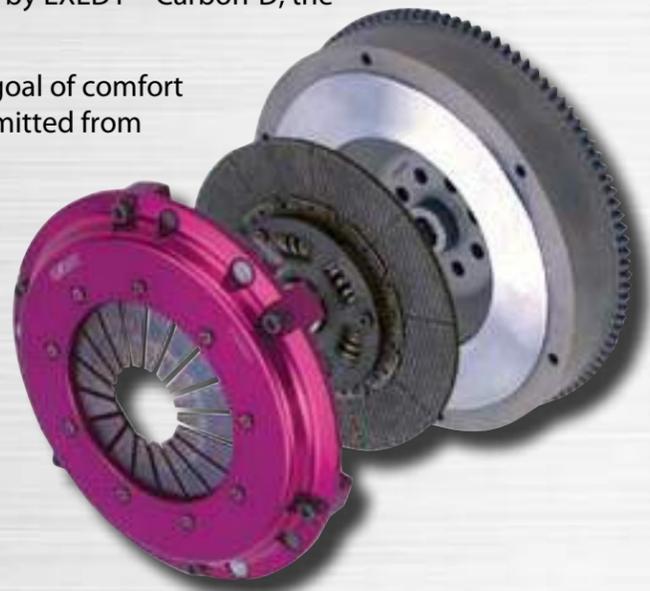
Carbon-D Single

- Introduction of a damper to absorb and dissipate noise and vibration
- High clamp load, lower pedal effort and ideal clutch engagement is obtained with the use of the re-engineered diaphragm spring
- Quiet Strap Drive design to minimize mechanical noise
- Patent Pending Disc System
