FAULT FINDING

Trouble Shooting Clutch Systems

EXEDY

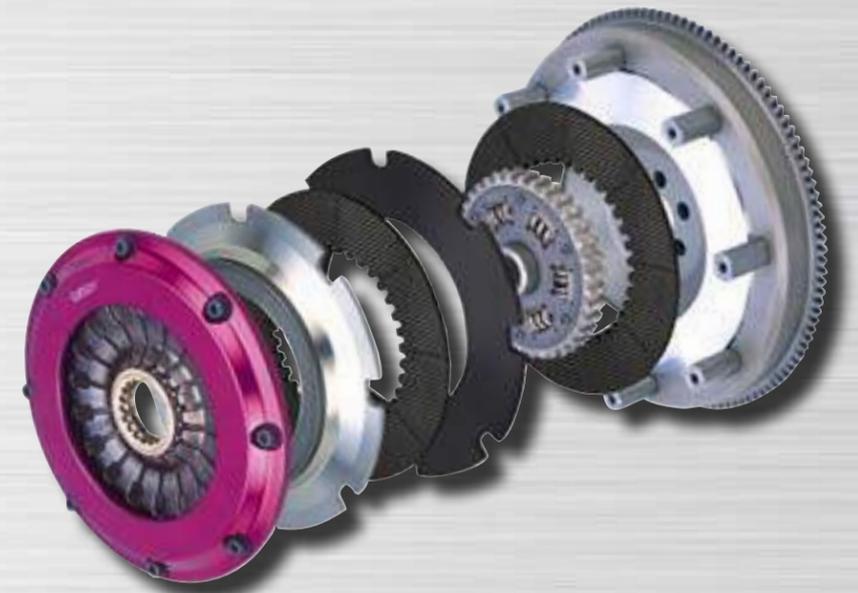
- Introduction of a damper to absorb and dissipate noise and vibration
- With a reduction in pedal effort and an increase in disc size to 225mm, the Carbon-D Twin clutch is ideally suited to high performance street vehicles
- By optimizing the weight and inertia of the Carbon-D Clutch System, drivability is improved at low speeds
