Destructive Findings and Shift Detent mod.

Discussion in 'Technical Chat' started by Key-Rei, Jun 12, 2019.

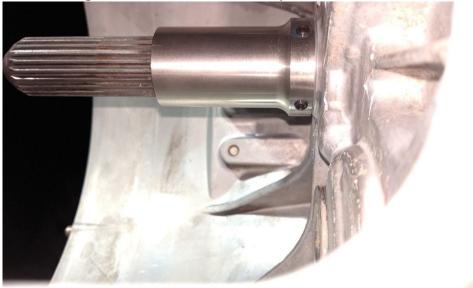
It wears straight from the start and when as it wears the throw out bearing becomes miss aligned and difficult to, well, throw out further exacerbating the wear.

Worn quill, look how scarred that surface is! It should be near

polished to allow the TOB to slide. As is nearly a full mm of material has been removed from the TOB sliding back and forth. As the TOB wears the quill the bearing becomes more and more misaligned and greater pedal force is needed this and wears the quill faster and faster.

Another angle similar to the scarred quill's:

Solution <u>URD</u> stainless quill sleeve. This is a solution to the quill wear however it is possible your quill is BENT and this will not bring your TOB back into alignment. Note you can also see the fork support post mentioned earlier here in the top left.

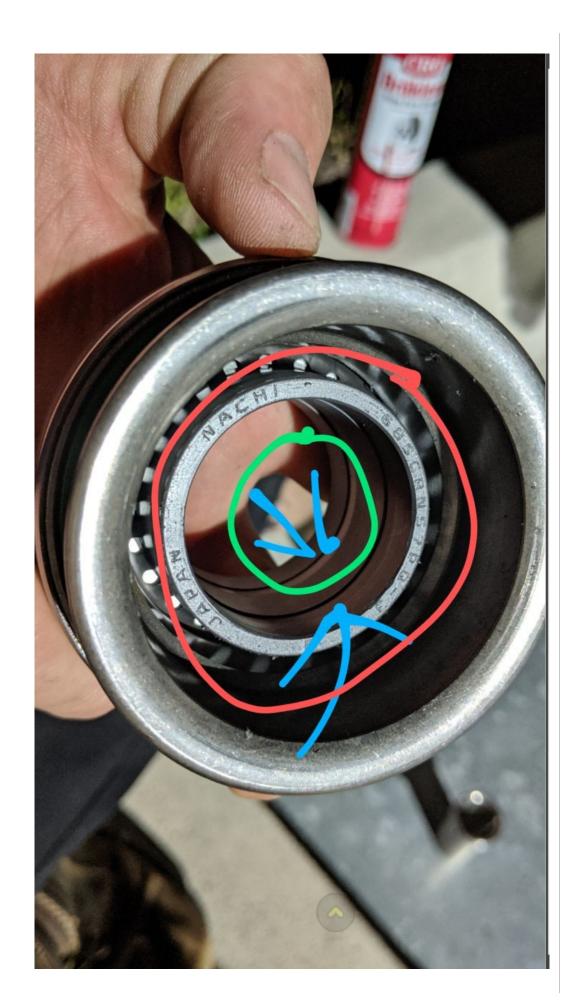
Blue arrows are the grease reserve grooves that need filled.

Green ring bearing "inside"

Red ring:

Retainer snap ring for the TOB's actually bearing inner seal.

The fork should be LIGHTLY greased on top of those humps, on the flat insides where it makes contact with the sides of the release bearing and a small dab of grease in the channels on the back where the release bearing spring clips onto it. (Not pictured)

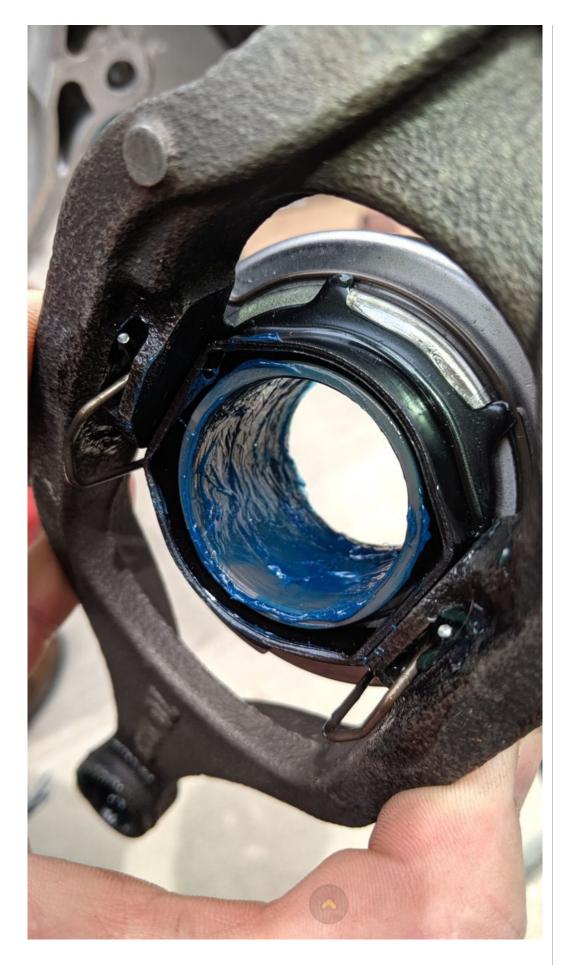
Proper greasing of the throw out bearing / release bearing according to the FSM and my findings below. (Excuse my finger painting)

(URD modified bearing specific.)

Probably a little on the heavy side here but I wanted to ensure the grease reservoirs the URD instructions mention were well and filled. After installing I slid the bearing back and forth on the guill and removed the excess grease build up from the end of the quill.

I used the blue URD grease on the TOB to maintain URD warranty but I would have normally used the green Honda Urea grease in it's place.

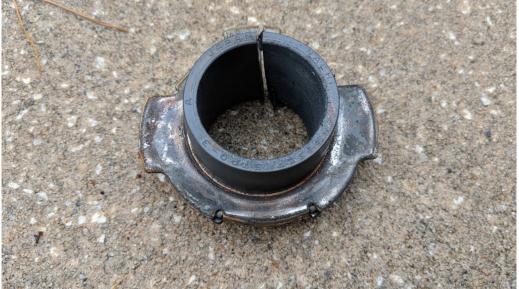
Front that normally has the bearing against it:

The back of the thatbearing that sits against the fork you can see the spots of wear and notice the flats that fit between the fork fingers when installed. Both the horizontal and vertical surfaces should have a LIGHT film of grease put on them when installing the new bearing.

You can also see residue of Toyota's misunderstanding of the issue squeak fix. What appears to be brass impregnated grease, that is the copper colored funk all over the back side. This is NASTY SHIT like thick nickel anti seize. Power degreaser and a pressure washer won't

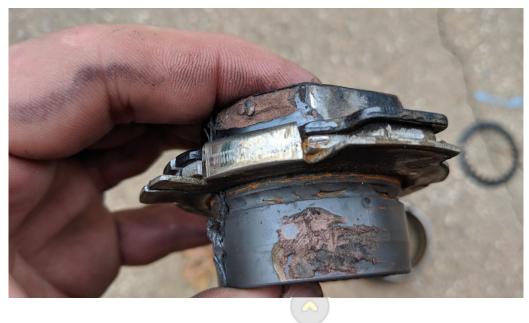
Here you can see the multiple layer sandwich construction of the body of the bearing (and more brass grease goose poo) the top layer is actually the edge of the core of the bearing sleeve that is encapsulated in the composite.

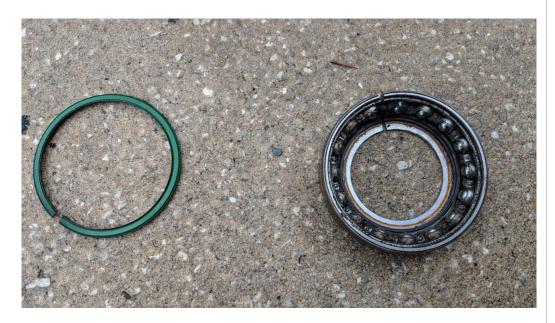
Here is the bearing top seal (green to the side) bearing case, outer race, ball cage holding the ball bearings, and you can JUST make out the lower lip seal in black that prevents any grease getting in or out at the bottom of the bearing extension tube.

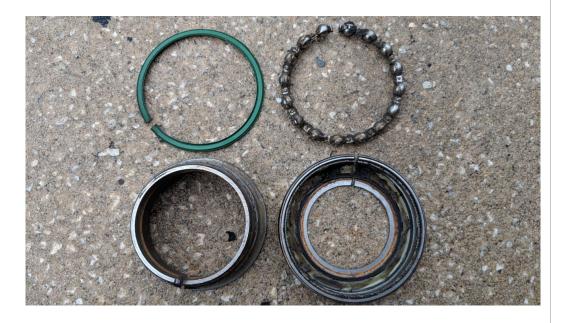
That's right, the bottom of the extension tube (bottom left) is shiny as it rotates and seals against the black ring in the case (bottom right)

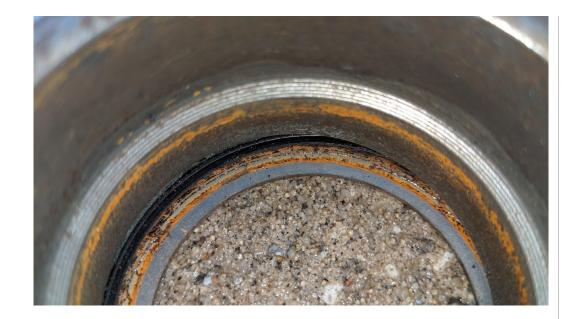
detail A misaligned to show seal:

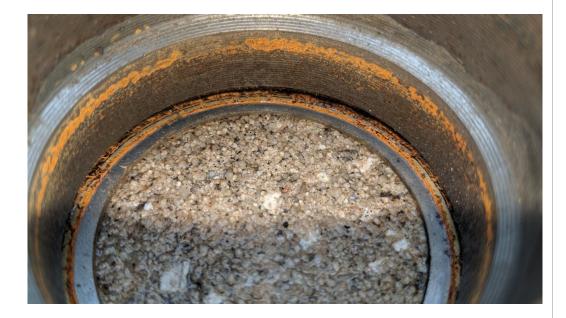
detail B properly resting against seal

You normally cannot see this as the inner slide tube passes through the opening the pictures were taken through and has very minimal clearance around it.

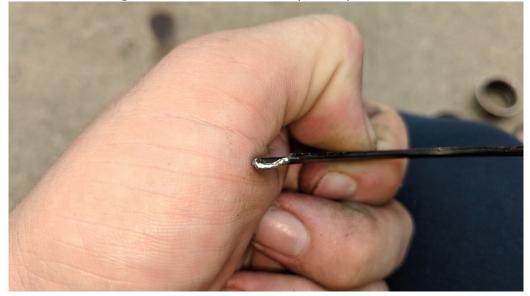
Detail c showing cleaned and remove lip seal profile:

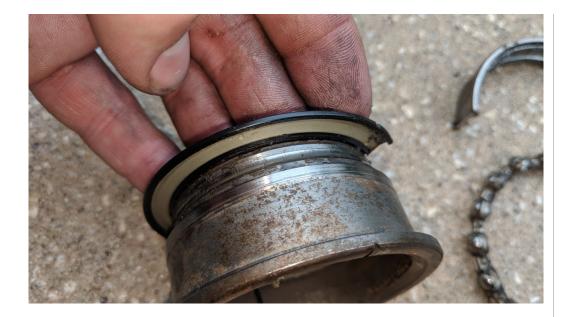
detail d showing bearing extension tube mated to seal.

NOTE: extension tube IS the inner race:

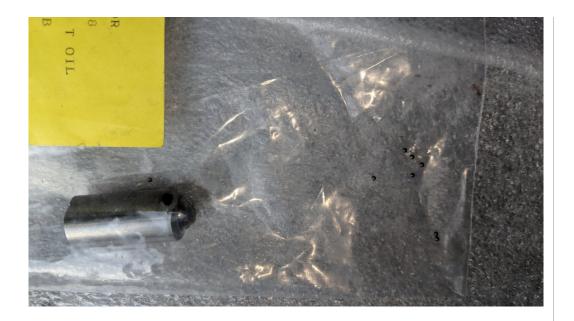
Going to far opens a cavity where behind the big ball are about a hounded tiny shot balls seen here:
